## **Educational Suitability Summary Report**

Toney Burger Activity Center

Date: 01/05/2021

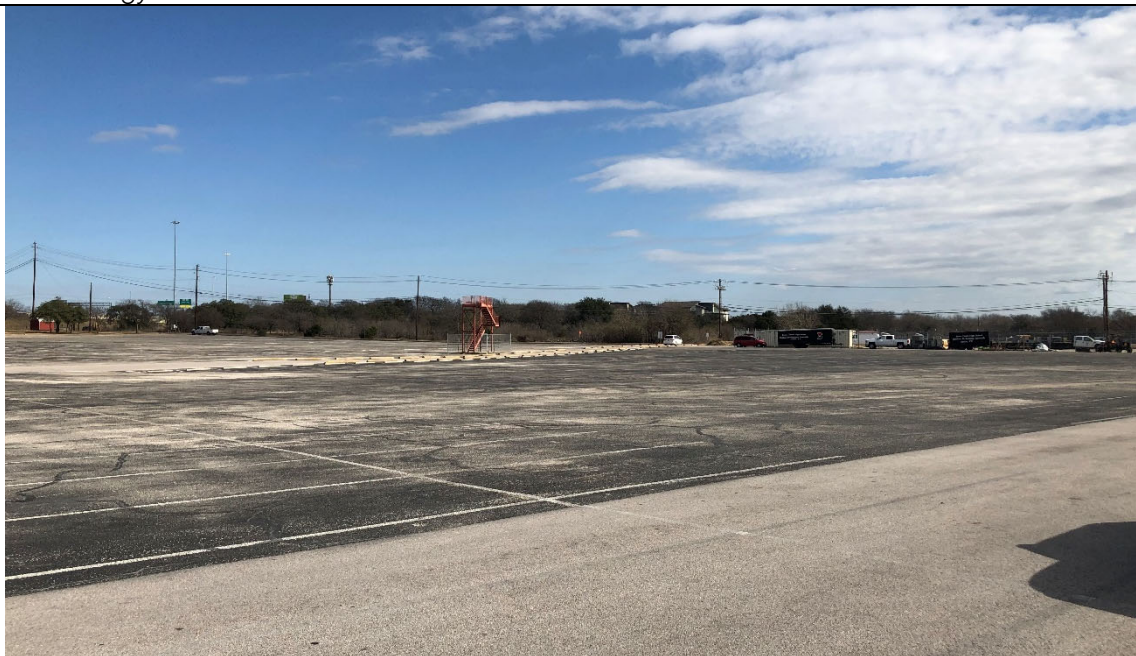
[REDACTED] The parking lot is used by the public for driving practice and shows wear and tear. The striping is faded and needs to be redone. One safety concern is that people walk across the road to get to the stadium during events. The field event area is not conducive to accommodating spectators. The field event area needs to be updated and the location needs to be evaluated. The outfield of the baseball field acts as a football practice field due to the limited space. The city of Austin used to let AISD use softball and baseball fields at a city-owned park, but this is no longer a viable option. As a result, there is an increase in the usage of all fields. This is creating a need for artificial turf at the baseball field to decrease maintenance.

*Condition of parking lot appears in fair condition. Some areas need repairs.*

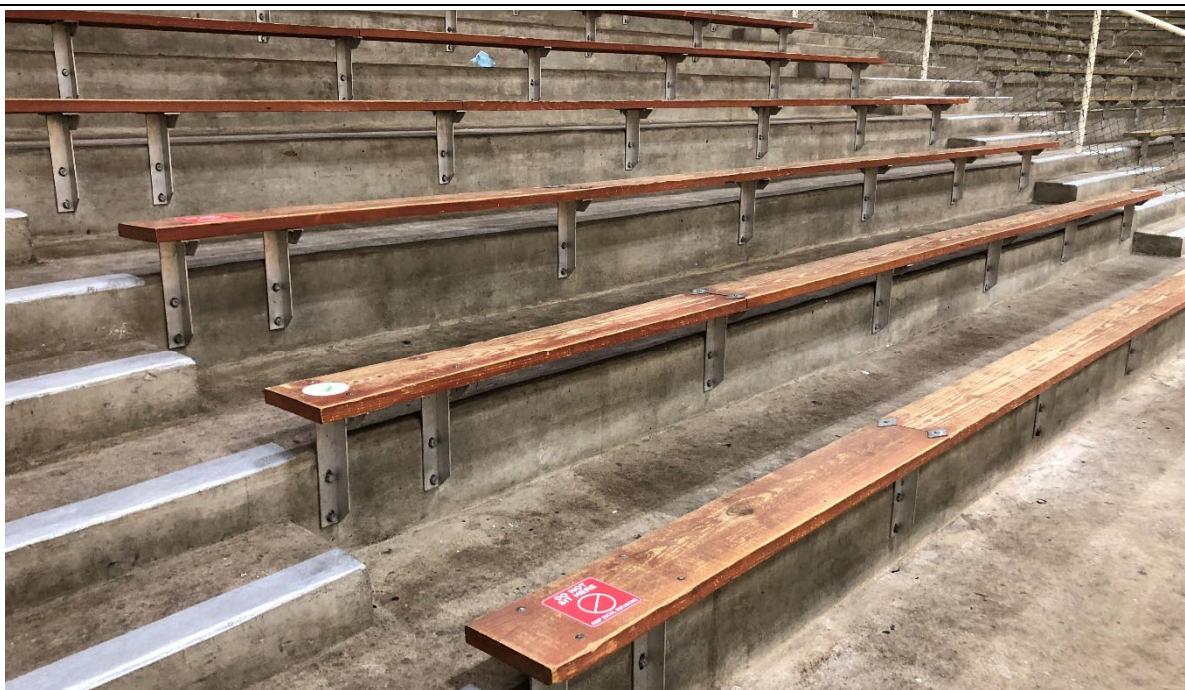
The wooden bleachers are original in the arena and are worn and splintering. The concrete steps are a tripping hazard and need visibility on the nosings. Railings need to be painted. The locker rooms need updated fixtures due to leaks and other issues. The training rooms do not have adequate supplies and are mostly used as storage rooms. The staff indicated mold issues around the office and locker rooms as well as rodent and odor issues. The facilities also have issues with the PA system's motherboard in the gym. The restrooms lack an ADA-compliant stall [REDACTED]

*Seating in arena area old and in worn condition.*

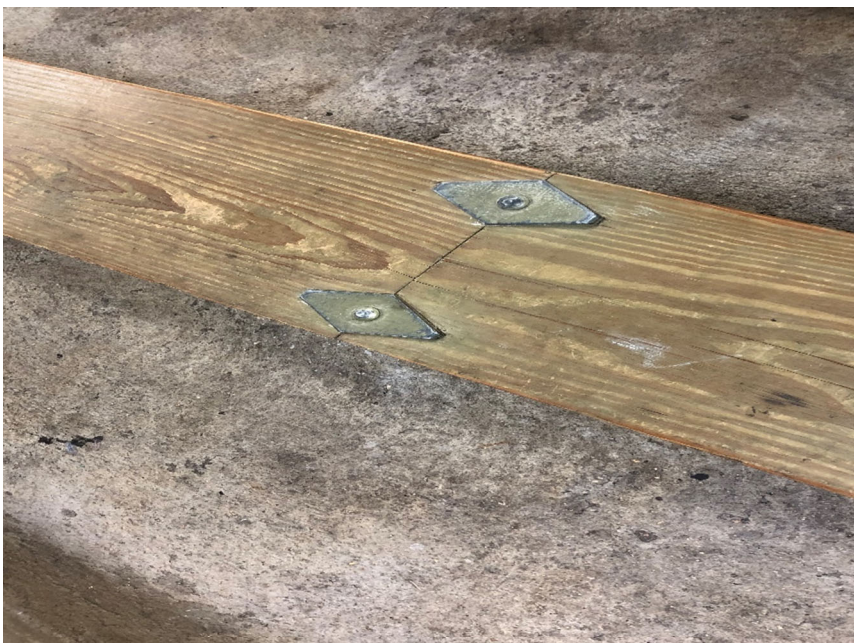
*Rough connection between sections of bench seating for spectators.*

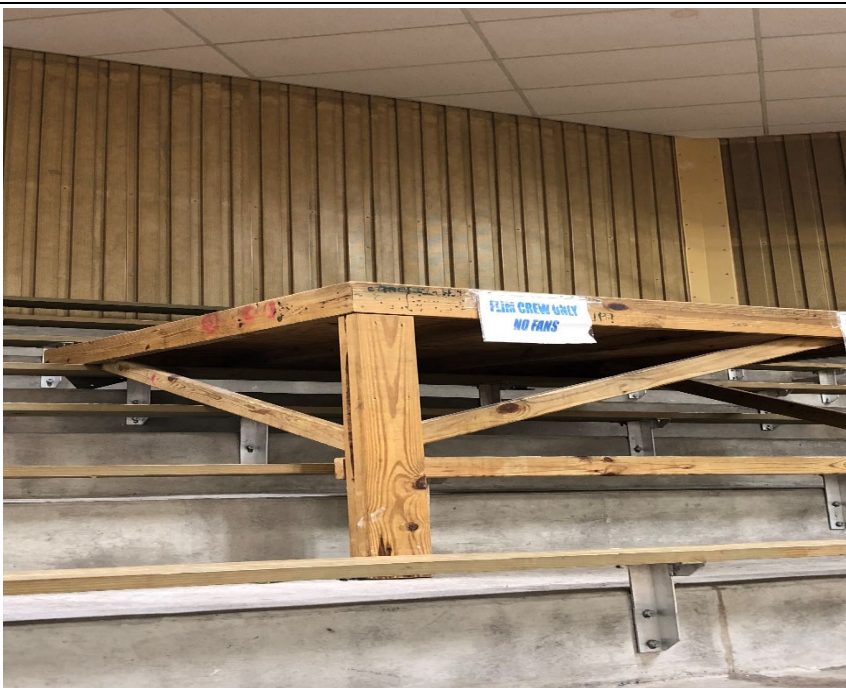
*Film crew platforms in bleachers appear worn, unstable and not in good condition.*

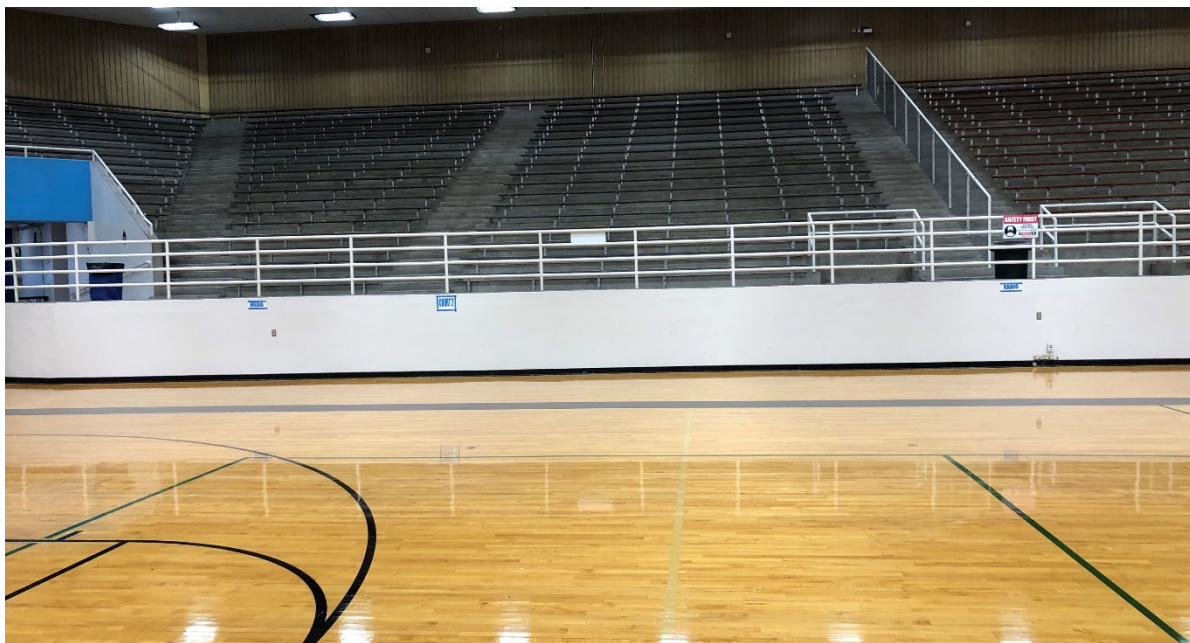
*Limited connectivity on opposite side for media.*

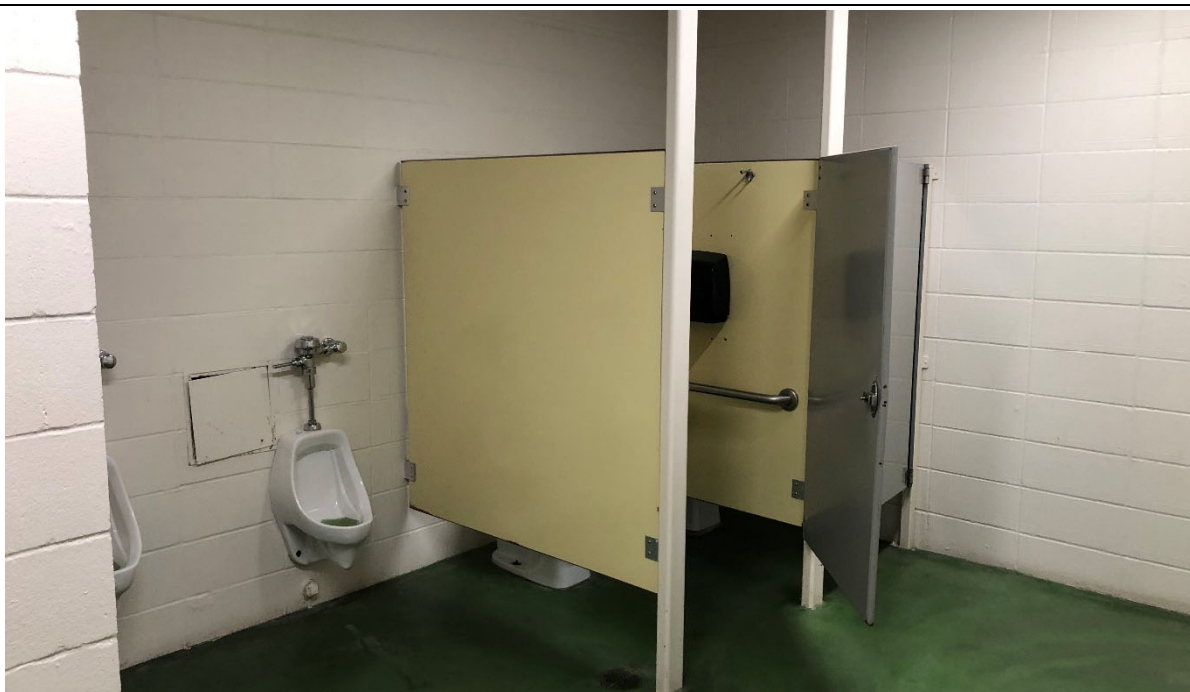
*Typical restroom under bleachers of gym/arena. Missing accessible restroom stall.*

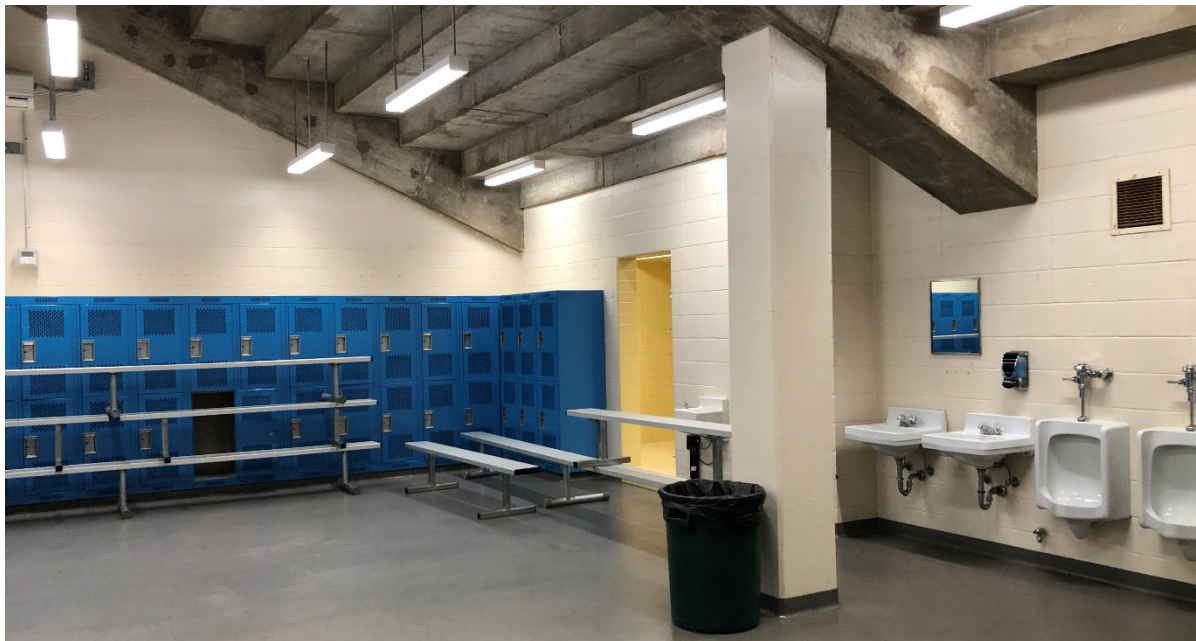
*Locker/dressing room under bleachers in fair condition. One restroom has leaking plumbing fixture. Lockers in good condition.*

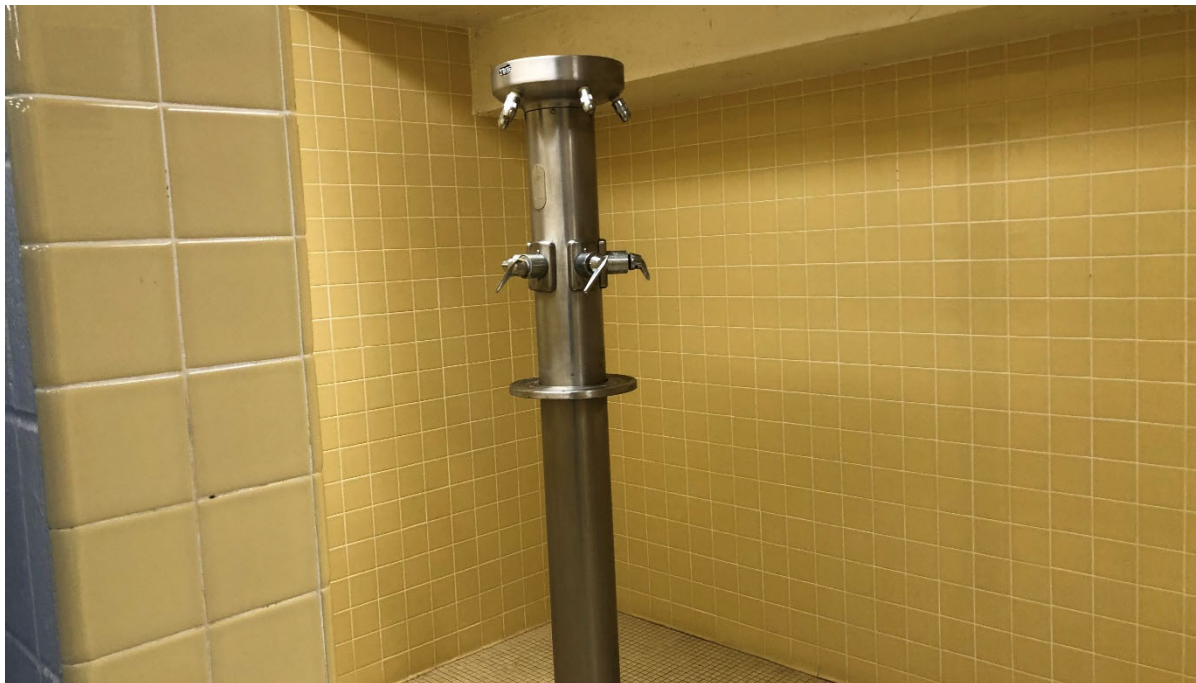
*Shower area in locker/dressing room appears in fair condition.*

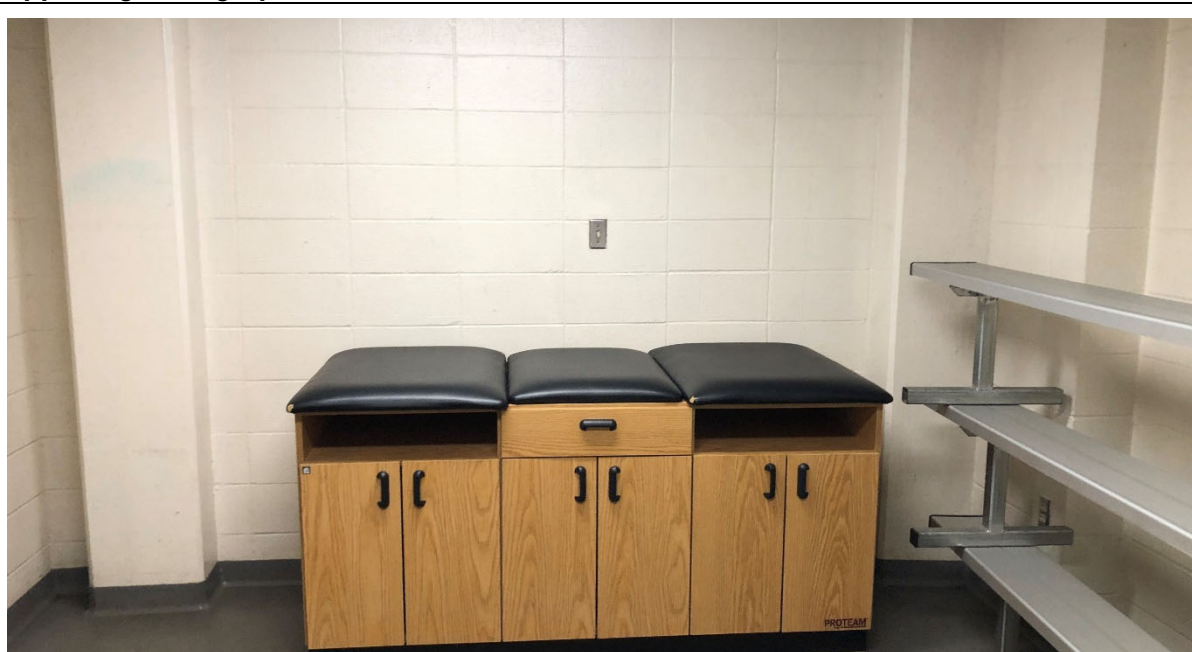
*Trainer room with bench in cushions that are worn.*

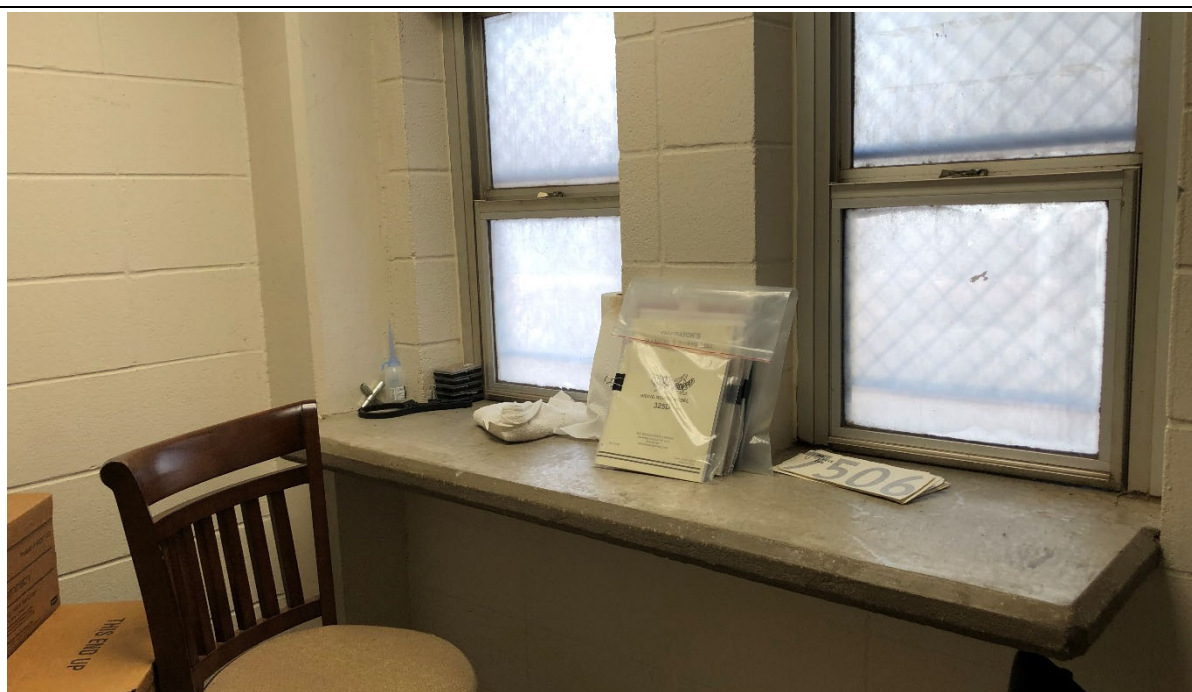
*Typical ticket booth at gym/arena building. No power or data at counter. Power at opposite wall of counter in booths.*

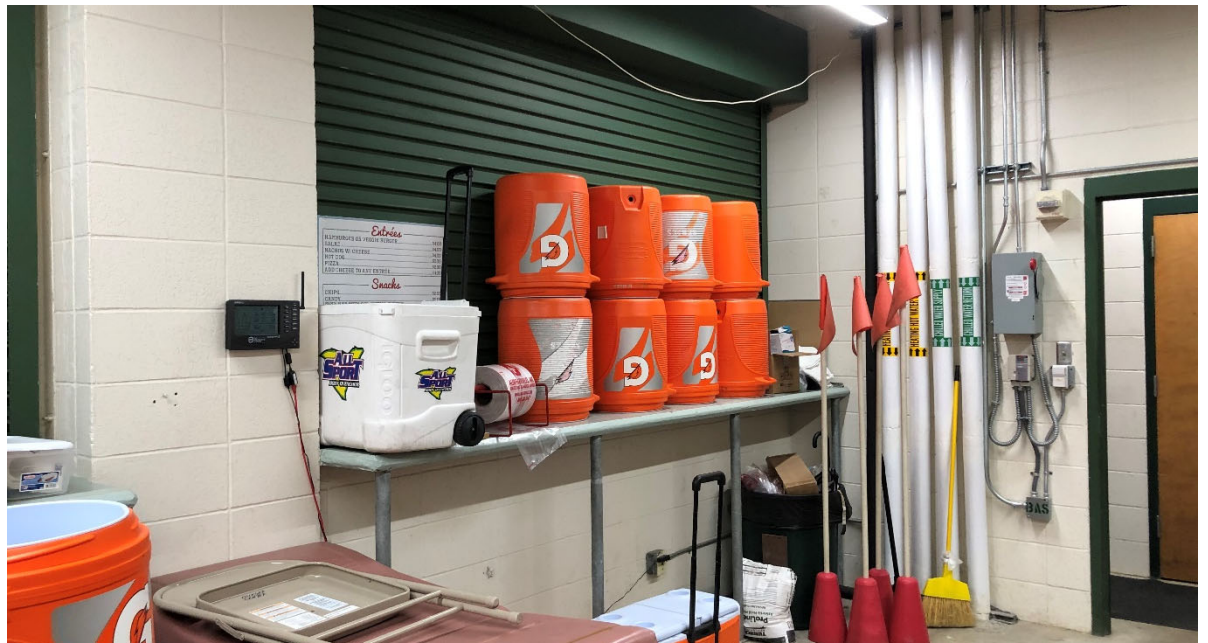
*Exposed utility lines in the concession room.*

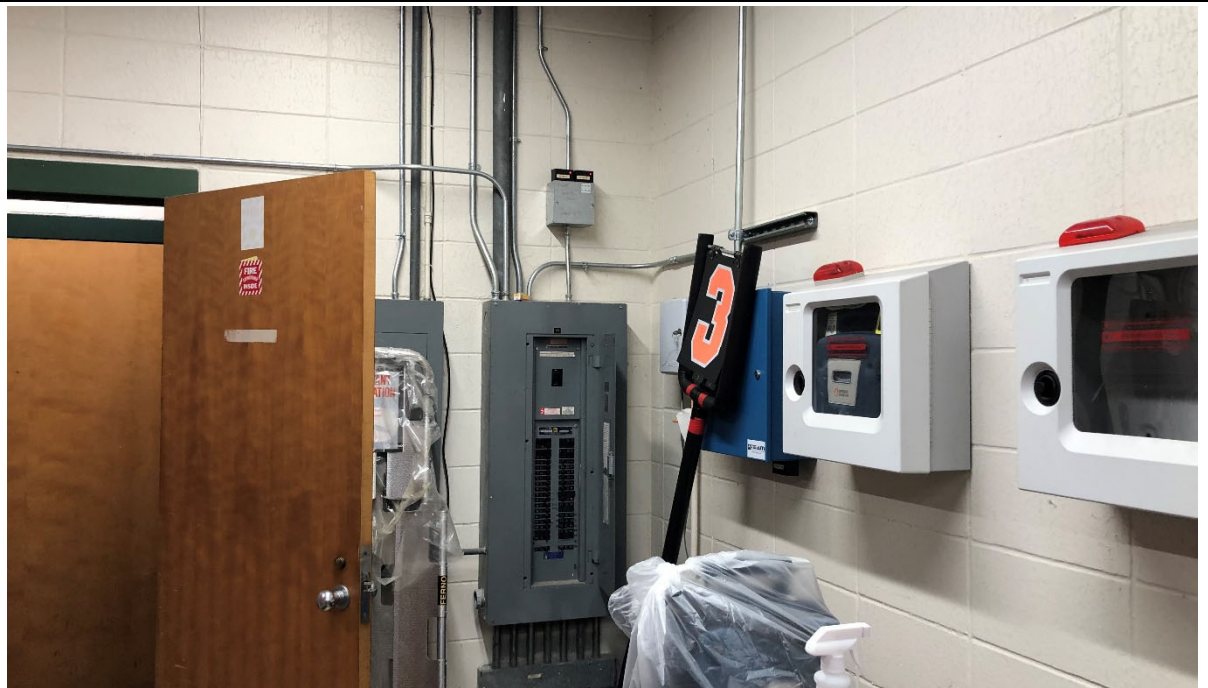
*Electrical panels sharing space in the concession room.*

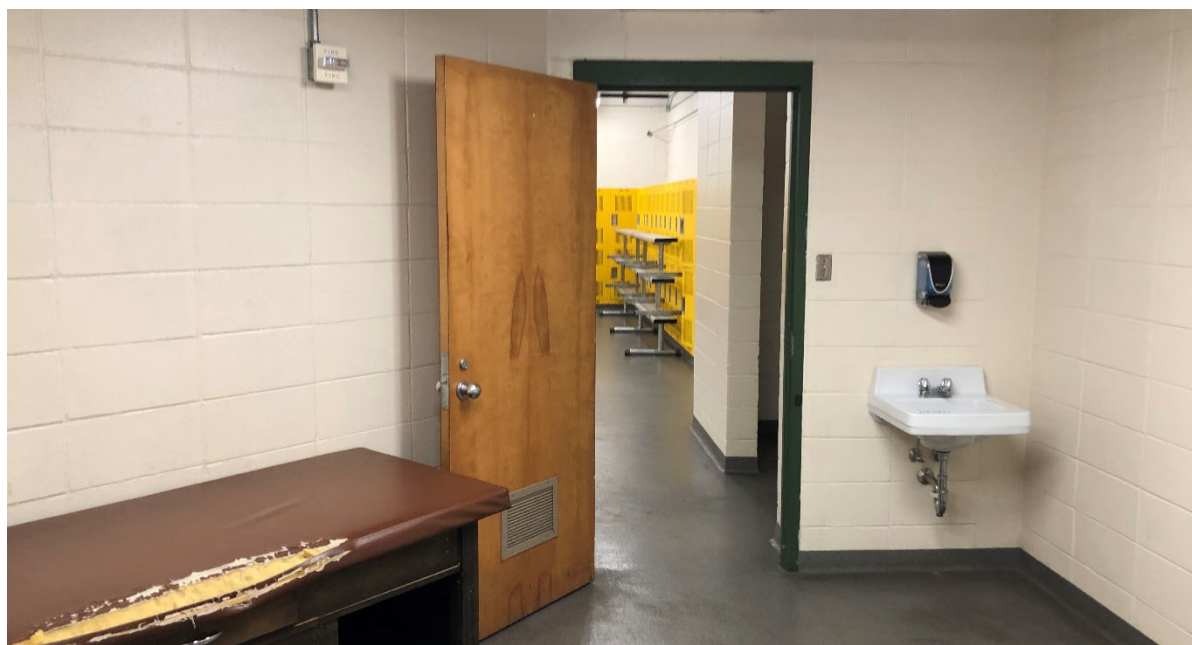
*Other training room with torn equipment/furniture.*

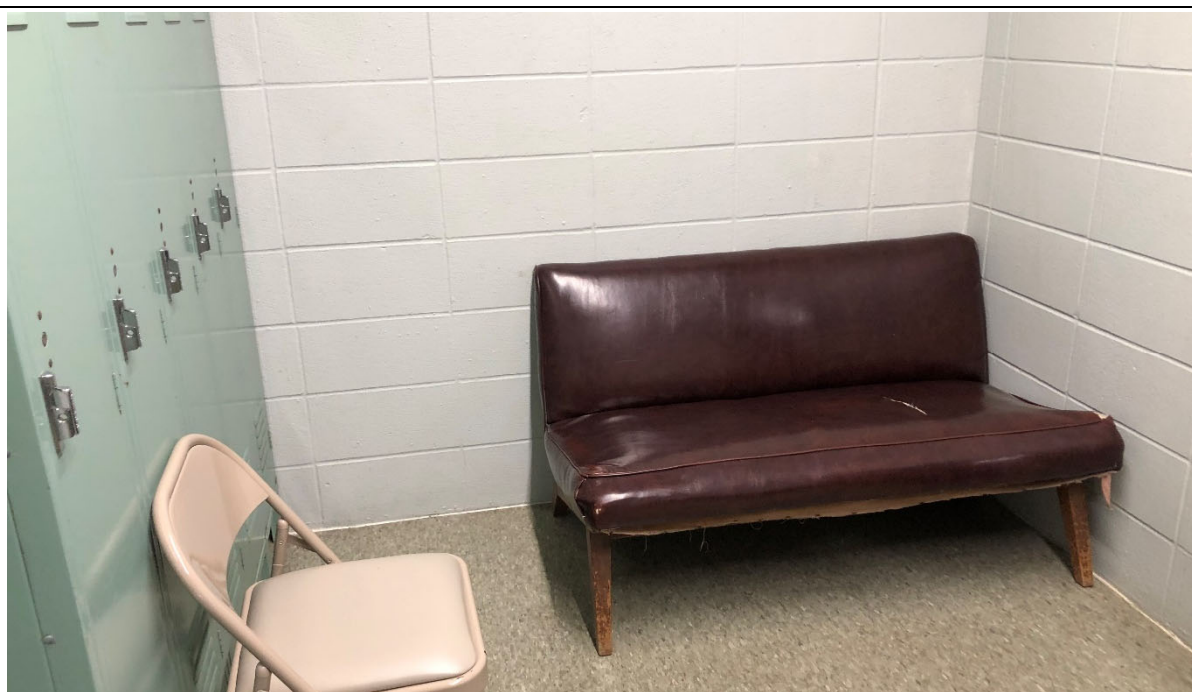
*Officials' room with minimal old and worn furniture.*

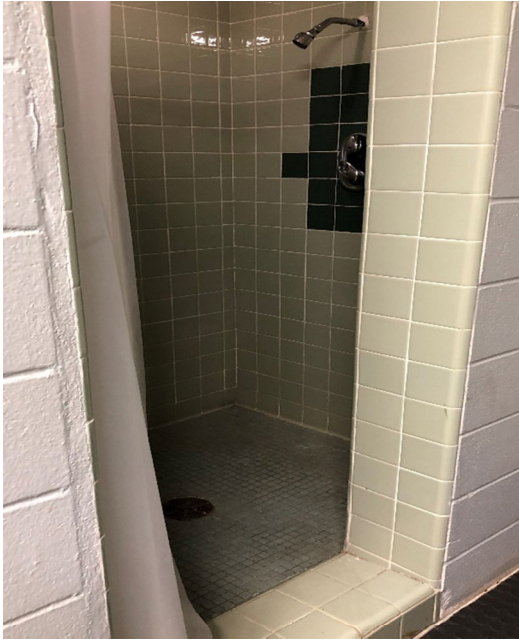
*Officials' room shower with dated tile and in poor condition. Shower is not ADA-compliant.*

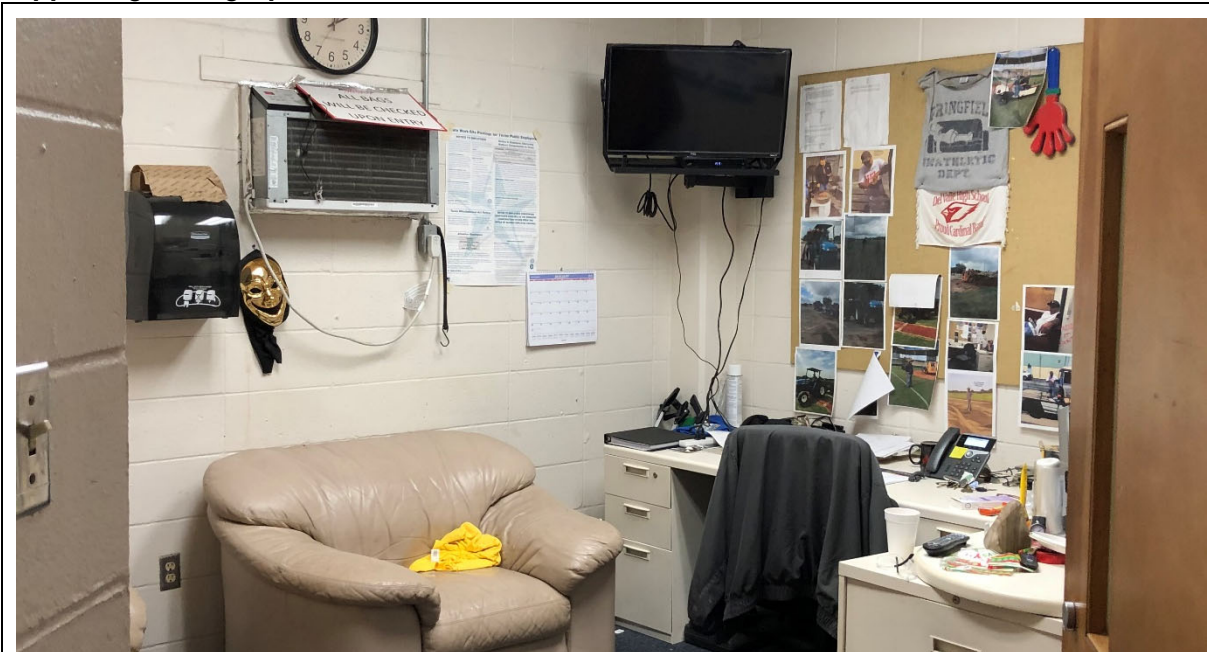
*Small, windowless grounds maintenance department office.*

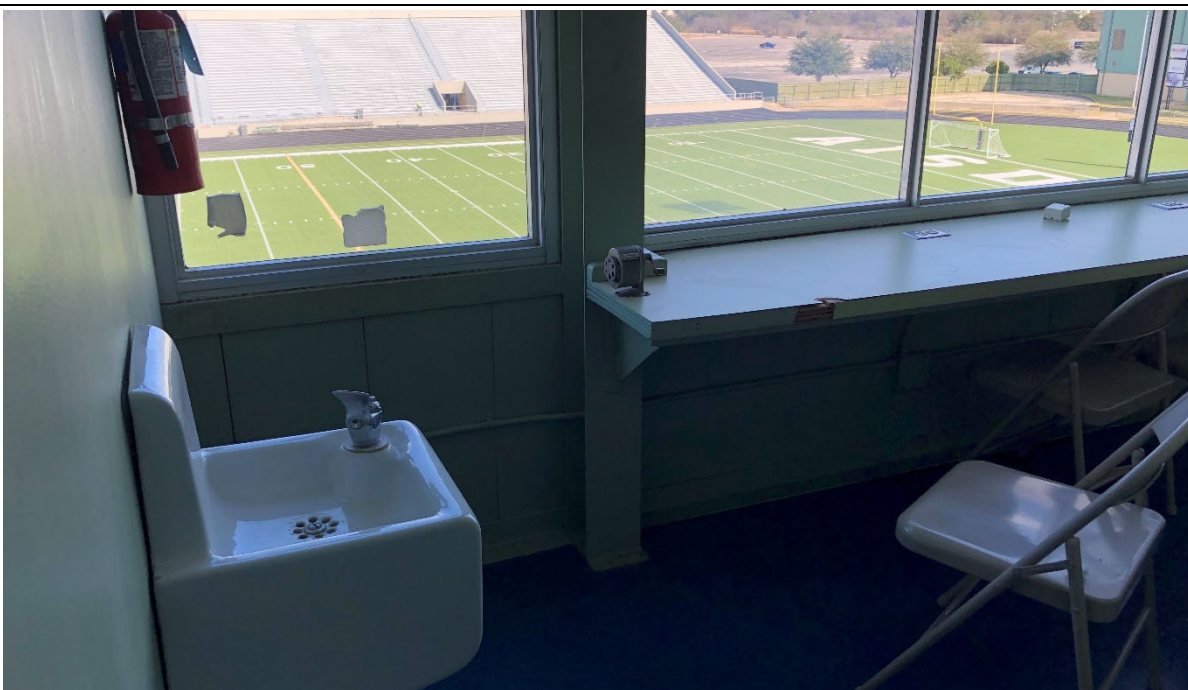
*View of press box with dated fixtures and worn and deteriorating countertop.*

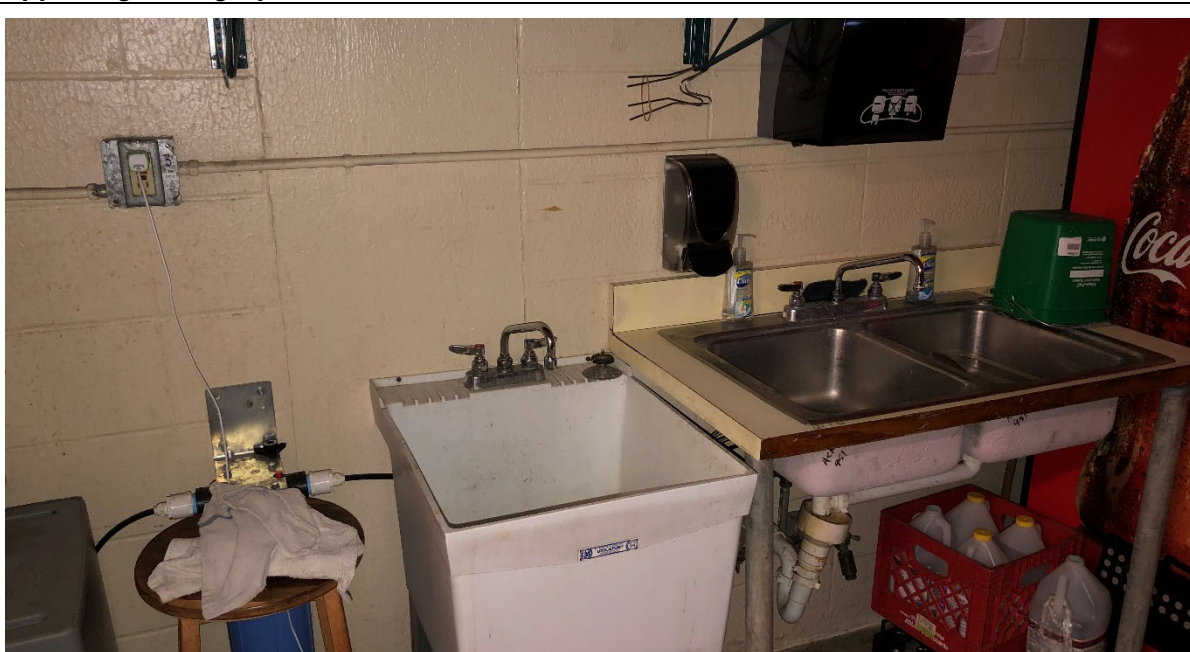
*Sink at concession with deteriorating countertop and old plumbing fixtures.*

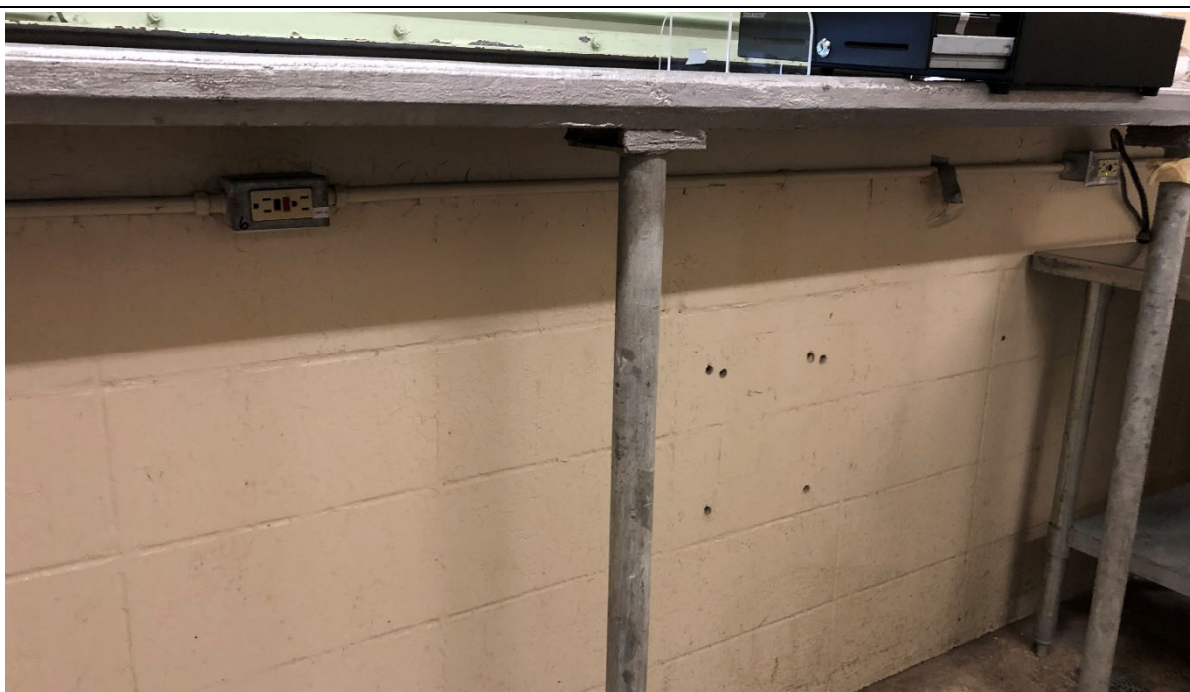
*Power outlets not conveniently located under concrete counter at concession. Wall and posts stained and in need of painting.*

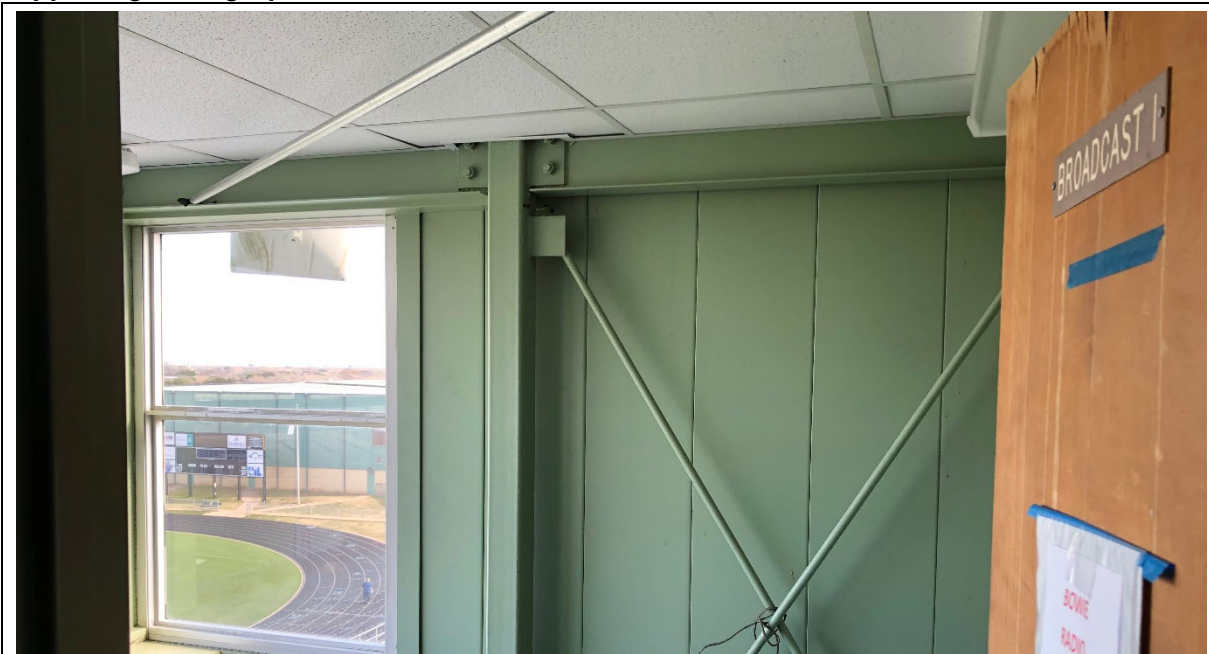
*Broadcast space at press box with deteriorating door and exposed cables.*

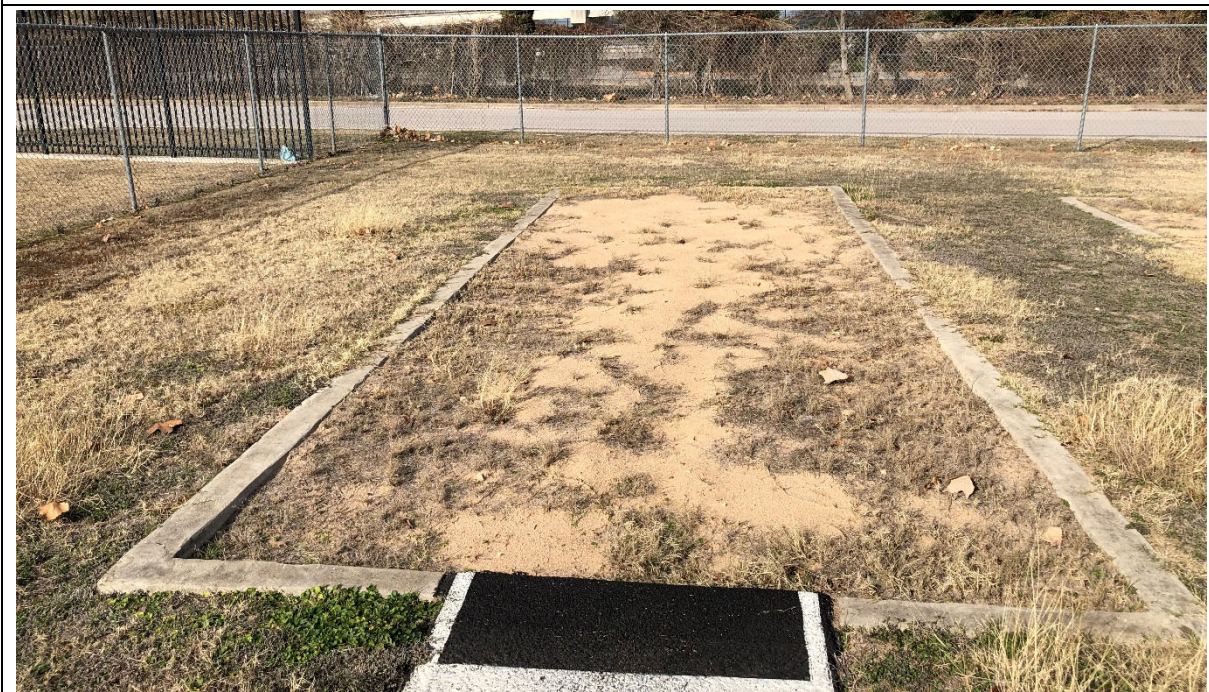
*Landing at long jump runway needs maintenance with overgrowth of grass into sand pit.*

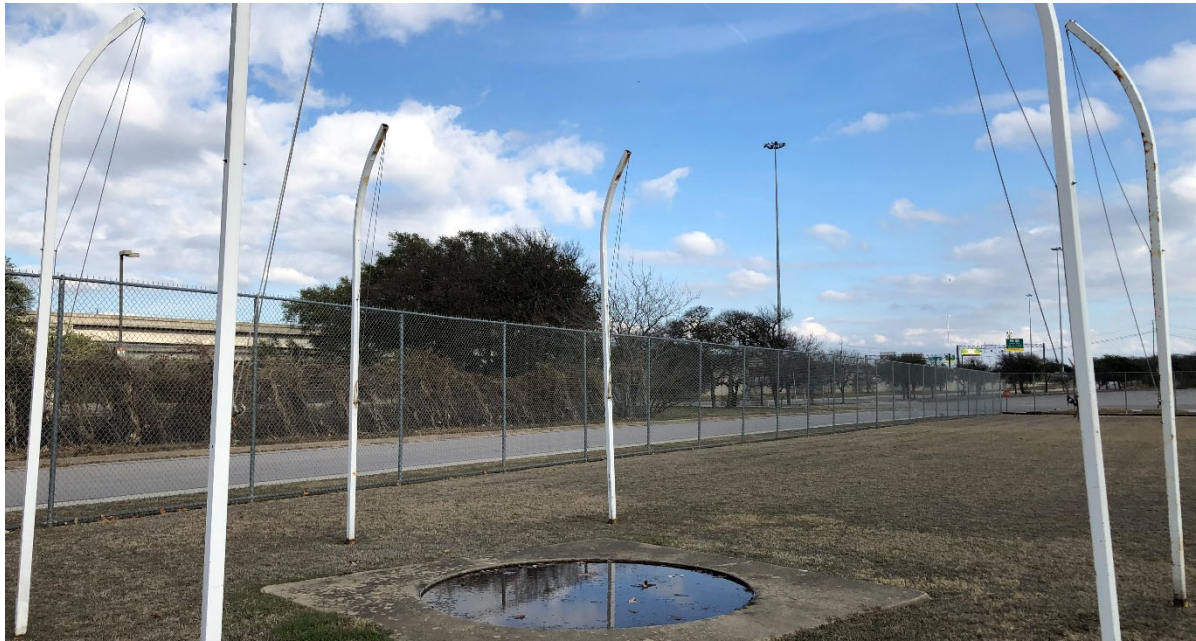
The turf on both play fields and their respective scoreboards appear to be in very good condition. Press boxes at the main stadium do not have elevator access. The seating is in poor condition and needs improvements. Concession and ticket booths also need updates. There are deteriorating countertops and dated plumbing fixtures in the concessions area. Stadium restrooms have been updated and appear to be in good condition. The baseball field and track appear to be in fair condition. The press box at the baseball field is very small and is in poor condition with both old and new technology. The long jump runways appear to be in good condition; however, the sand pit landing area is overgrown with grass. The pole vault box is filled with water. The discus cage frame appears rusted and in poor condition.

*Discus cage frame appears in poor condition and rusted.*

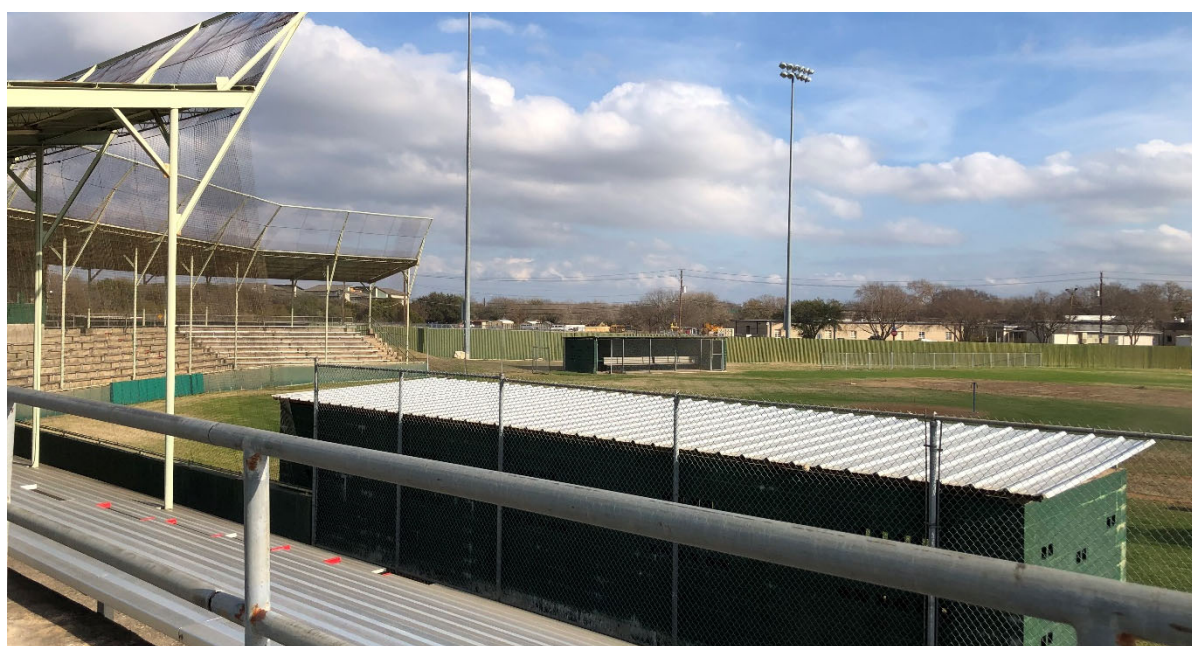
*Baseball field requiring maintenance from overgrown grass at dirt base areas.*

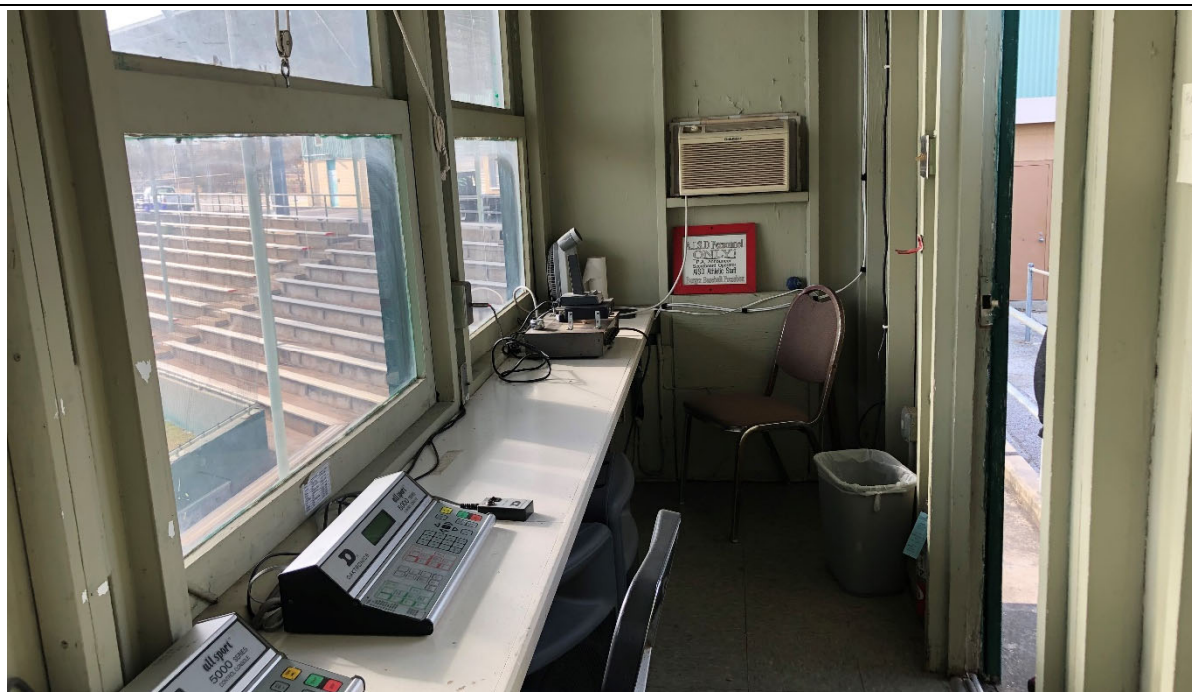
*Press box of baseball field small with old equipment.*
