# FACILITY CONDITION ASSESSMENT

Allison ES | February 2022

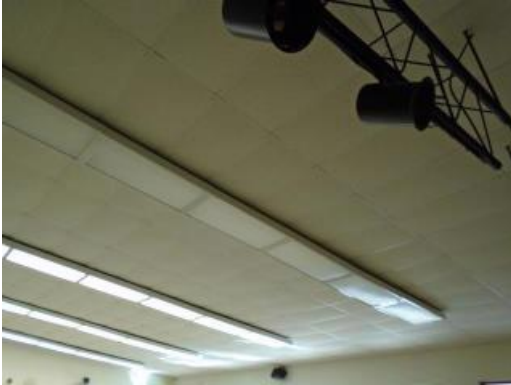
Ceiling lights out

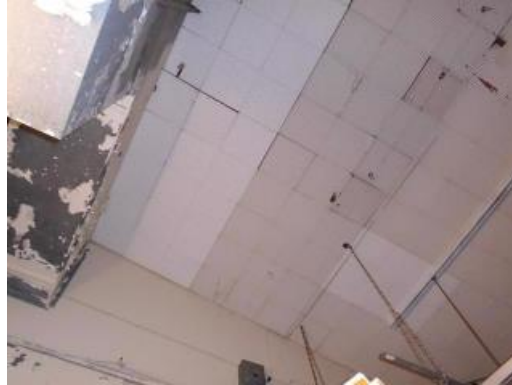
Ceiling accoustical tiles aged

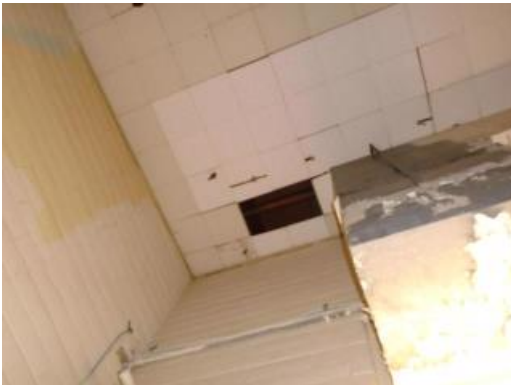
Aged glued accoustical tiles

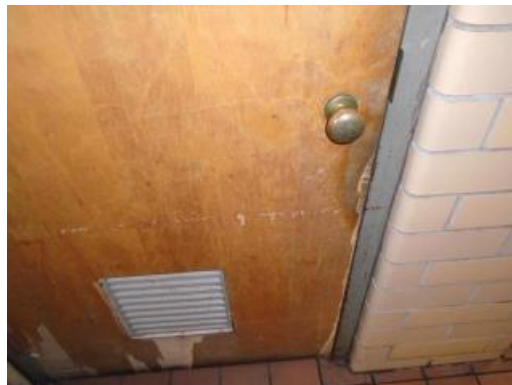
Interior wood door at end of life

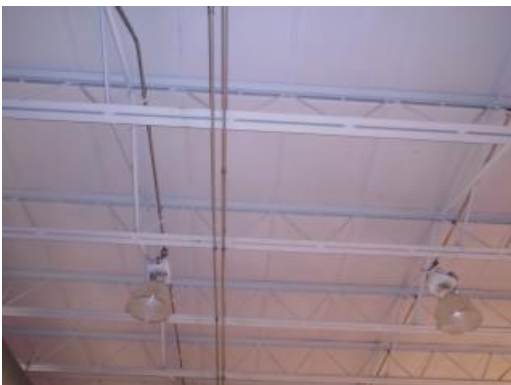
HID lights out

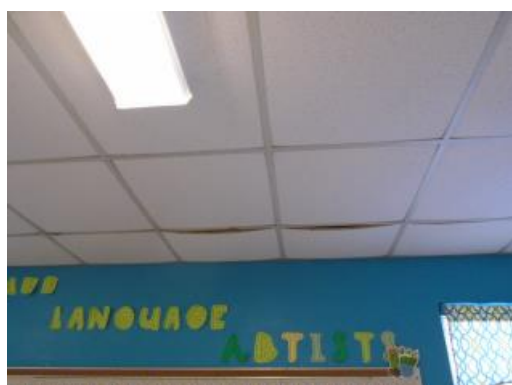
Sagging classroom ceiling tiles

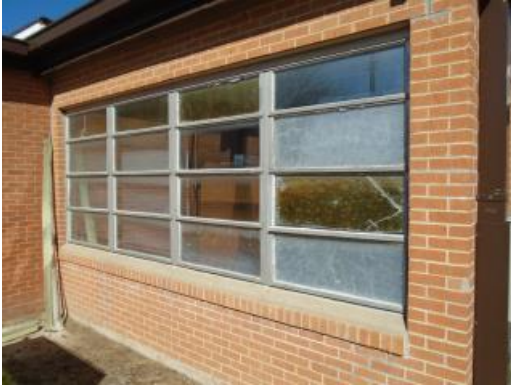
Broken exterior aluminum windows

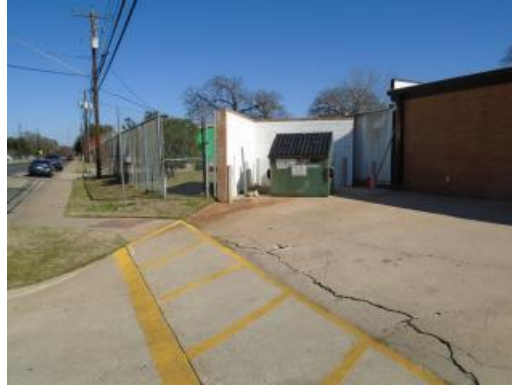
Cracked concrete driveway

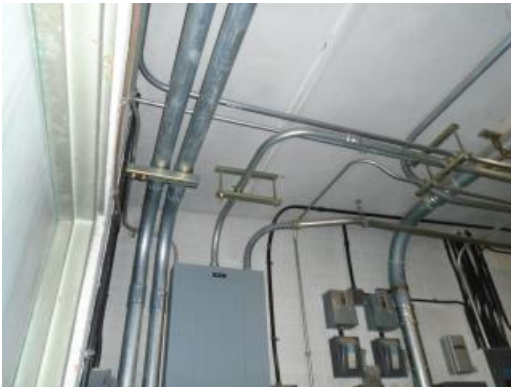
Aged electrical system

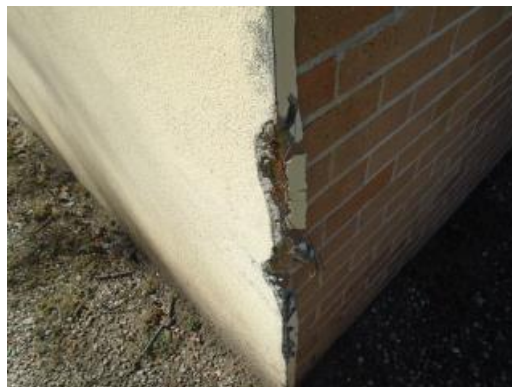
Broken and aged exterior wall

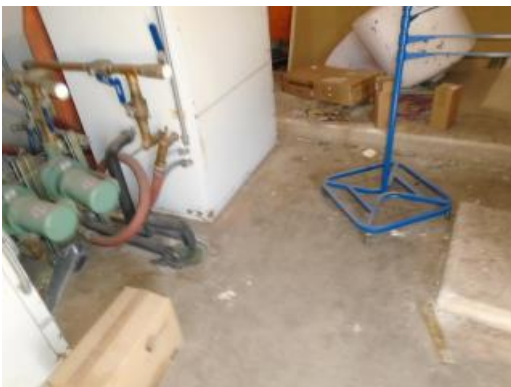
Old domestic water pumps at end of life
