FACILITY CONDITION ASSESSMENT

Baldwin ES | February 2022

Executive Summary

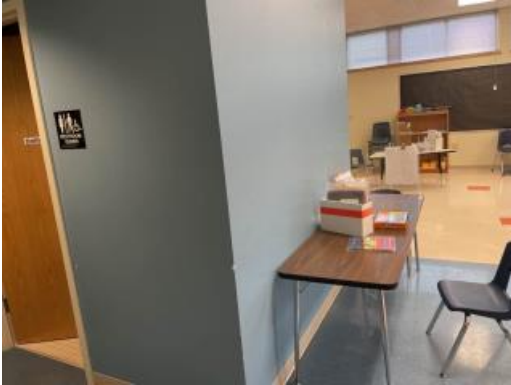
Nicks and peeling paint in classrooms

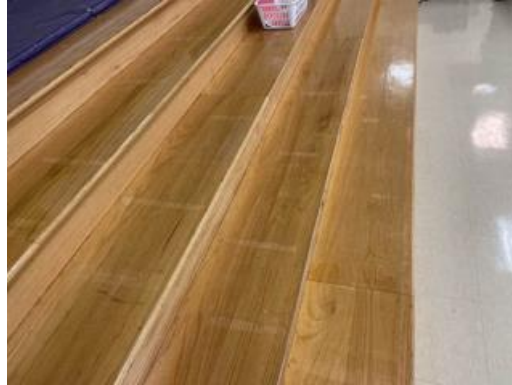
Deficient wood stage

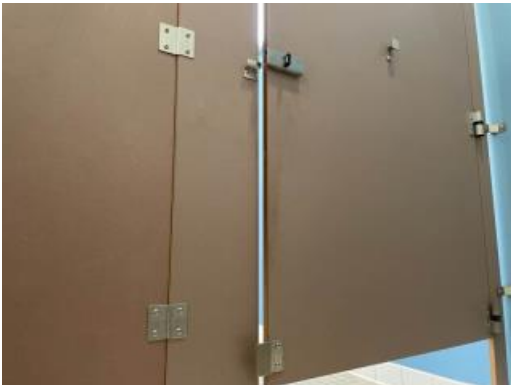
Restroom partition wall at end of life

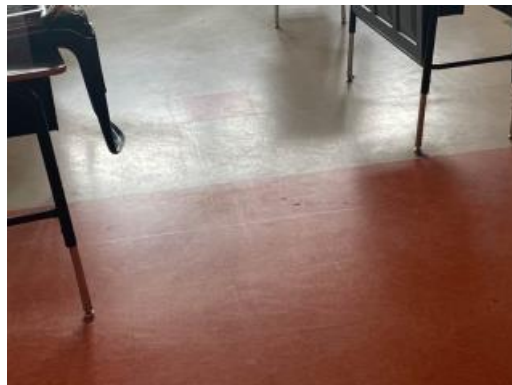
Vinyl composition tile flooring at end of life

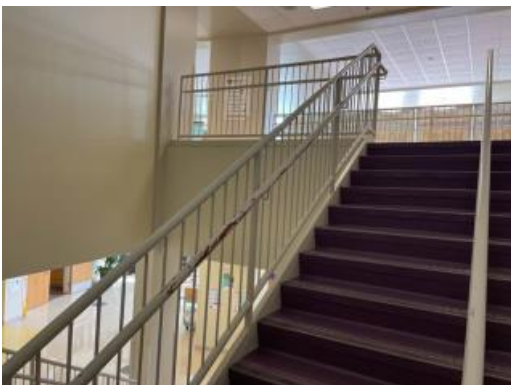
Stairwell railing missing paint and is aged

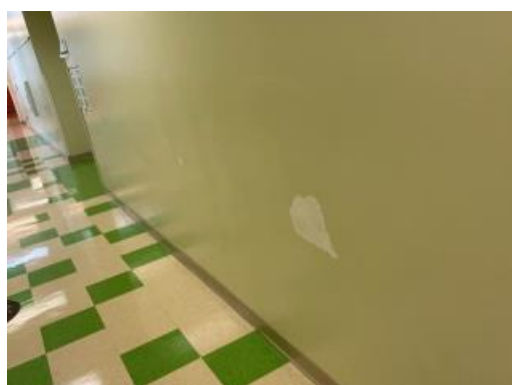
Missing paint on walls

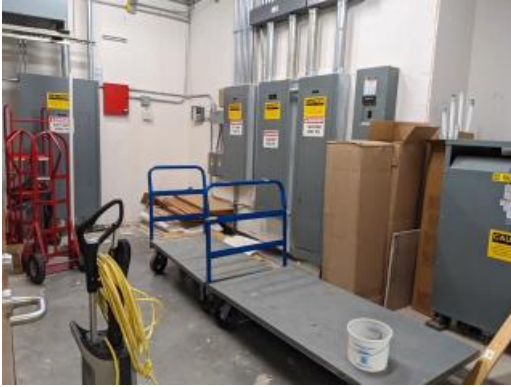
Obstructed electrical panels
