# FACILITY CONDITION ASSESSMENT

*Barton Hills ES* | February 2022

Barton Hills ES is located at 2108 Barton Hills Dr in Austin, Texas. The oldest building is 56 years old (at time of 2020 assessment). It comprises 38,170 gross square feet.

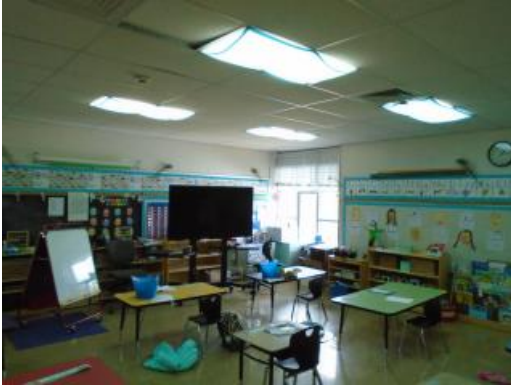
Broken classroom interior lighting and ceiling tiles

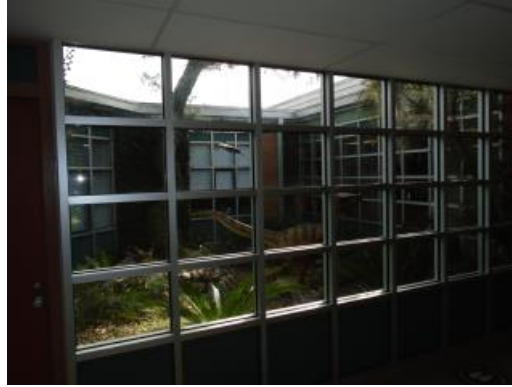
Aged aluminum windows

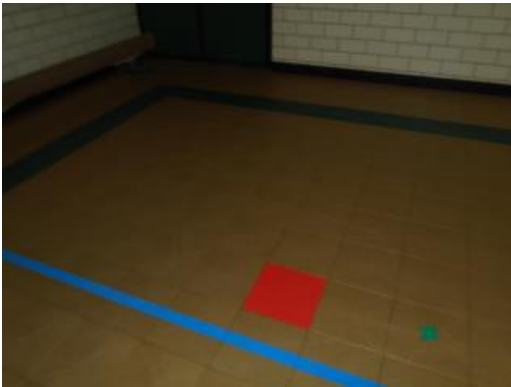
Aged floor tiles

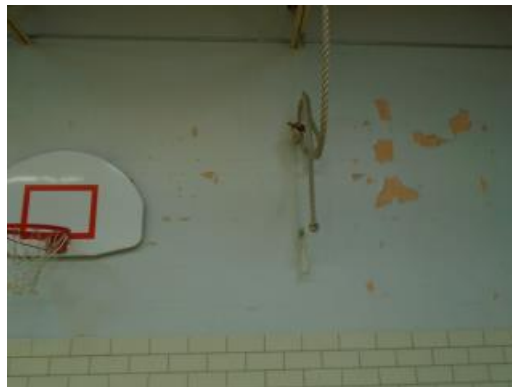
Peeling wall paint
