# FACILITY CONDITION ASSESSMENT

*Clayton ES* | February 2022

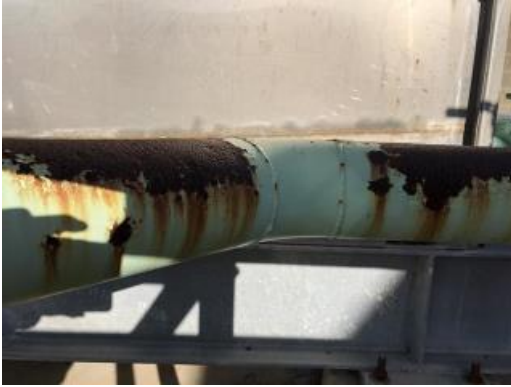
Rusted exterior pipe

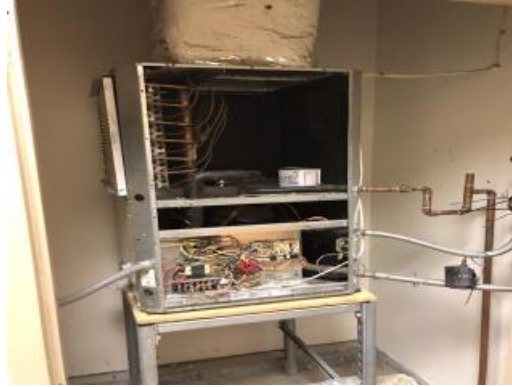
Exposed wiring
