# FACILITY CONDITION ASSESSMENT

*Dawson ES* | February 2022

Dawson ES is located at 3001 S 1st St in Austin, Texas. The oldest building is 66 years old (at time of 2020 assessment). It comprises 55,301 gross square feet.

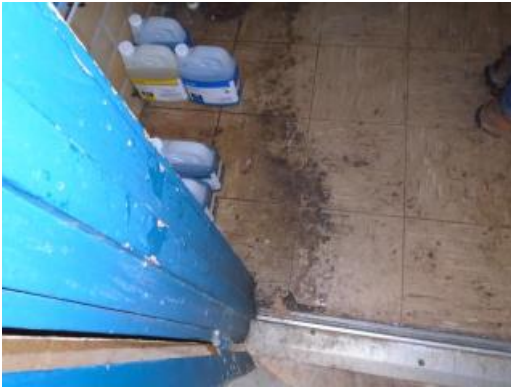
Damaged wooden door frame and floor tiles

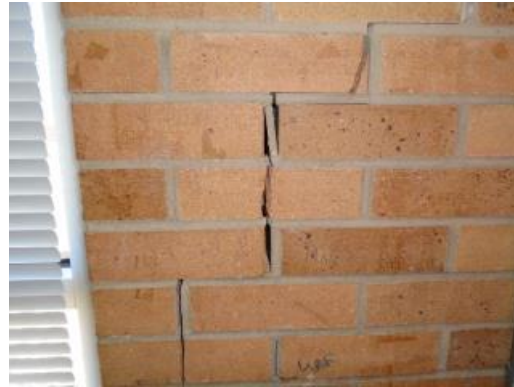
Mortar failure on brick

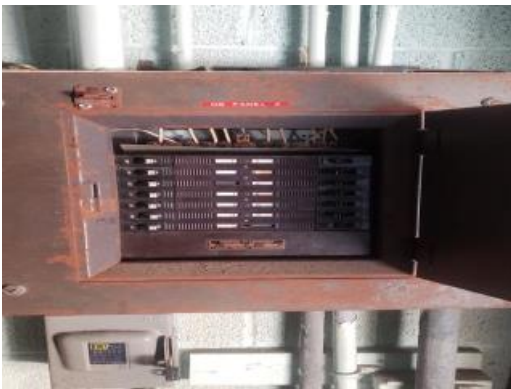
Aged electrical panels

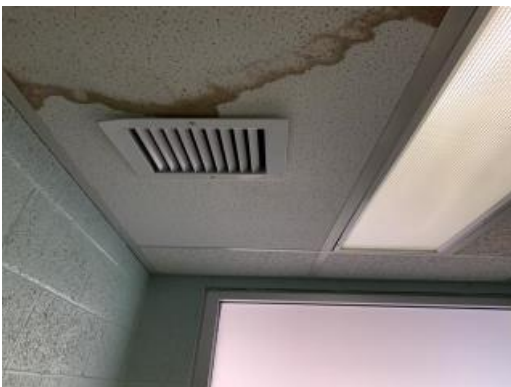
Stained Ceiling

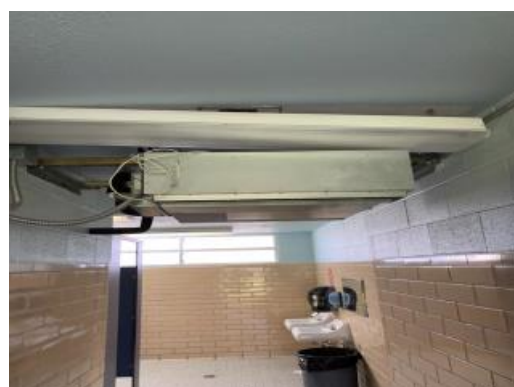
Mechanical equipment beyond useful life

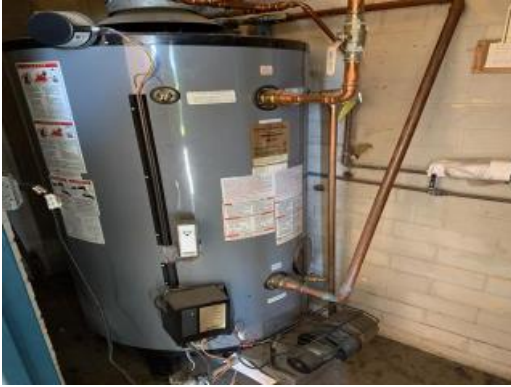
Aged water heater
