# FACILITY CONDITION ASSESSMENT

*Galindo ES* | February 2022

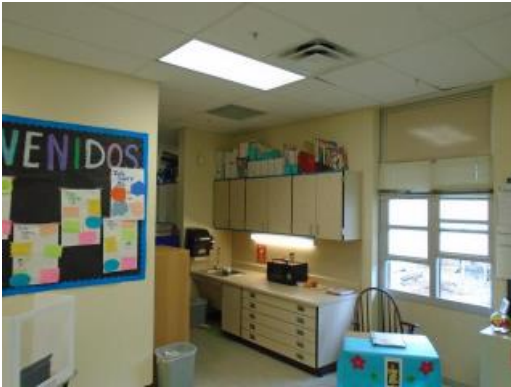
Classroom casework

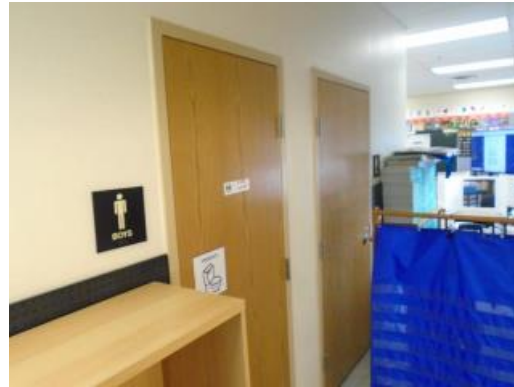
Interior wooden doors at men's and women's restrooms

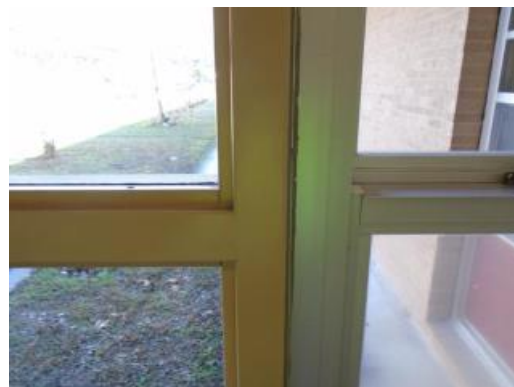
Exterior windows are aged

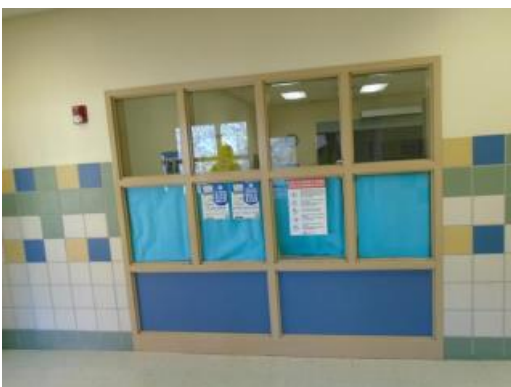
Metal interior window and Ceramic Tile

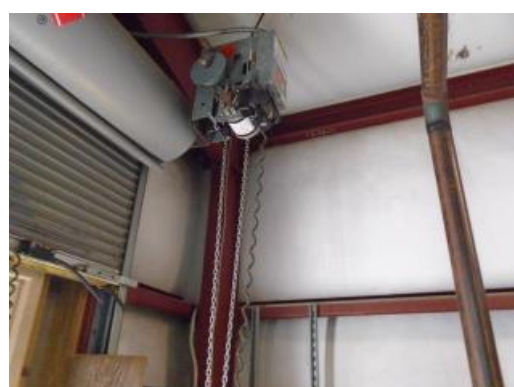
Overhead door equipment

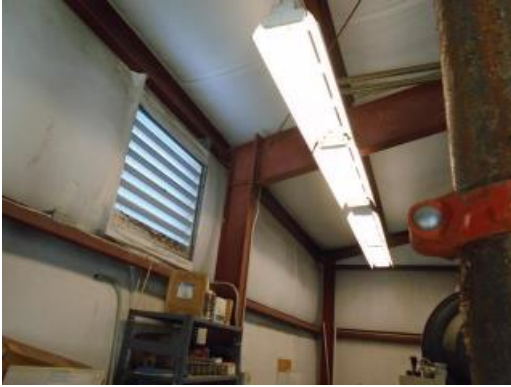
Interior lighting aged
