# FACILITY CONDITION ASSESSMENT

*Govalle ES* | February 2022

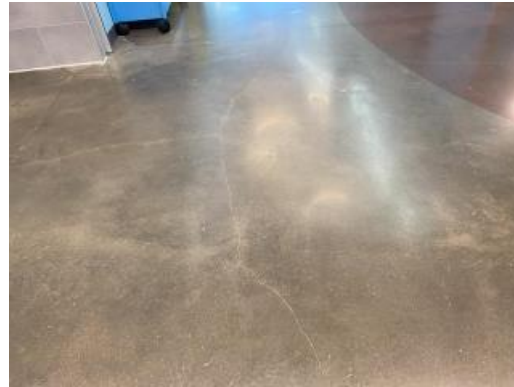
Concrete floor is beginning to crack.
