FACILITY CONDITION ASSESSMENT

Highland Park ES | February 2022

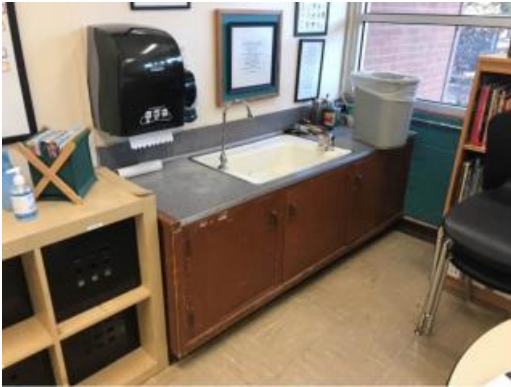
Classroom cabinets are beyond service life.

Deficiency	Category	Qty	UoM	Priority	Repair Cost	ID
Replace Cabinetry In Classes/Labs	Capital Renewal	25	Room	4	\$220,047	6006

Note: Casework needs to be replaced.

Location: All Old Classrooms

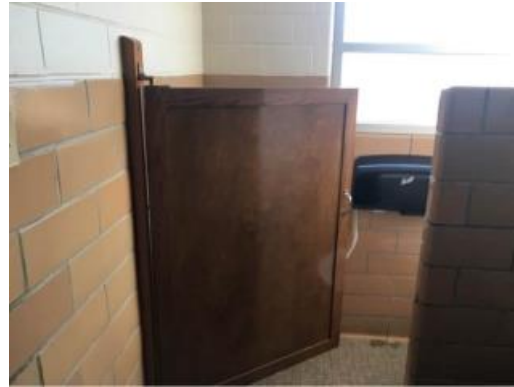
Class restroom partitions are beyond service life.

Deficiency	Category	Qty	UoM	Priority	Repair Cost	ID
Toilet Partition Replacement	Capital Renewal	20	Stall	4	\$40,330	6004

Note: Beyond Usueful life

Location: Classroom Restrooms and Rooms 101, 102, 103, 104, 105, 106, 201, 202, 203, 204, 205, 206, 207, 208,209, 210.

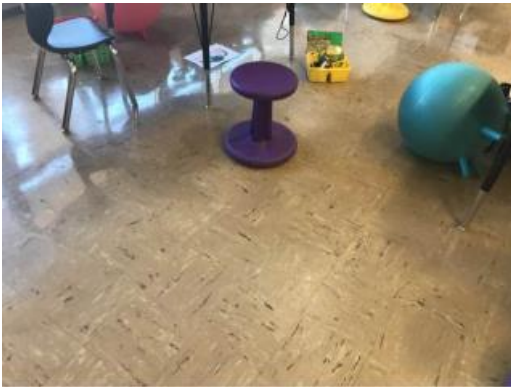
Classroom vinyl asbestos tile flooring is beyond service life.

Vinyl Composition Tile Replacement	Capital Renewal	12,199	SF	4	\$99,760	6005
------------------------------------	-----------------	--------	----	---	----------	------

Location: VAT Flooring Classrooms, 201 thru 210, 102, 104,108

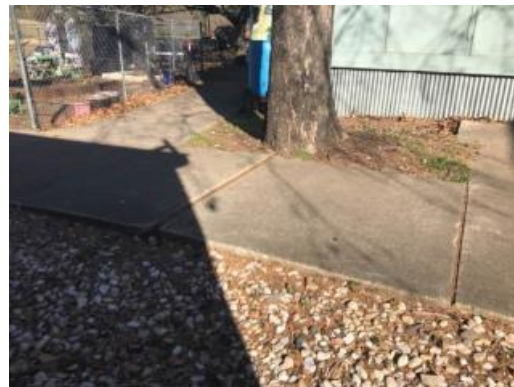
Site sidewalk is damaged and is a trip hazard.
