FACILITY CONDITION ASSESSMENT

Mathews ES | February 2022

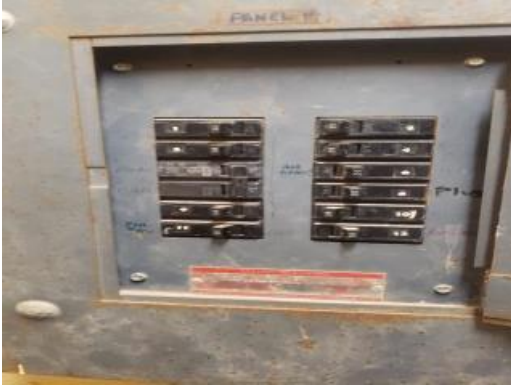
Aged distribution panel

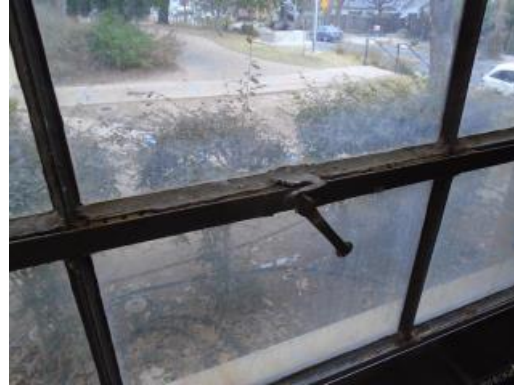
Aged window panel

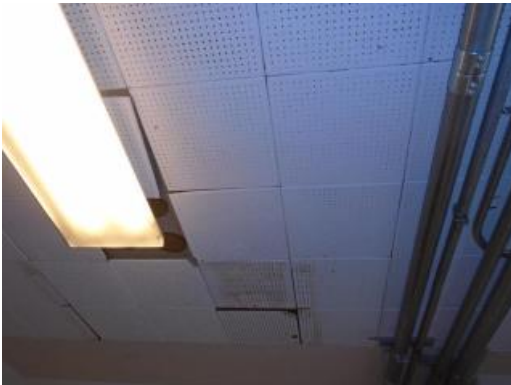
Glued ceiling tiles are damaged and missing

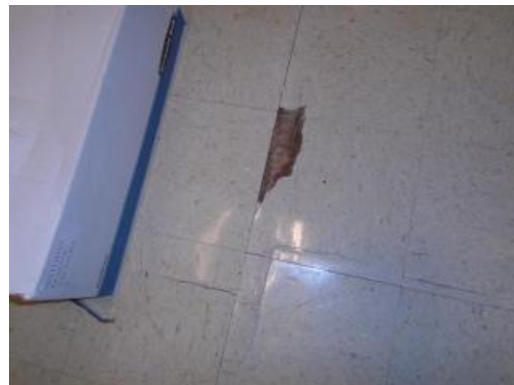
Damaged vinyl composition tile flooring

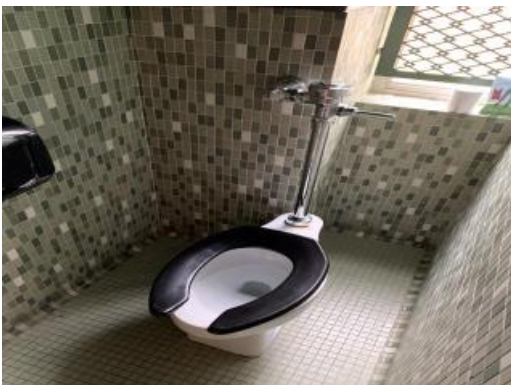
Aged plumbing fixtures
