# FACILITY CONDITION ASSESSMENT

*McBee ES* | February 2022

### Building: 165A - Main building includes Administration Offices, Classrooms, Cafeteria, & Gym.

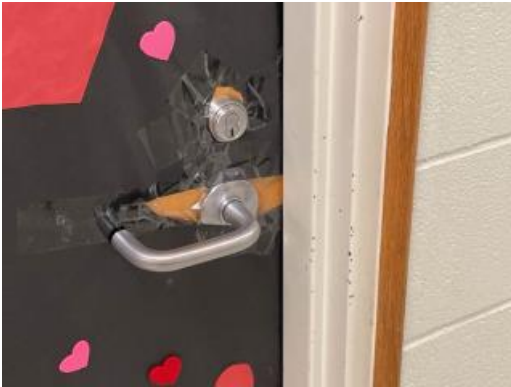
worn door entryway paint

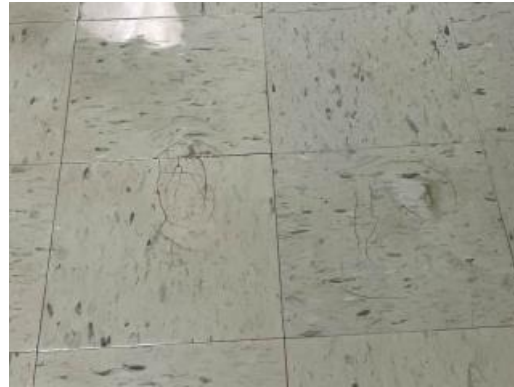
Worn vinyl composite tile

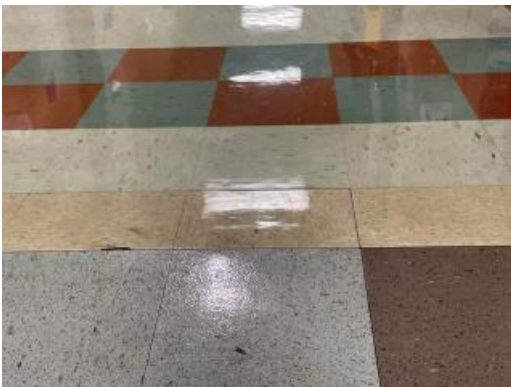
Worn vinyl composite tile is chipped

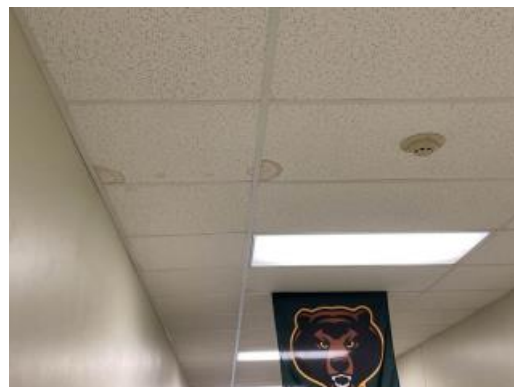
Stained acoustic ceiling tiles

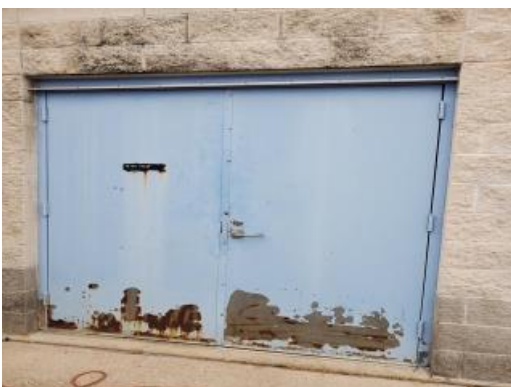
Exterior metal door

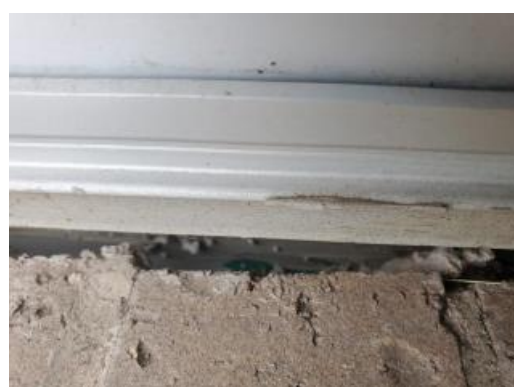
Aged sealant

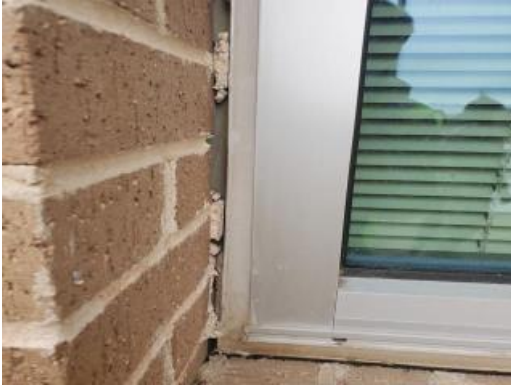
Aged sealant

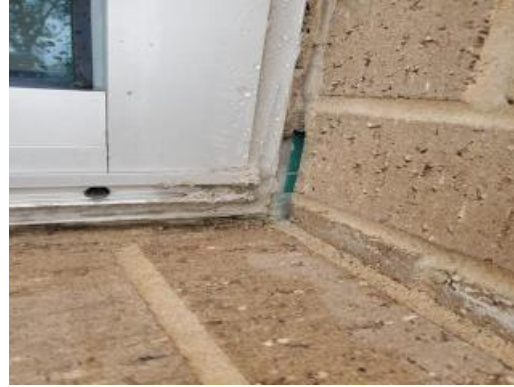
Aged sealant
