FACILITY CONDITION ASSESSMENT

Norman Sims ES | February 2022

Norman Sims ES is located at 4001 Tannehill Ln in Austin, Texas. The oldest building is 50 years old (at time of 2020 assessment). It comprises 58,519 gross square feet.

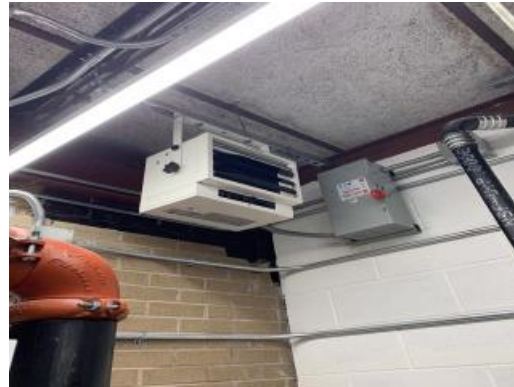
Unit heater is aged

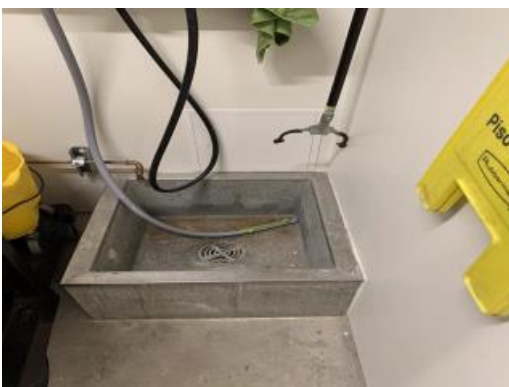
Mop sink is worn
