# FACILITY CONDITION ASSESSMENT

*Patton ES* | February 2022

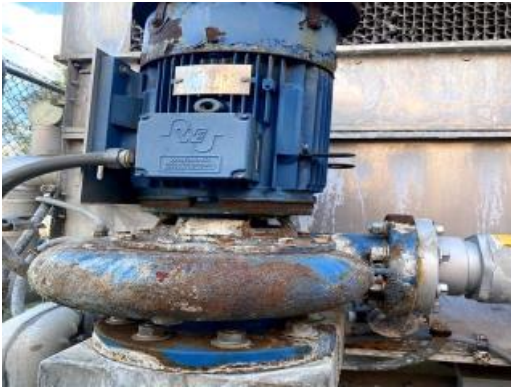
Pump is beyond its service life

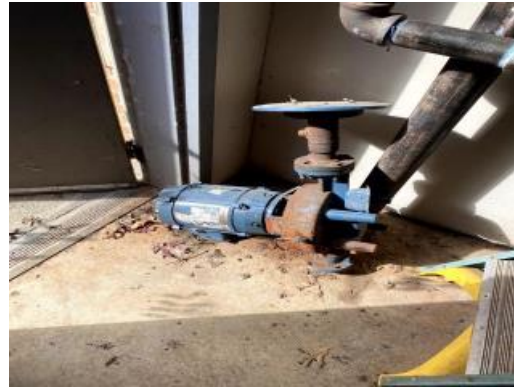
Rusted valve

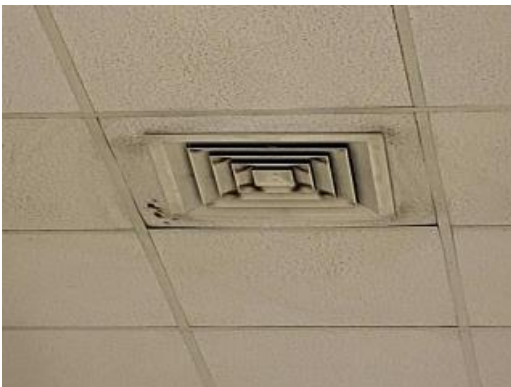
Water Damage to acoustical ceiling tile containing vent

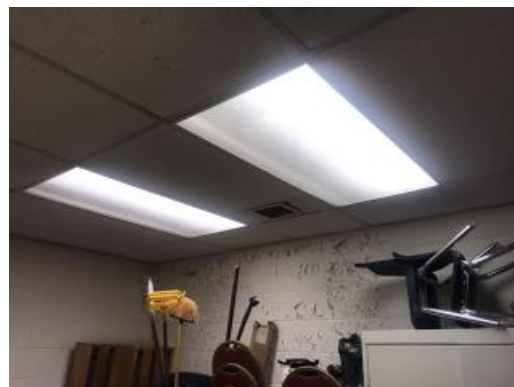
Peeling wall paint
