# FACILITY CONDITION ASSESSMENT

*Perez ES* | February 2022

Perez ES is located at 7500 S Pleasant Valley Rd in Austin, Texas. The oldest building is 14 years old (at time of 2020 assessment). It comprises 82,223 gross square feet.

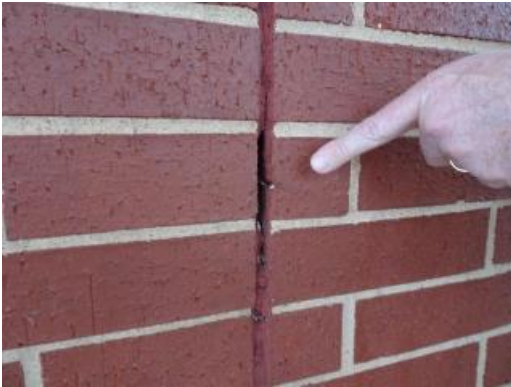
Damaged control joint

Deficiency	Category	Qty	UoM	Priority	Repair Cost	ID
Caulking Replacement	Deferred Maintenance	640	LF	3	\$4,833	706
<b>Sub Total for System</b>		<b>1</b>	<b>items</b>		<b>\$4,833</b>

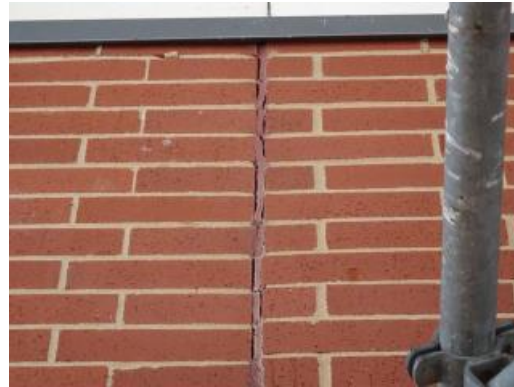
Brick Control Joint

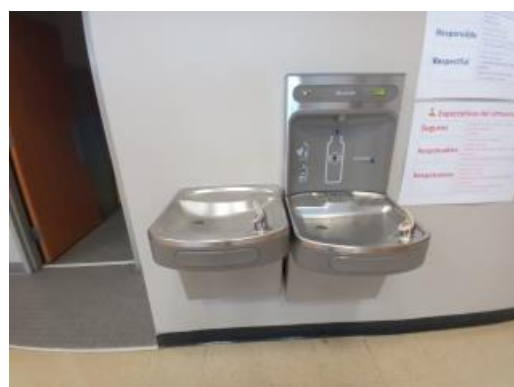
Drinking fountain

Deficiency	Category	Qty	UoM	Priority	Repair Cost	ID
Non-Refrigerated Drinking Fountain Replacement	Capital Renewal	6	Ea.	4	\$2,384	782
<b>Note:</b> Unit is beyond useful life and needs to be replaced						
<b>Location:</b> Cafeteria/Gym						
<b>Sub Total for System</b>		<b>3</b>	<b>items</b>		<b>\$64,446</b>	
<b>Sub Total for Building 190A - Main building includes Administration Offices, Classrooms, Cafeteria, &amp; Gym.</b>		<b>16</b>	<b>items</b>		<b>\$439,924</b>	
<b>Total for Campus</b>		<b>16</b>	<b>items</b>		<b>\$439,924</b>

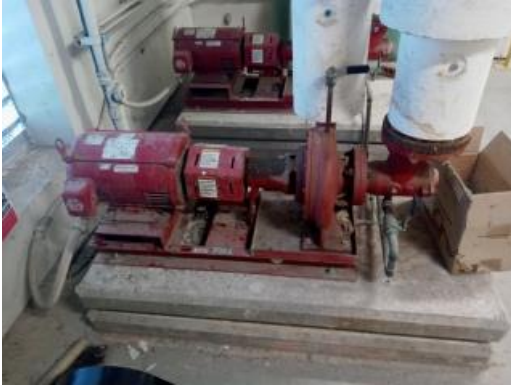
Pump system

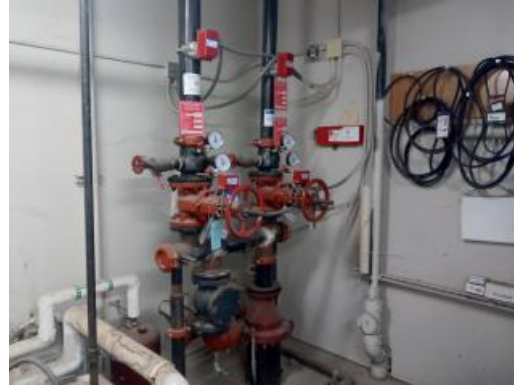
Fire riser system
