FACILITY CONDITION ASSESSMENT

Widen ES | February 2022

Widen ES is located at 5605 Nuckols Crossing in Austin, Texas. The oldest building is 34 years old (at time of 2020 assessment). It comprises 74,523 gross square feet.

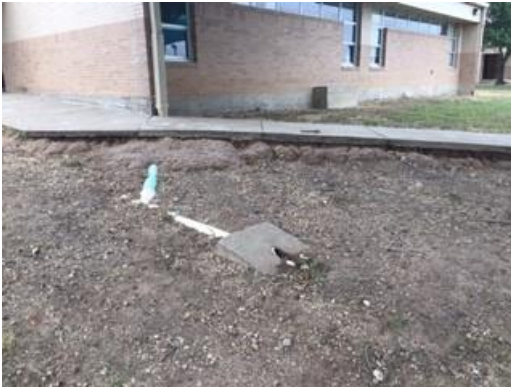
Exposed drainage pipe

Note: Parking lot has failures and cracking						
Location: South, southeast, southwest, and northwest parking lot						
Site Regrading And Gravel Fill	Deferred Maintenance	27	SF	4	\$77	64
Note: Water does not properly flow into storm drain						
Site Regrading And Gravel Fill	Deferred Maintenance	3,500	SF	4	\$9,924	232
Note: Sidewalk drainage box along path from buildings to basketball court area is completely blocked and needs to be cleaned out; regrading adjacent to this may be necessary to re-establish drainage pattern. Outfall structure at pond is damaged and needs to be repaired; inlet pipe from west is exposed at surface and also needs to be maintained (basketballs and other vegetation visible at outlet), re-establish cover over pipe. Storm outfall on south side of building is overgrown and needs to be cleaned out; discharges into what appears to be a channel, which is overgrown and needs to be regraded. Unclear if this channel was designed or a result of erosion; review is needed. Culverts and drainage channel adjacent to west entrance need to be regraded; overgrown and blocking path of drainage flow. Pipe and storm outfall on south side of building adjacent to sidewalk is exposed; re-establish cover over pipe and regrade from outfall for positive drainage.

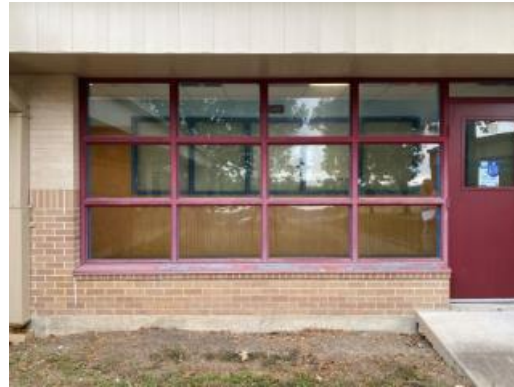
The exterior windows are in need of maintenance.

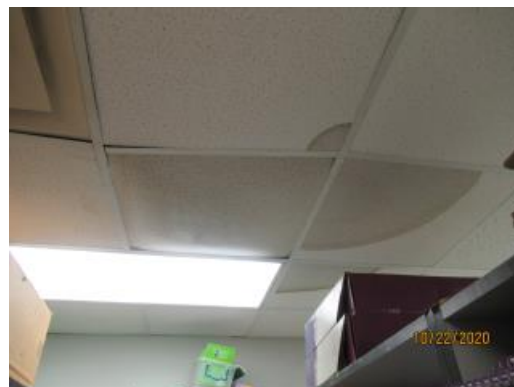
Deficiency	Category	Qty	UoM	Priority	Repair Cost	ID
Acoustical Ceiling Tile Replacement	Capital Renewal	12	SF	4	\$41	70
Note: Tiles have water damage						
Location: Bookroom						
Sub Total for System		1	items		\$41

Damaged accoustical ceiling system.

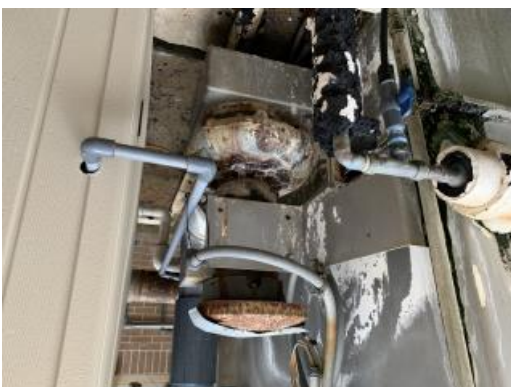
Corroded HVAC equipment.
