FACILITY CONDITION ASSESSMENT

Mills ES | February 2022

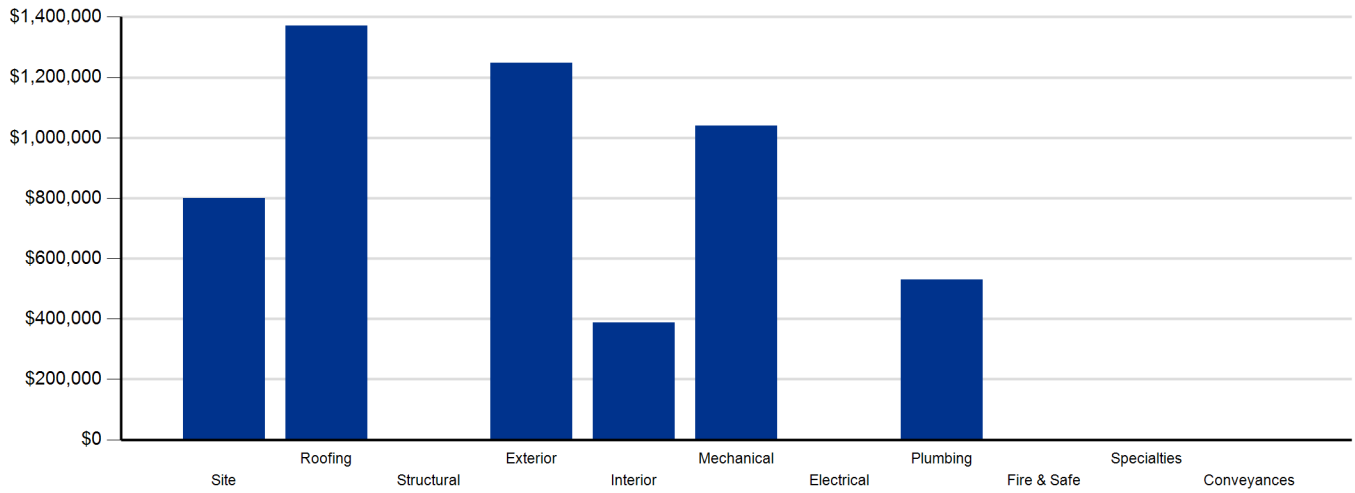
Figure 1: System Deficiencies

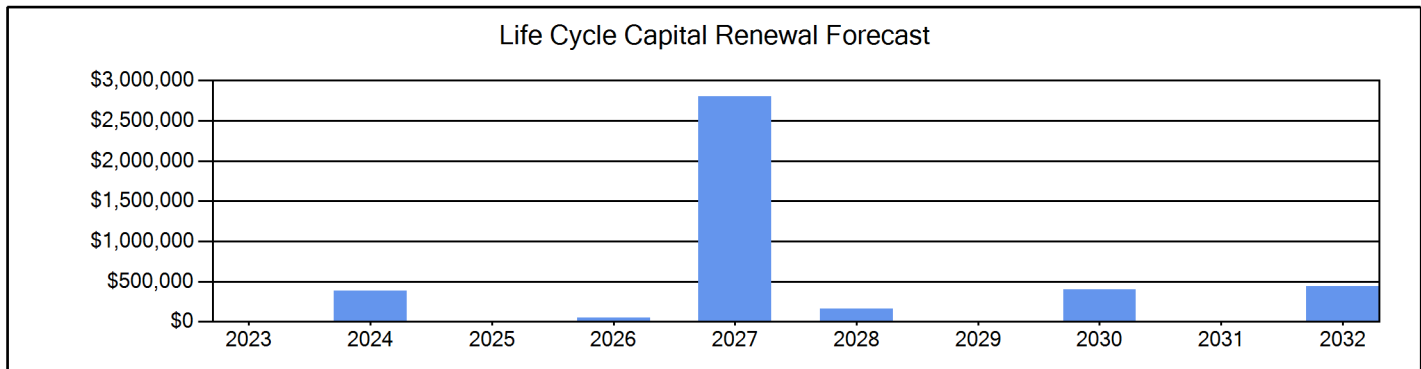
Figure 2: Ten Year Capital Renewal Forecast

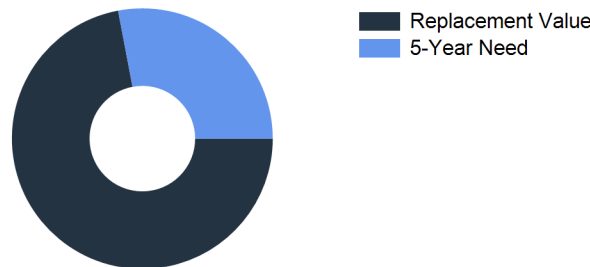
Figure 3: 5-Year FCA

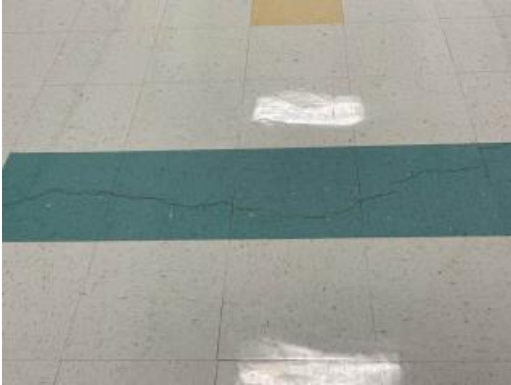
Cracked vinyl composite tile

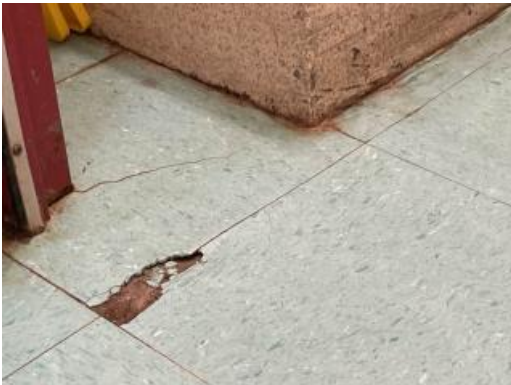
Damaged vinyl composite tile

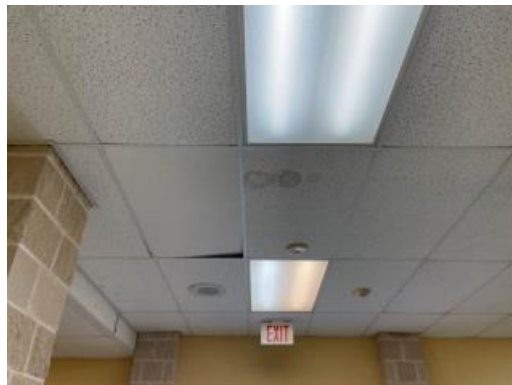
Damaged acoustic ceiling tile

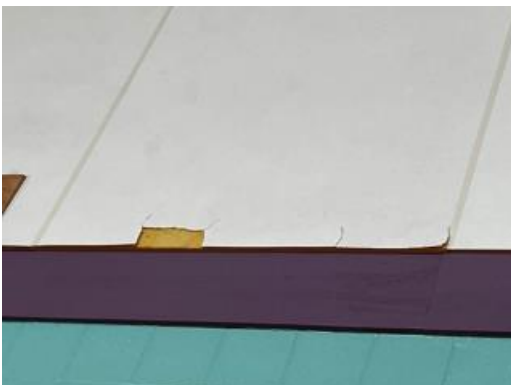
Plastic wall paneling is aged

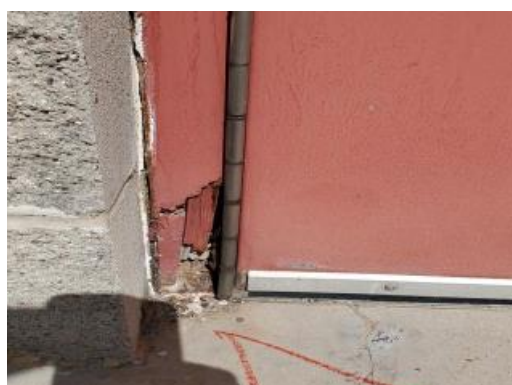
Damaged exterior door frame

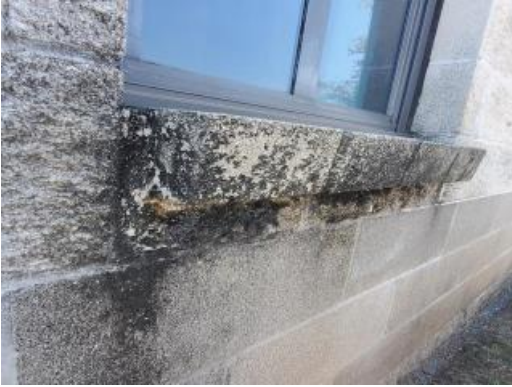
Stained exterior concrete wall

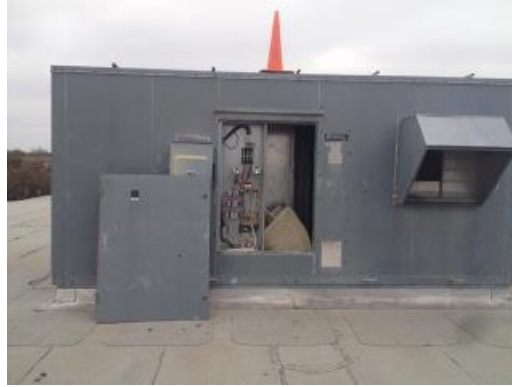
Exposed electric box on roof
