Educational Suitability Summary Report

Clifton Career Development School

Date: 10/30/2020

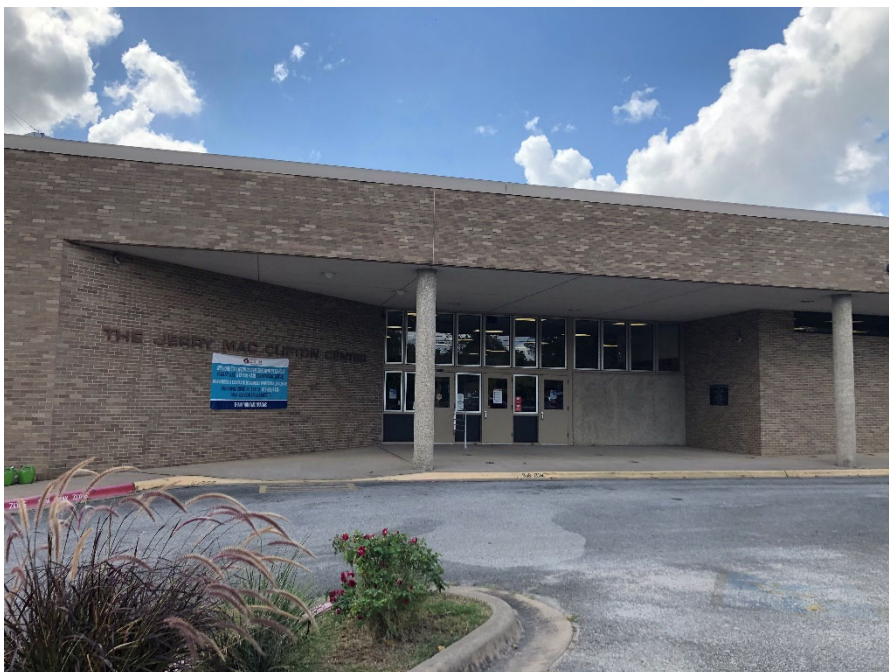
Main entry of school.

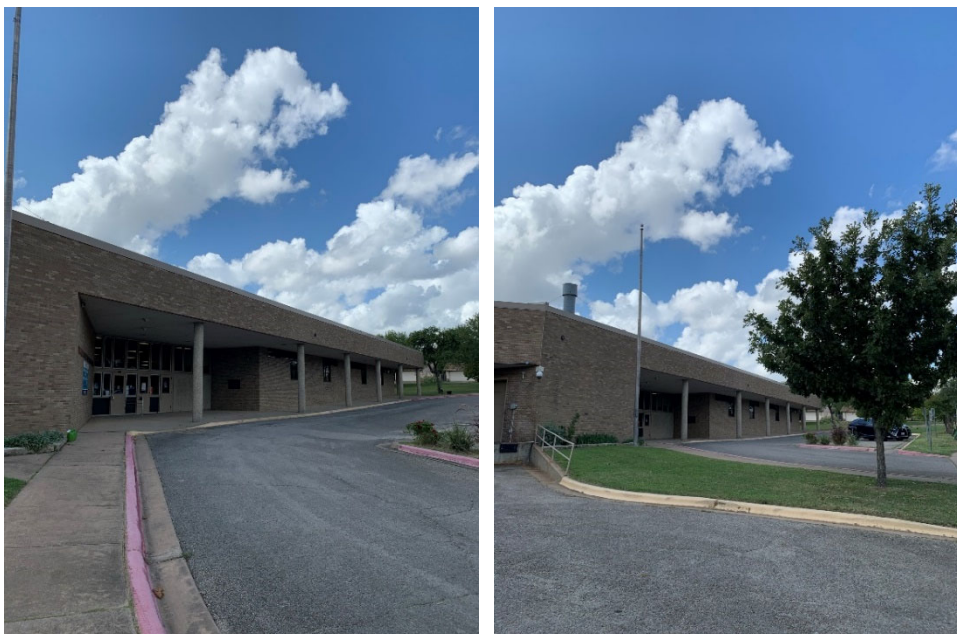
Bus drop-off and main entrance are the same. Only one loop and has very short stack space. Staff parking is separate and distant from front entry. Signage on building is visible but not apparent. No street marquee or other signage to identify the building. No compost. Trash and recycling are far from building and there is a ramp from the loading dock to parking lot level.

Minimal parking in front for visitors and short stack space. Signage is inadequate.

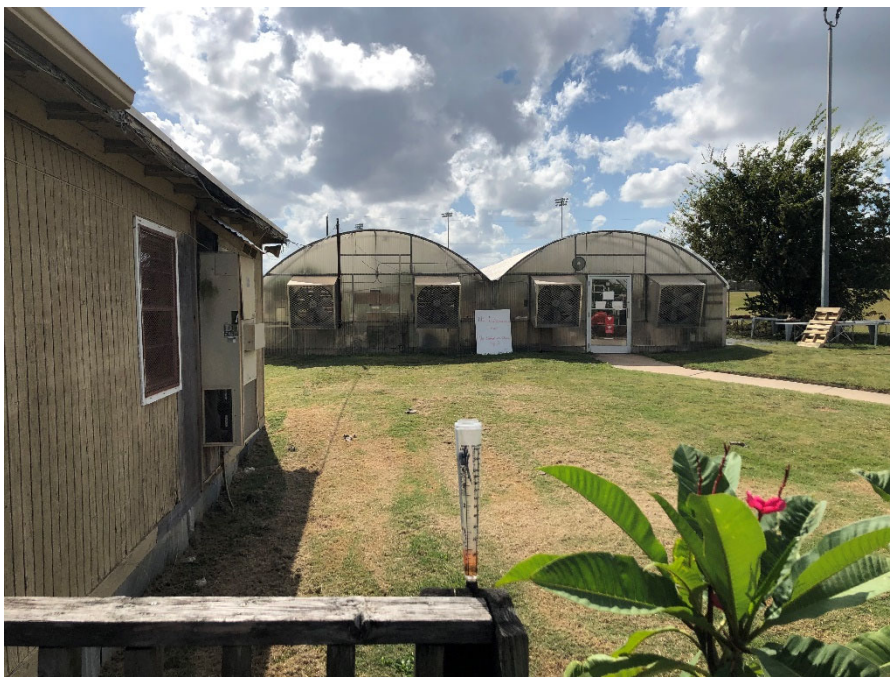
Outdoor spaces for learning do not have space with seating. Large garden area with greenhouse and studio is configured well but needs updates and is disconnected from the rest of the school.

Outdoor learning space with greenhouse.

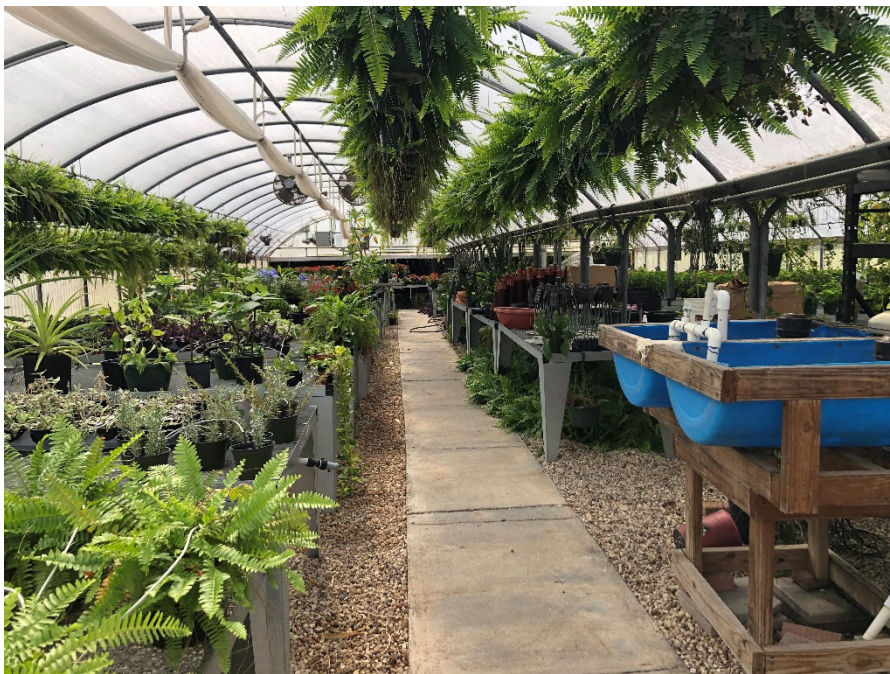
Greenhouses for horticulture, floral design and landscape design.

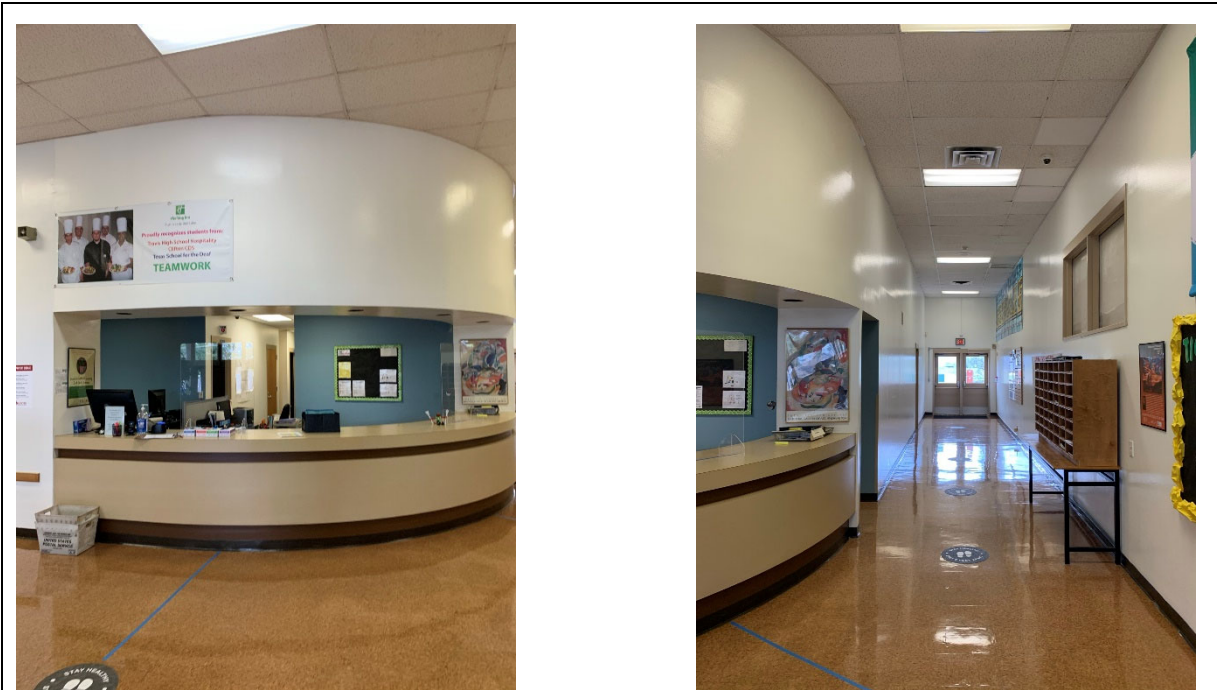
Primary circulation to studios is less than 7 feet in width. Larger corridor at main entry of building only. Small, centralized gathering space is present but only accessible through main entry. New carpet, wall base and paint in studios and corridors, but most spaces are aged with old, movable partitions that allow sound to transmit easily.

Front Entry: Narrow corridors with only one wide area at front entry.

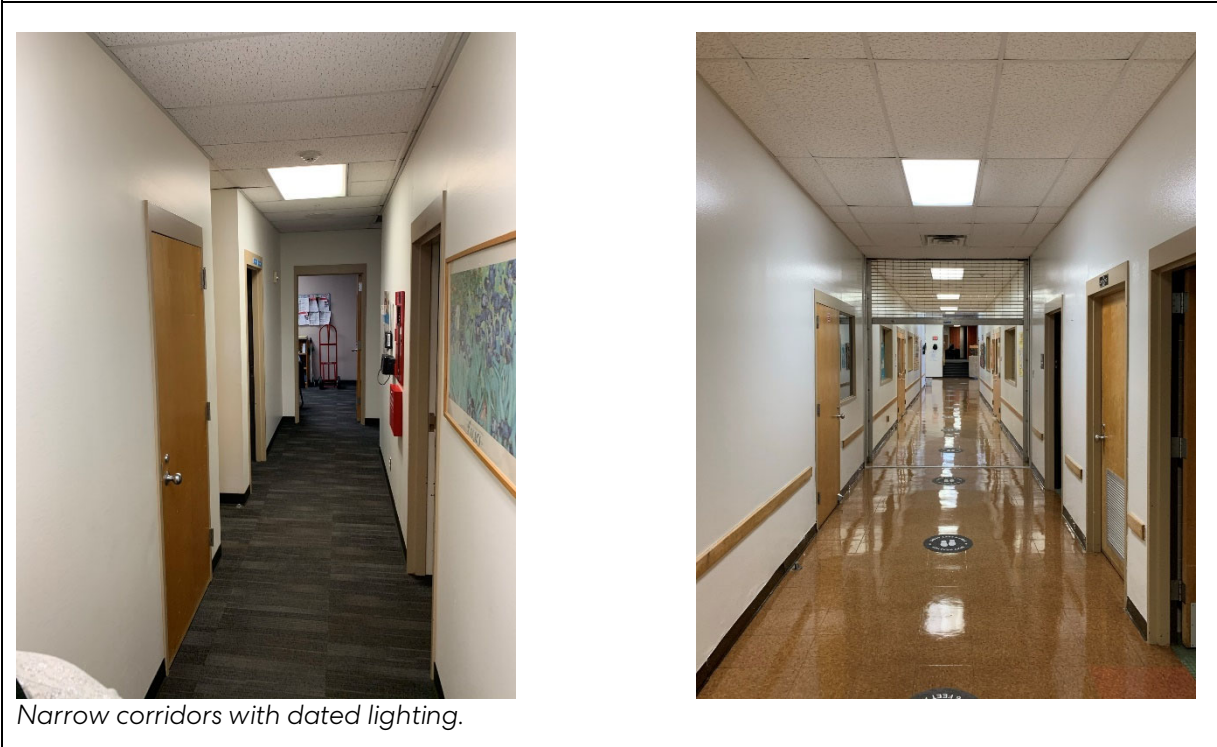
Narrow corridors with dated lighting.

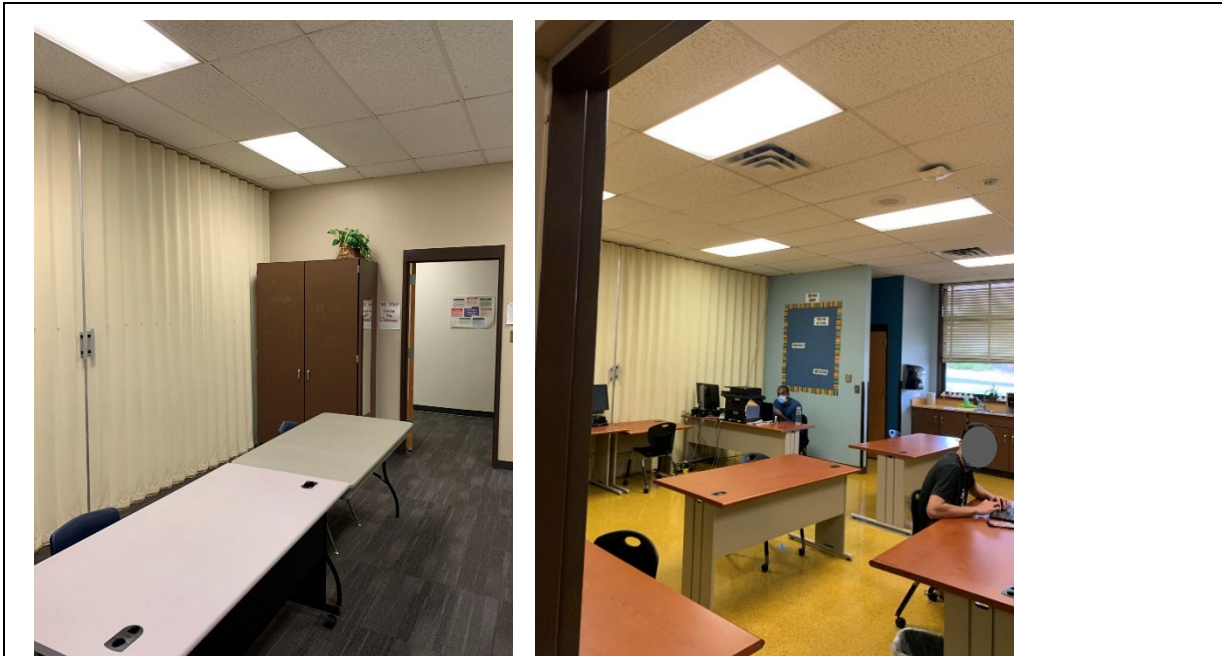
Learning neighborhood studios are adequately sized, but dated accordion partition separates adjacent studio, limiting ability to have multiple learning areas. Studios have built-in casework with limited mobile storage. There is a lack of collaboration spaces within learning neighborhoods. No furniture is provided for informal interaction in circulation spaces. Multiple rooms for different programs have same configuration. Special education areas are in typical studios. Campus has not been updated for needed ADA spaces.

Acoustics between adjacent studios are poor due to aged movable partitions. Artificial light levels are average with minor glare on some surfaces. Most spaces have access to outside views and natural light. No evidence of pests or odors and appears very clean.

Typical studios with dated accordion partition. Typically kept closed due to sound transmission.

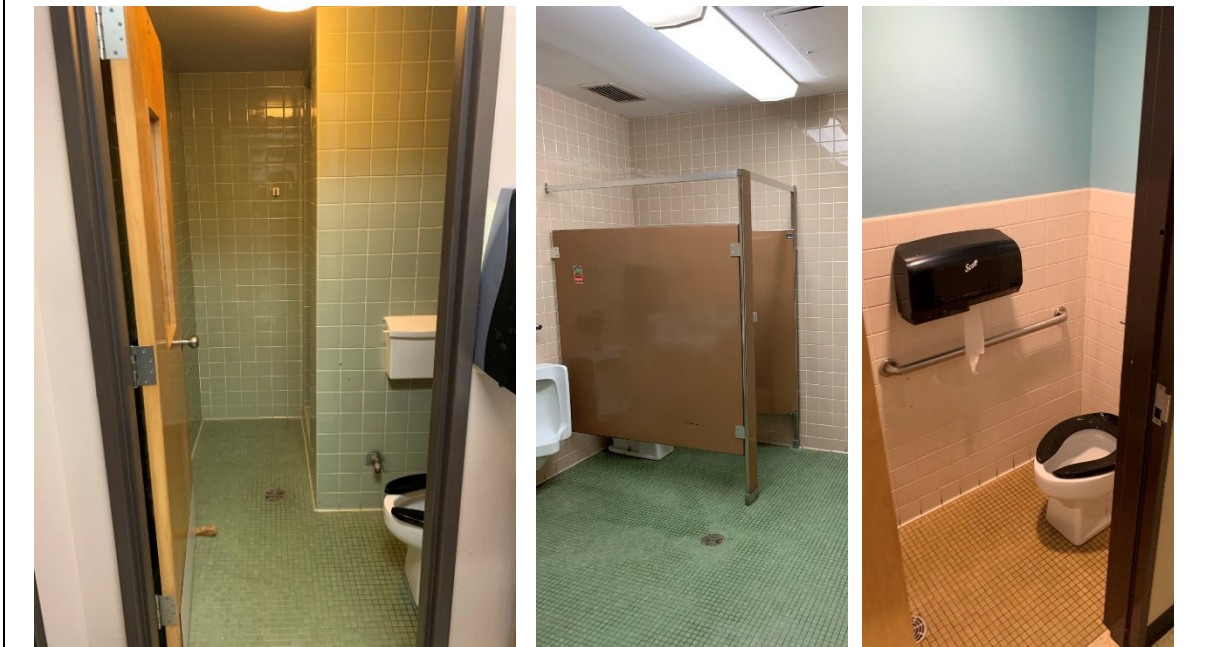
Learning spaces are mostly adequate but lack ADA-accessible restrooms.

No restroom on campus appears to have adequate ADA accessibility. Accessibility will be covered within the Facility Condition Assessment but is noted here since it does not create an equitable use of space for all students.
