Educational Suitability Summary Report

Lamar Middle School

Date: 01/12/2021

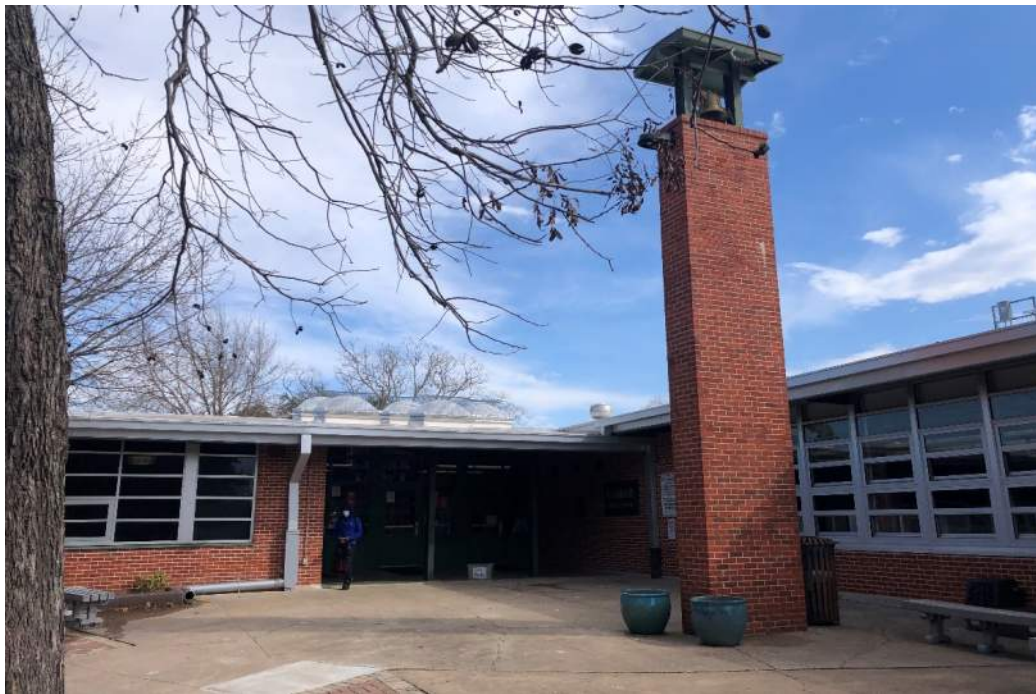
School Entry: Not very inviting or open. Belltower adjacent to entry is well-loved and is one aspect of the campus that should not change in the future.

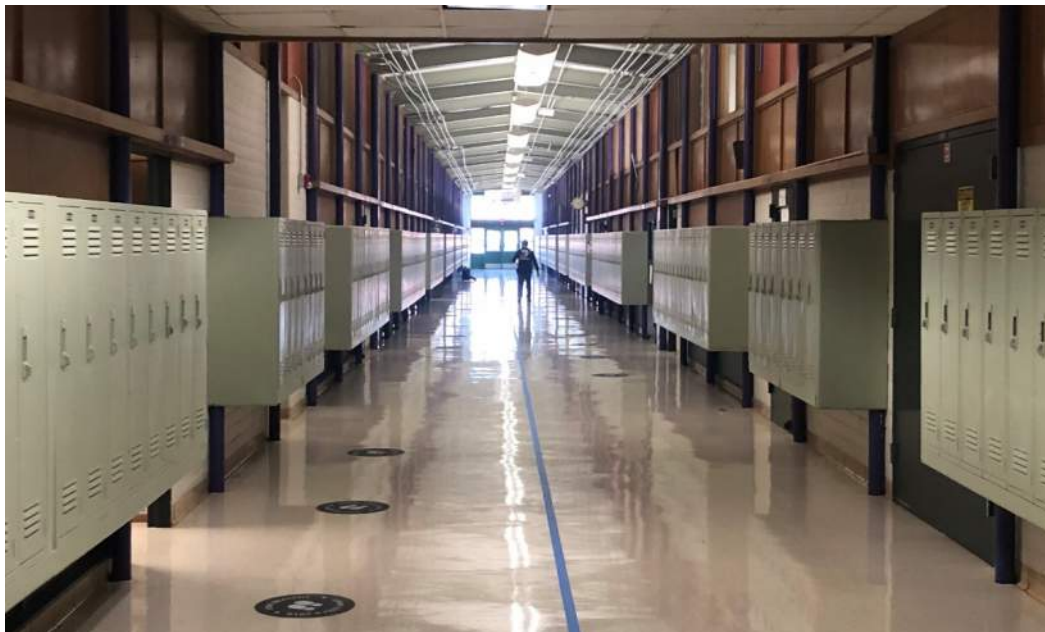
Main corridors are generous in width and have daylight at the end. There are no collaboration spaces or spaces for informal interaction within any of the corridors where studios are located.

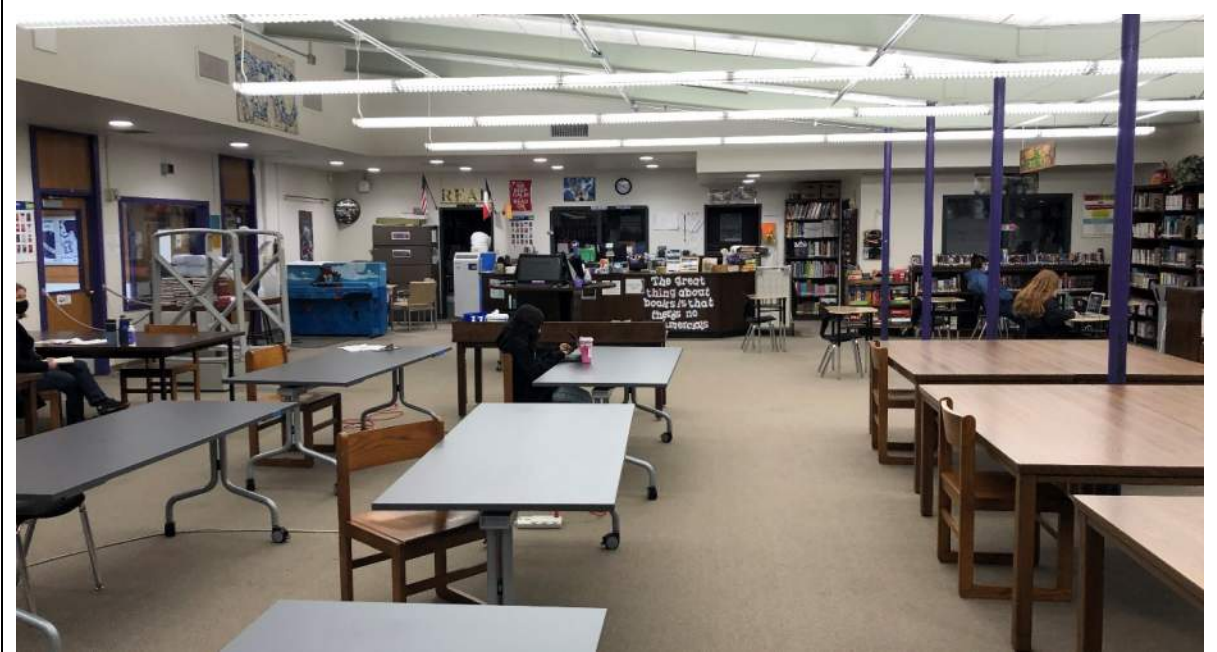
Media Center: Square footage is adequate and there is a mix of old and new furniture. Space needs updates to function well. Media center does not have adequate support space.

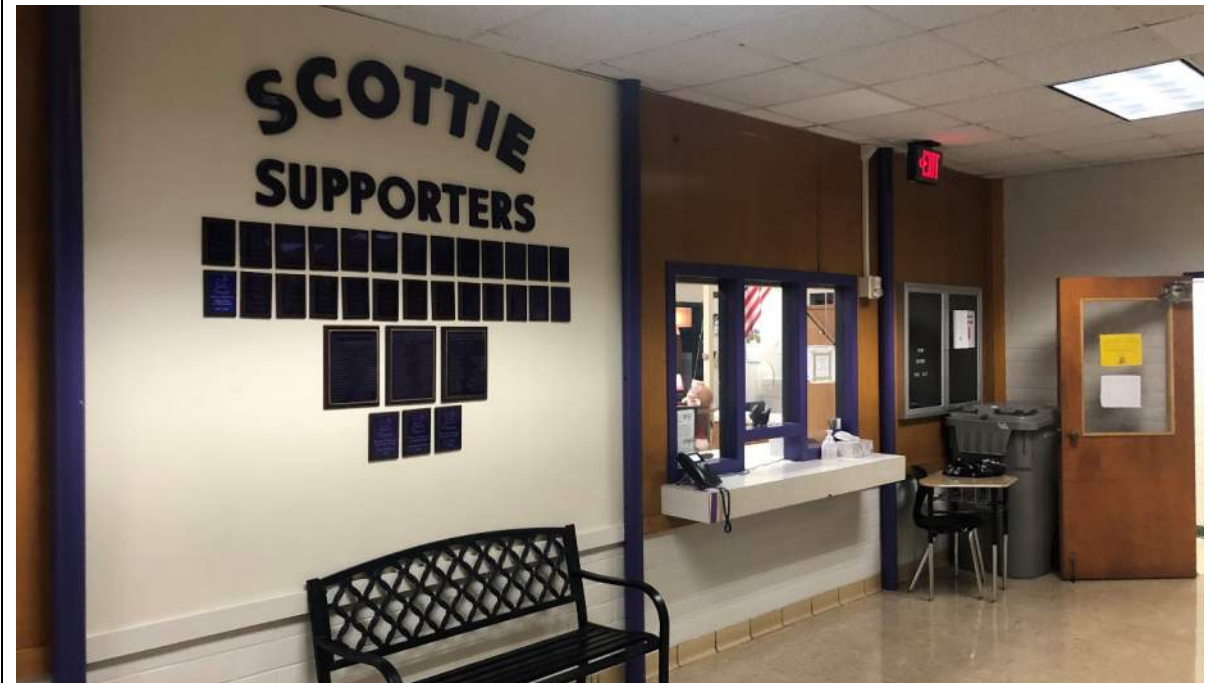
Administration space/main office is small.

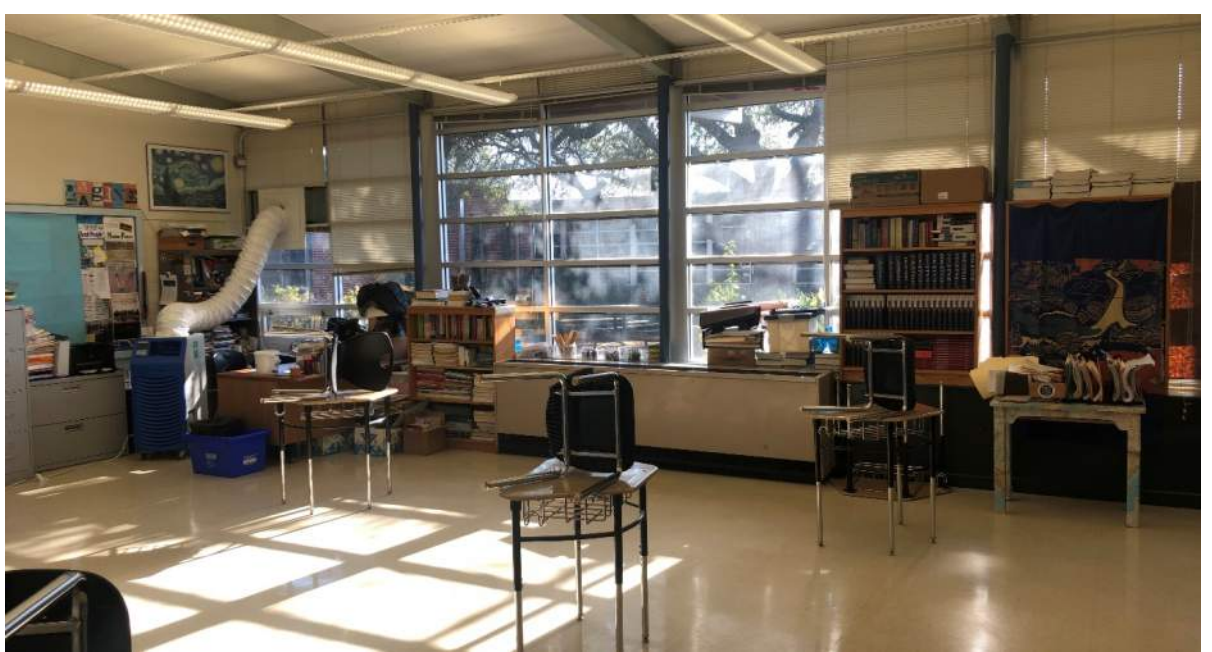
All studios are undersized per current Ed Spec square footage. All studios have excellent access to daylight and views. Outlet placement is sporadic and does not allow for adequate charging locations. Many studios have mechanical equipment units taking up floor square footage.

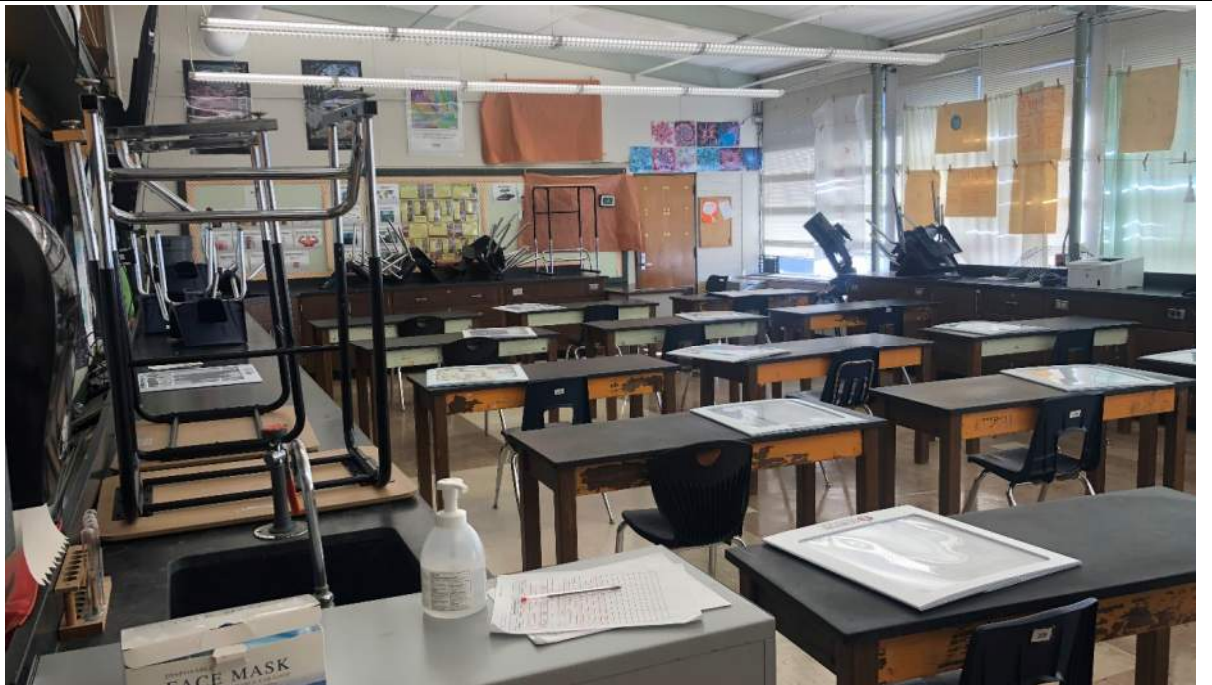
Science studios are undersized and have old heavy tables. Water at sinks is sporadically hooked up and many sinks do not have water.

8.4	Are Science Labs and support spaces appropriately configured per the ed spec?		2					Comments	1.00 2.00
	1 Very unsatisfactory - No dedicated science room 2 Unsatisfactory - Too small, poor condition, no connected support space 3 Average - Adequate size, adequate condition, needs some renovations or updates to function well 4 Satisfactory - Good size, good condition, connected support spaces 5 Very Satisfactory - Generous size, excellent condition, connected support spaces N/A Does not apply							All labs are undersized and need updates. Most eyewash and emergency showers do not work. Only two prep rooms but are used for storage.

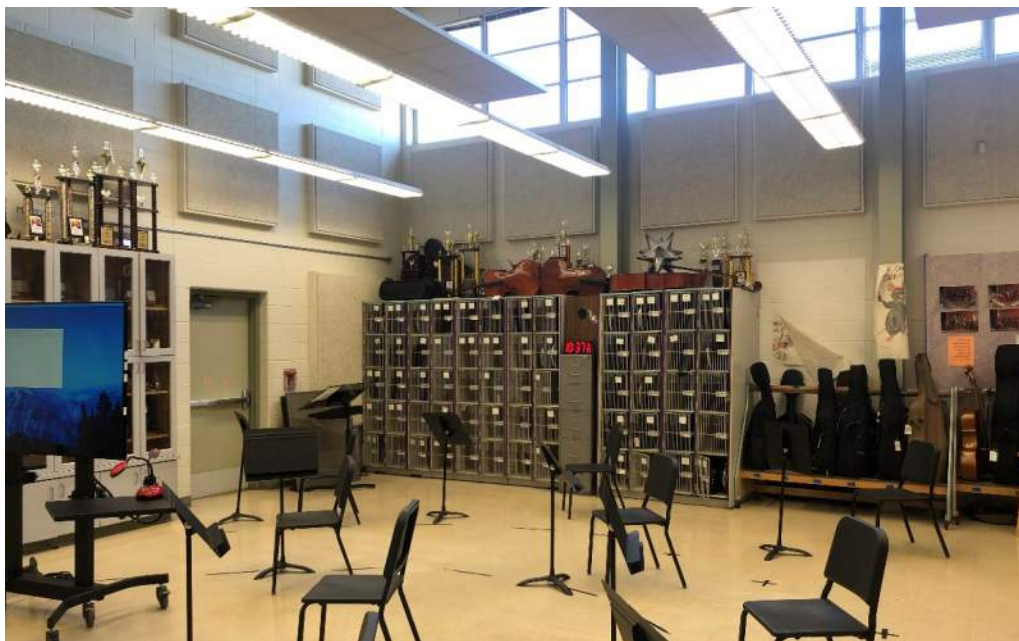
Orchestra Room: Undersized per Ed Spec and missing support spaces. Overall, the room is in satisfactory shape but cannot accommodate growing program.

10.3	Are orchestra and support spaces appropriately configured per the ed spec?		2					Comments	1.00 2.00	
	1 Very unsatisfactory - Too small, missing program spaces 2 Unsatisfactory - Too small, poor condition 3 Neutral - Adequate size, adequate condition, needs updates or renovations to function well. 4 Satisfactory - Good size, good condition 5 Very Satisfactory - Generous size, excellent condition N/A Does not apply								Small, no dedicated practice rooms and limited storage.

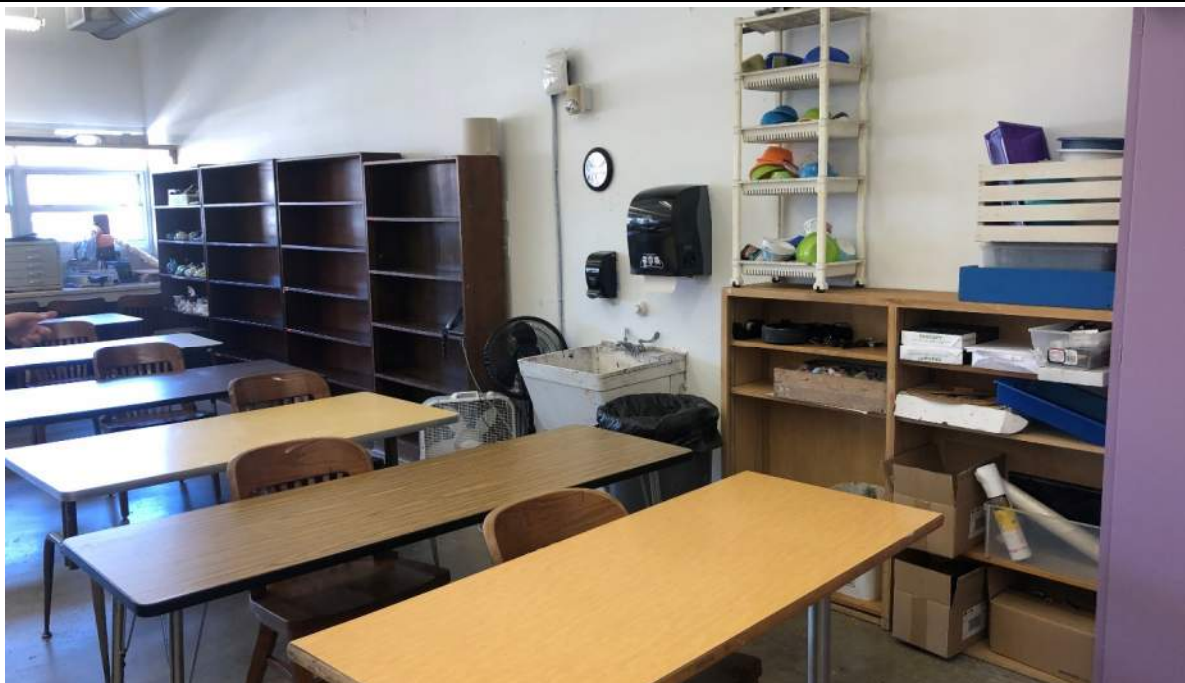
Art studios do not have adequate support. There is only one sink in each art studio, but they do not have clay traps and get clogged frequently.

10.7	Are visual arts and support spaces appropriately configured per the ed spec?			3				Comments	1.00 3.00	
	1 Very unsatisfactory - Too small, missing program spaces 2 Unsatisfactory - Too small, poor condition 3 Neutral - Adequate size, adequate condition, needs updates or renovations to function well. 4 Satisfactory - Good size, good condition 5 Very Satisfactory - Generous size, excellent condition N/A Does not apply								Need more sinks and in-room storage. Spaces are adequate in size but need updating and more countertop surface/laydown space.

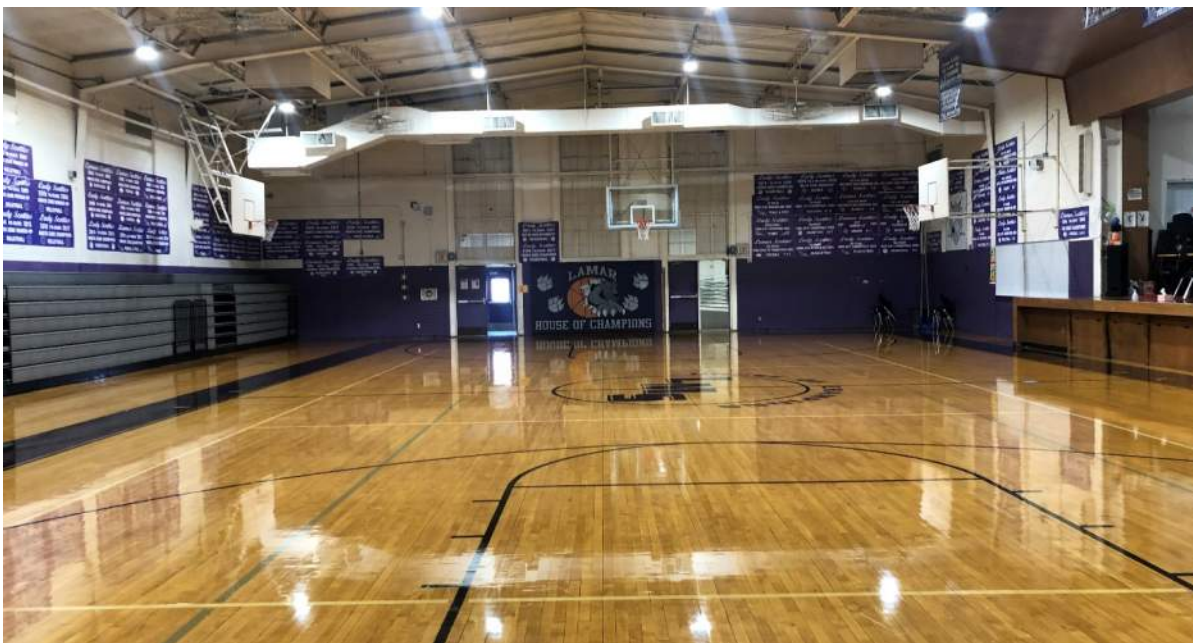
Main Gym: Main/aux gym are undersized per Ed Spec.

11 - Athletics and Wellness							18.75	36%	
11.1	Does the campus meet ed spec standard for physical education program spaces?	1					Comments	1.00	1.00
1	Very unsatisfactory - Too small, missing program spaces					Both gyms are undersized and all spaces need updating. No weight room.			
2	Unsatisfactory - Too small, poor condition								
3	Average - Adequate size, adequate condition, needs some renovations or updates to function well								
4	Satisfactory - Good size, good condition								
5	Very Satisfactory - Generous size, excellent condition								
N/A	Does not apply

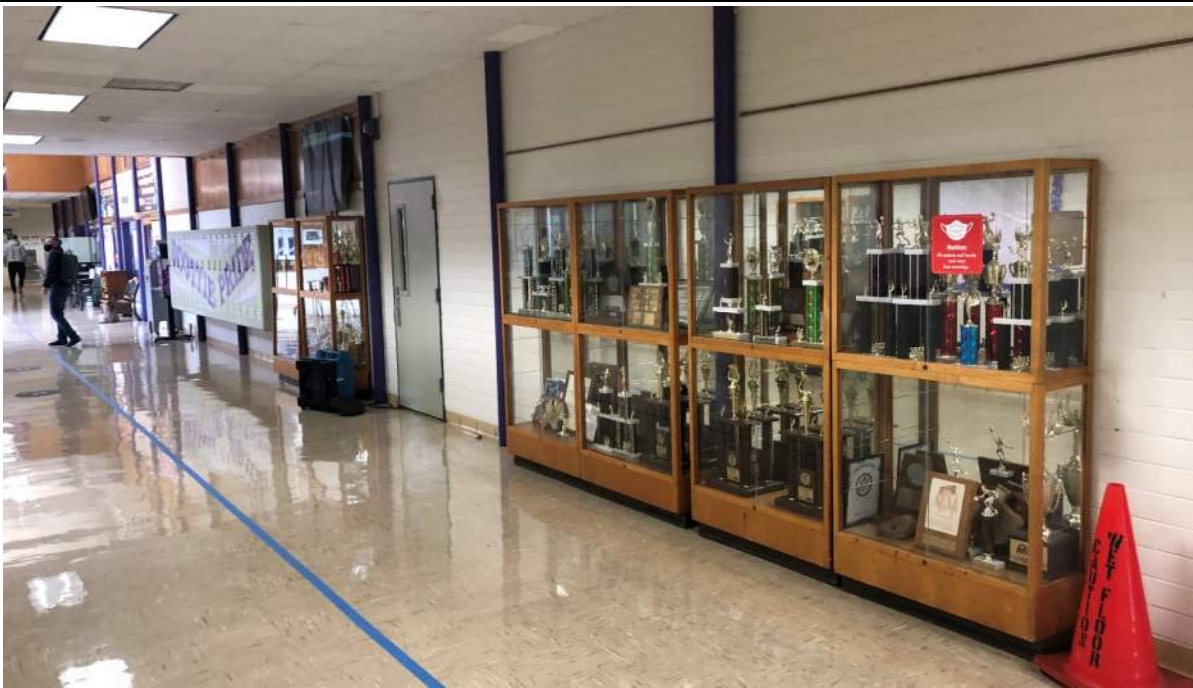
Display throughout the school is limited. Even though it is a fine arts academy, that is not evident when walking the halls.

8.7	Are there adequate places to display the evidence and artifacts of learning (both 2D and 3D)?		2					Comments		1.00	2.00	
1	Very unsatisfactory - No dedicated space							Very limited 3D display (2' x 6' cabinet) and most displays need updating.				
2	Unsatisfactory - Too small, non-dedicated, poor condition											
3	Average - Adequate size, adequate condition, needs updates or renovations to function well											
4	Satisfactory - Good size, good condition											
5	Very Satisfactory - Generous size, excellent condition											
N/A	Does not apply

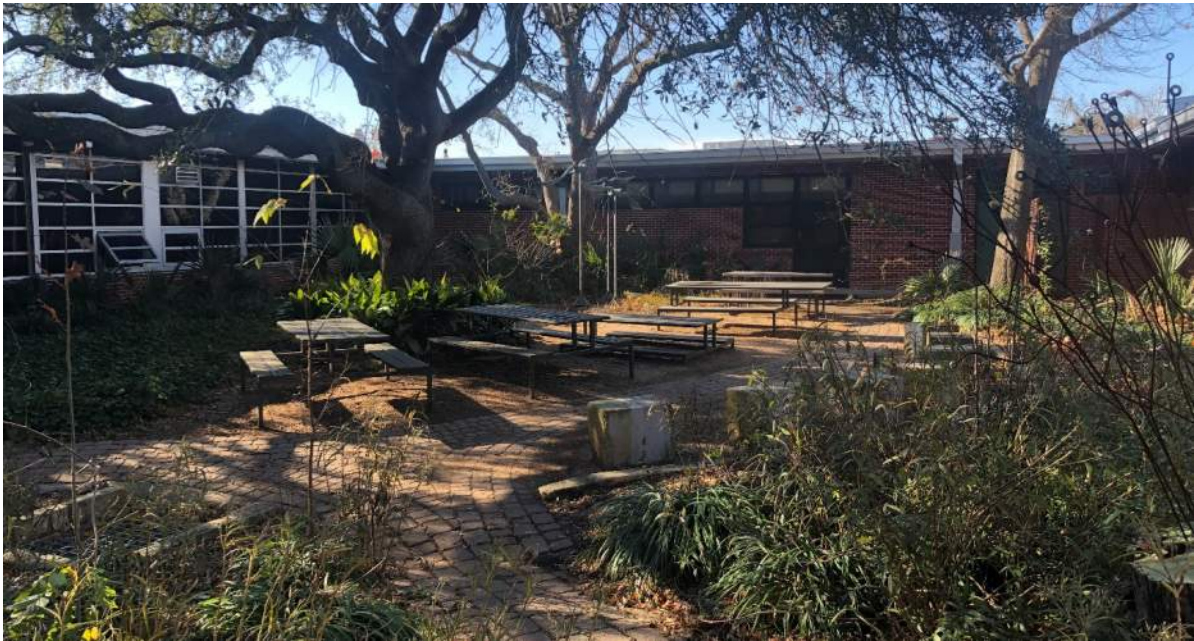
Main courtyard is a nice inviting space with shade. Studios do not have direct access to this space, and the library has no transparency into this space. Students use this space to study and collaborate.

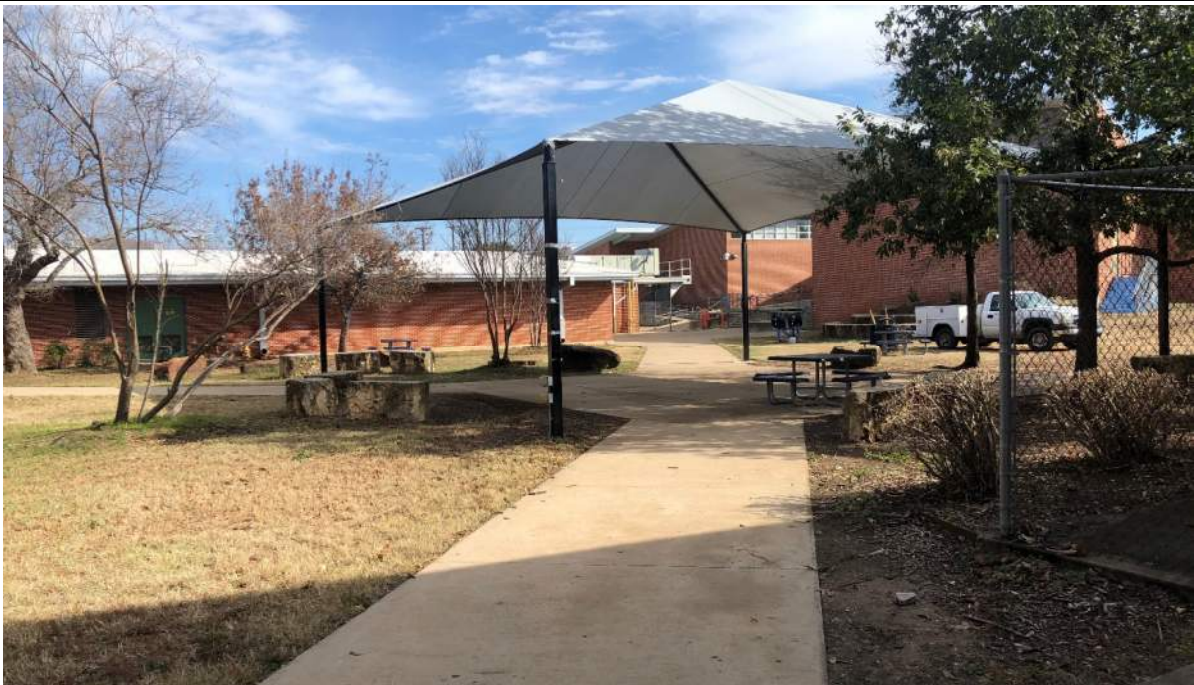
Outdoor space outside of cafeteria for potential outdoor dining.
