Educational Suitability Summary Report

Martin Middle School

Date: 01/21/2021

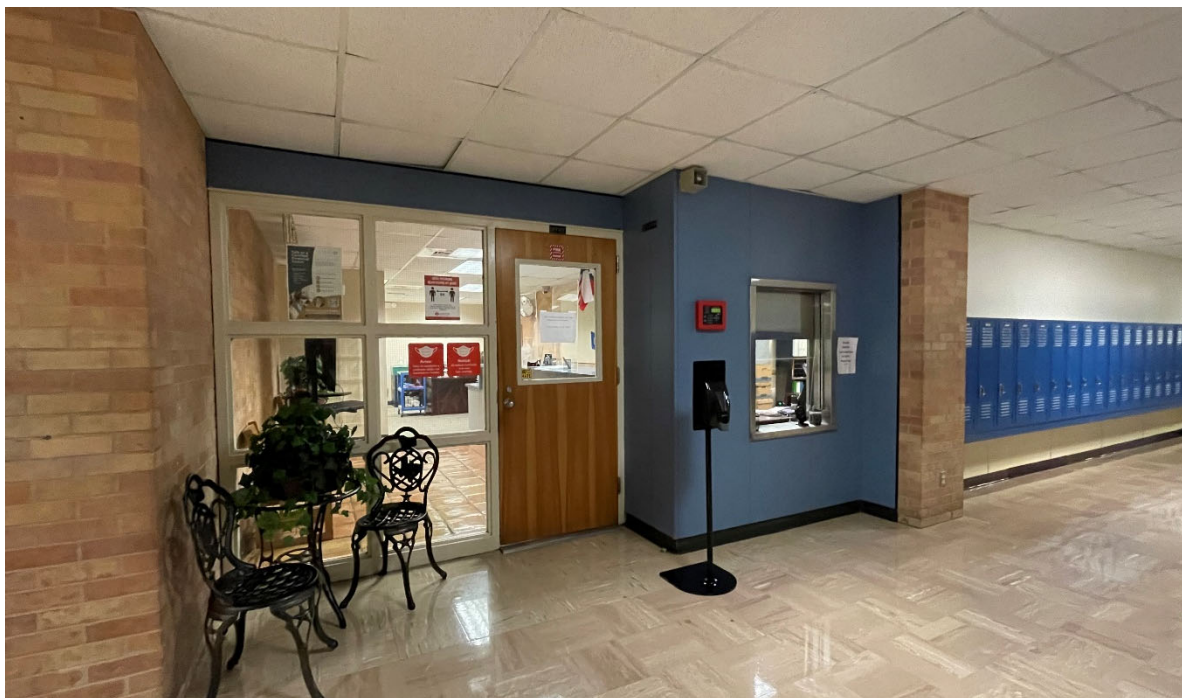
Main reception area is not welcoming.

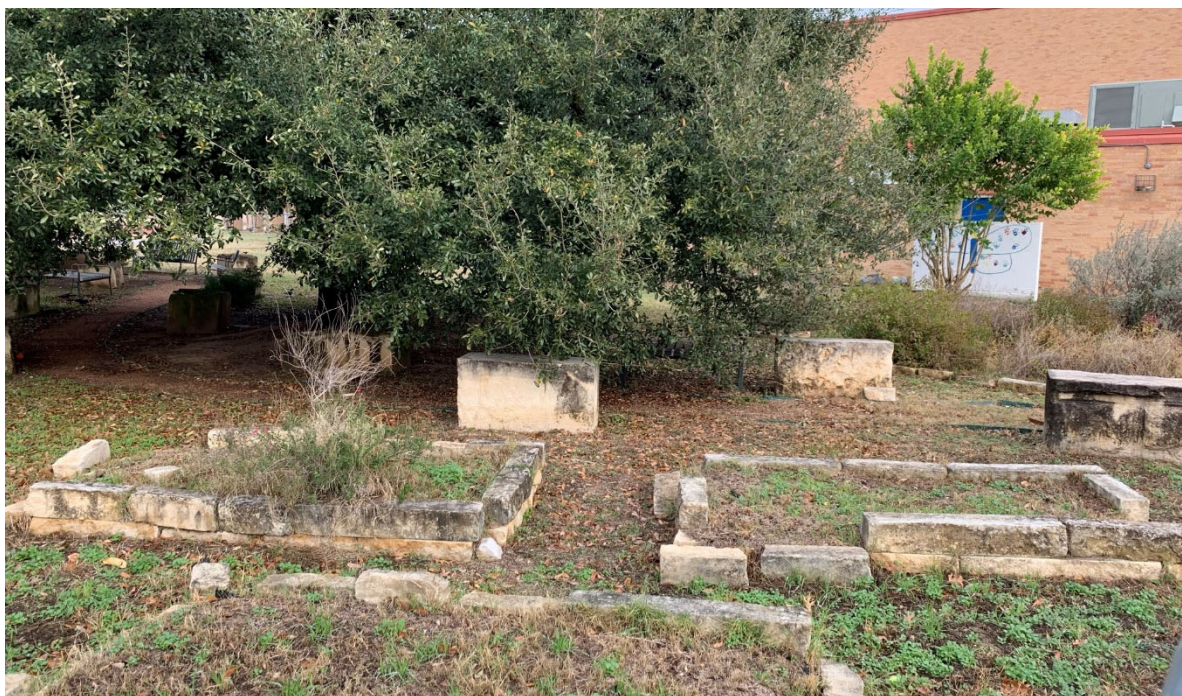
Gardens are a bit disconnected from learning spaces and need updates to function well.

Garden areas have access to a water source but are disconnected from learning spaces and need maintenance and updates to be more functional. Courtyards have picnic tables for seating, but other outdoor areas are lacking furniture to work well for outdoor learning.

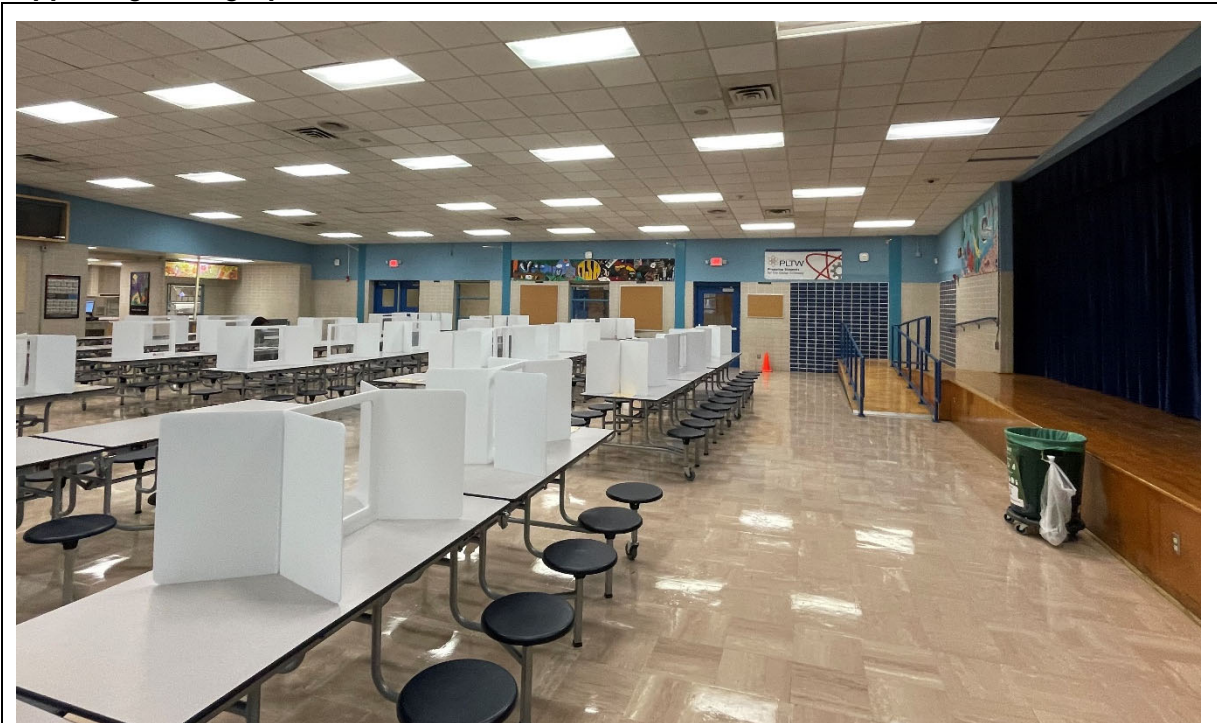
The small cafeteria stage is the only area for performances, and it is difficult to fit all students and visitors. The space is undersized for food service and performances.

The cafeteria is undersized but has good connection to the central courtyard for outdoor dining opportunities. There are minimal windows and natural lighting in the space. The kitchen has two serving lines but is undersized.

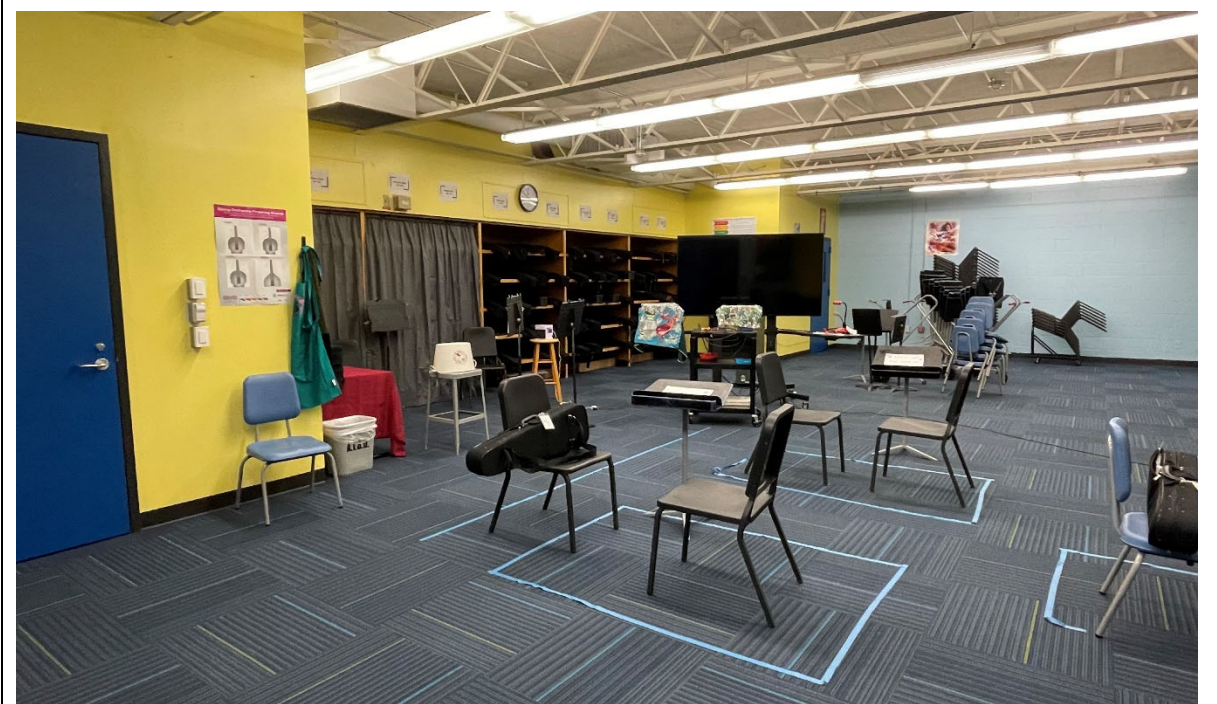
Orchestra and guitar share the same space with one practice room and limited storage.

10.3	Are orchestra and support spaces appropriately configured per the ed spec?			3				Comments	1.00 3.00	
1 Very unsatisfactory - Too small, missing program spaces 2 Unsatisfactory - Too small, poor condition 3 Neutral - Adequate size, adequate condition, needs updates or renovations to function well. 4 Satisfactory - Good size, good condition 5 Very Satisfactory - Generous size, excellent condition N/A Does not apply								Space is undersized but has appropriate office and storage spaces. Only one practice room.

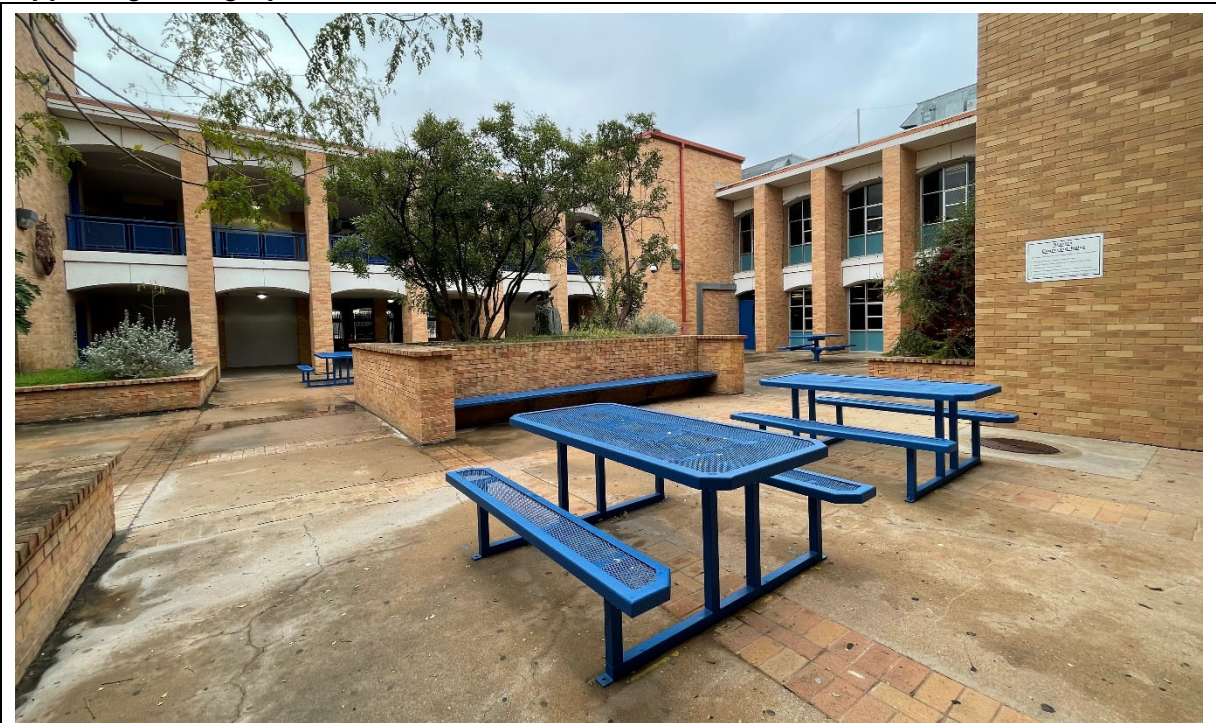
Courtyard spaces are equipped with furniture but lack shade canopies or power access.

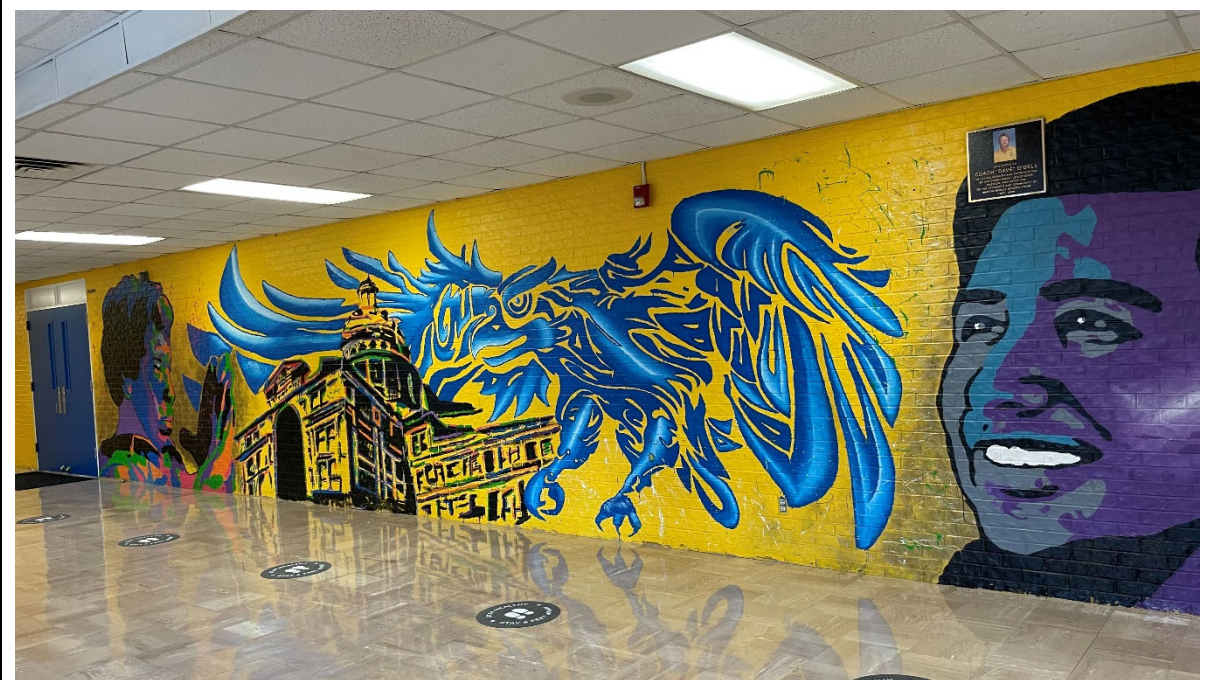
There are areas with murals around campus and most spaces are well-maintained given the age of the school.

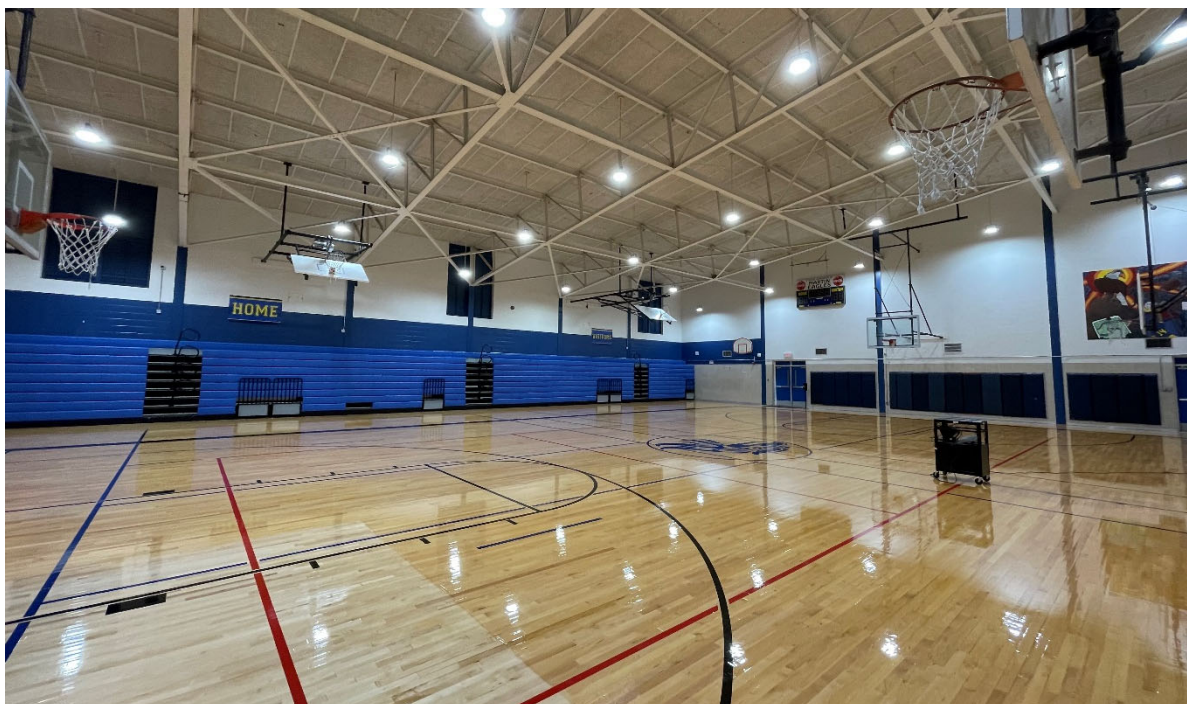
Large and small gym are appropriately sized and in good condition. Patch of new flooring can be seen in the foreground of the photo.

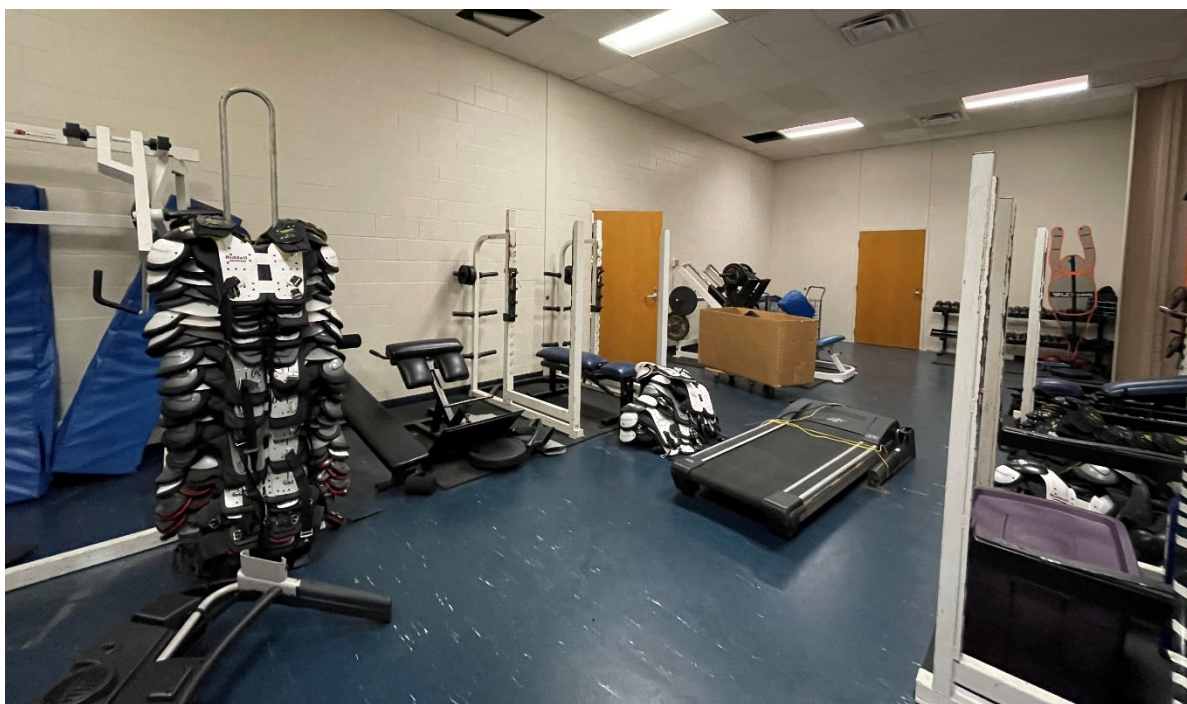
The weight room is in the converted stage area of the large gym and is very undersized.

Large and small gyms are appropriately sized and in good condition. Stage was converted into a weight room and storage area is very undersized. Indoor athletics spaces are well-connected to outdoor athletics areas. Spaces appear to be set up to support UIL basketball, volleyball and tennis. Tennis courts do not have lighting.

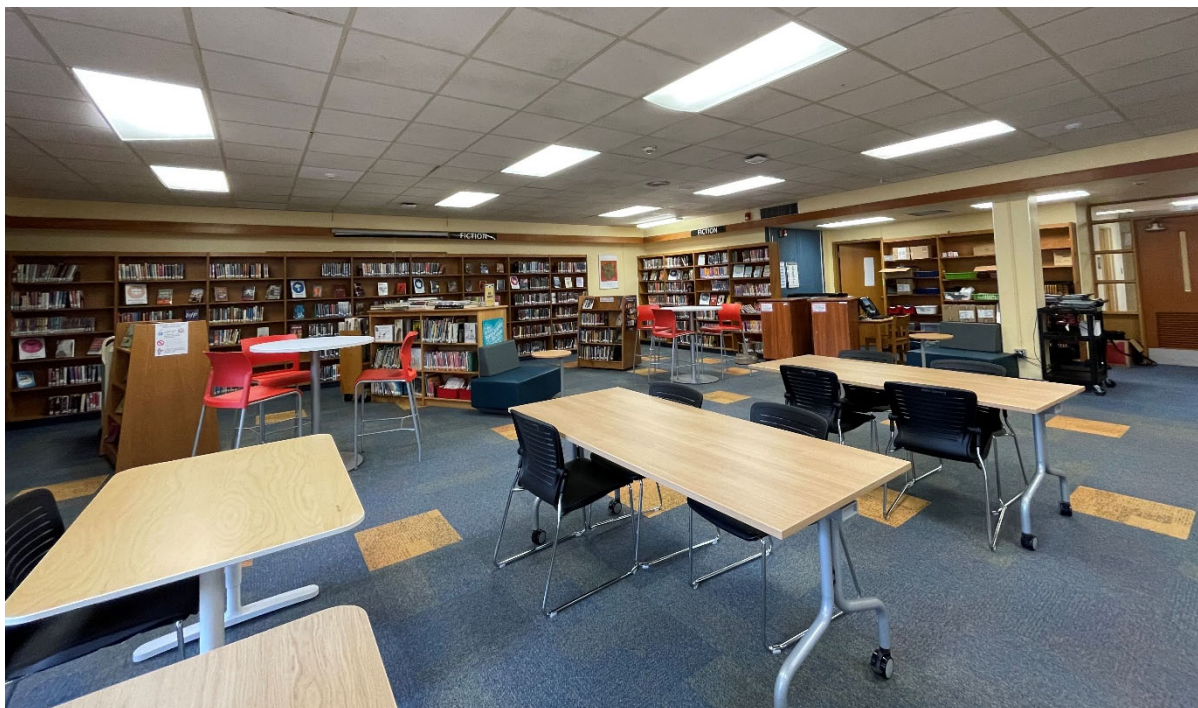
Media Resources: Library is slightly undersized with mostly flexible furniture that can be easily reconfigured.

The library is near the main office and main studio wings but is undersized. Due to its size, there is not much separation of space and no areas for quiet study. Most furniture is formal tables and chairs. Two projection screens, charging carts, two mobile TV displays and some power towers for charging devices are present.

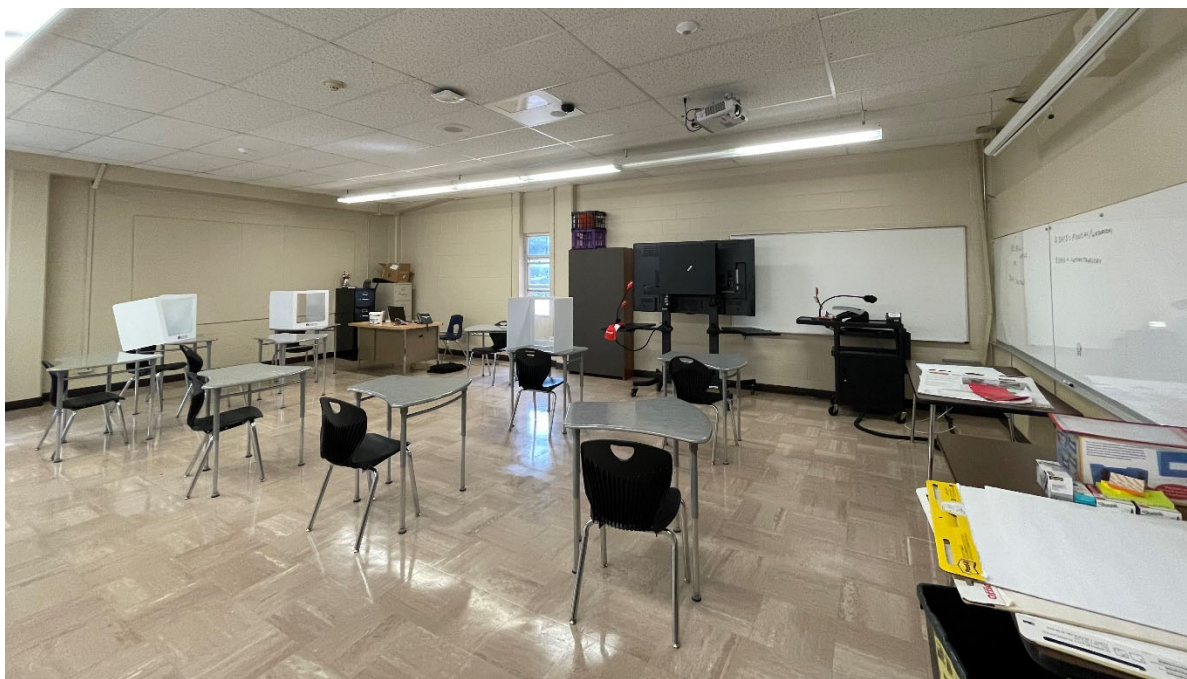
Studios are equipped with projectors and mobile TV displays. Windows in some studios are narrow and provide limited natural light and views.

All studios have projection and mobile TV displays, but outlets are sparse, and some are dated. There is no projector or projection screen in the cafeteria or small gym, but the large gym has a large screen and mobile projection cart. There is a mobile TV display being used for digital media signage in the reception area, but no permanently installed TV.
