Educational Suitability Summary Report

Mendez Middle School

Date: 01/18/2021

Score 62% Average

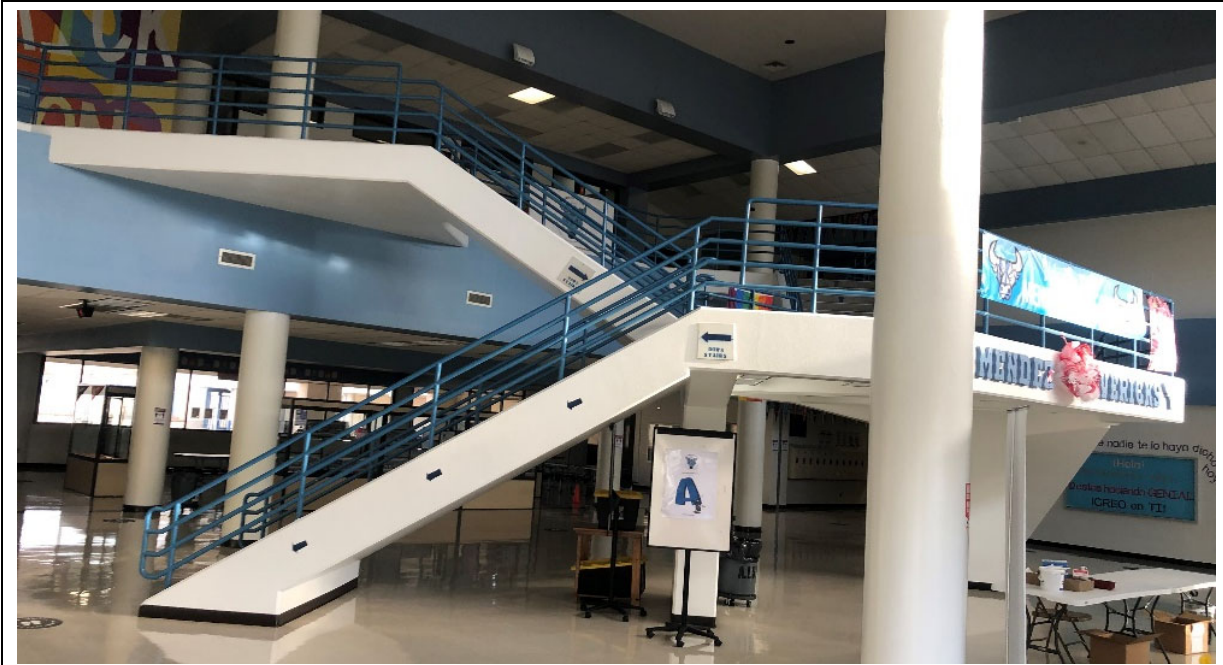
The school's entry is a generous, double-height daylit space. During a typical school year, the school provides couches and informal hangout space for students in this area.

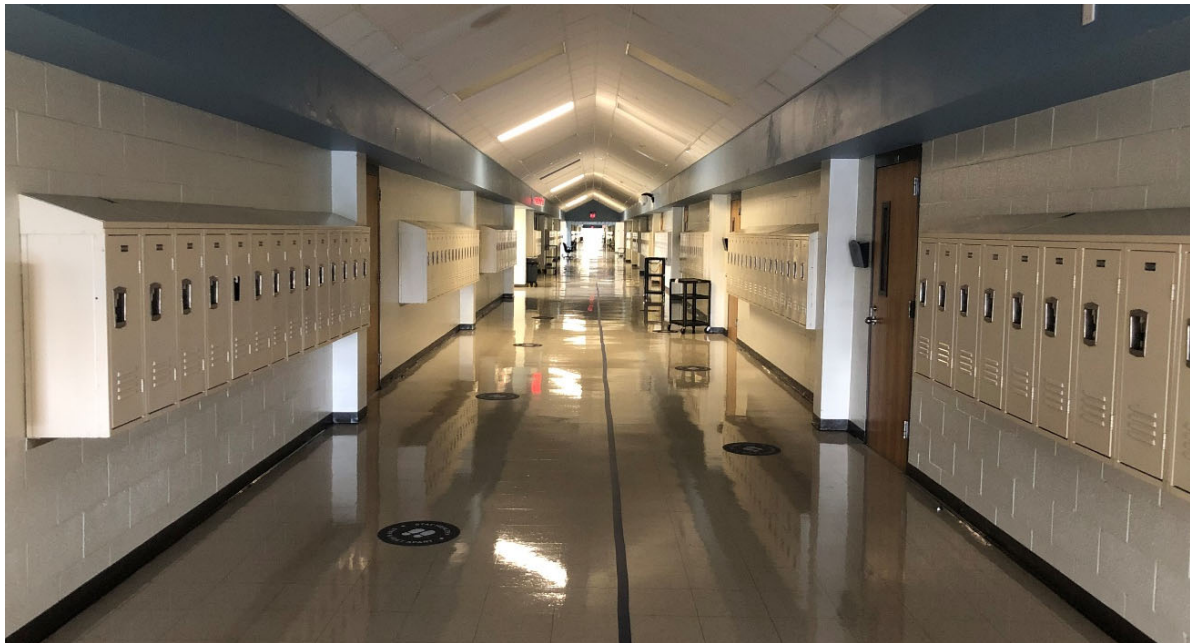
Corridors are generous in width but are long with limited daylight. Lockers are not used and run throughout the main corridors.

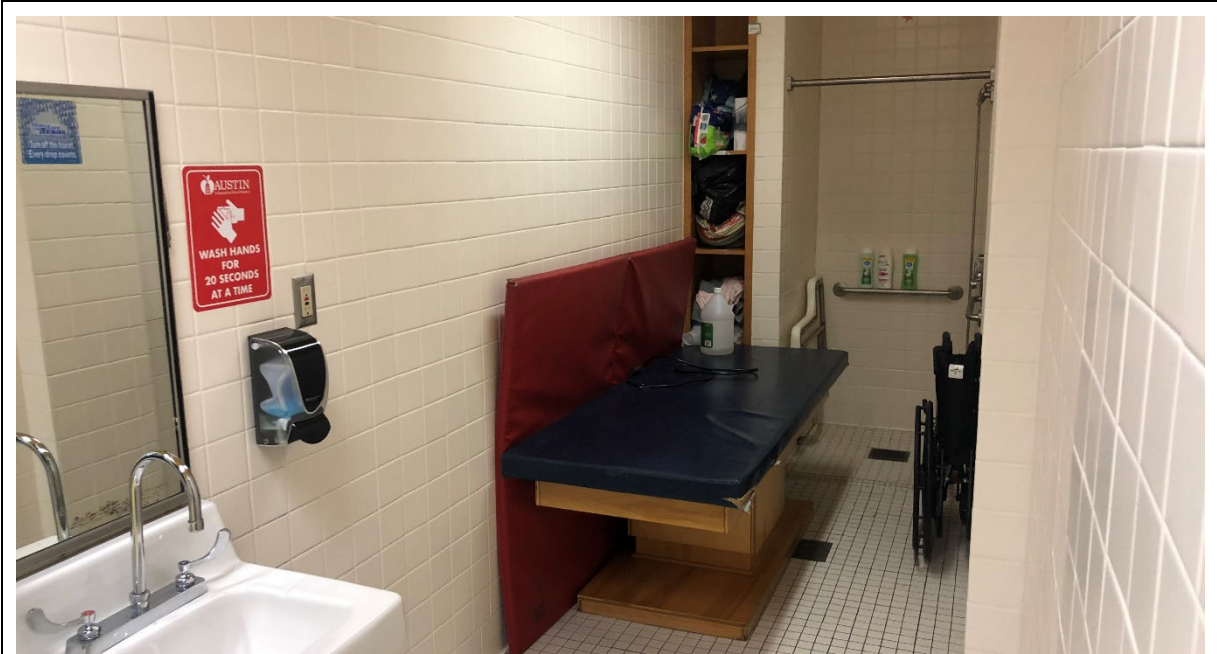
Life Skills Restroom: Shower does not function, and room is inaccessible due to changing table in the center.

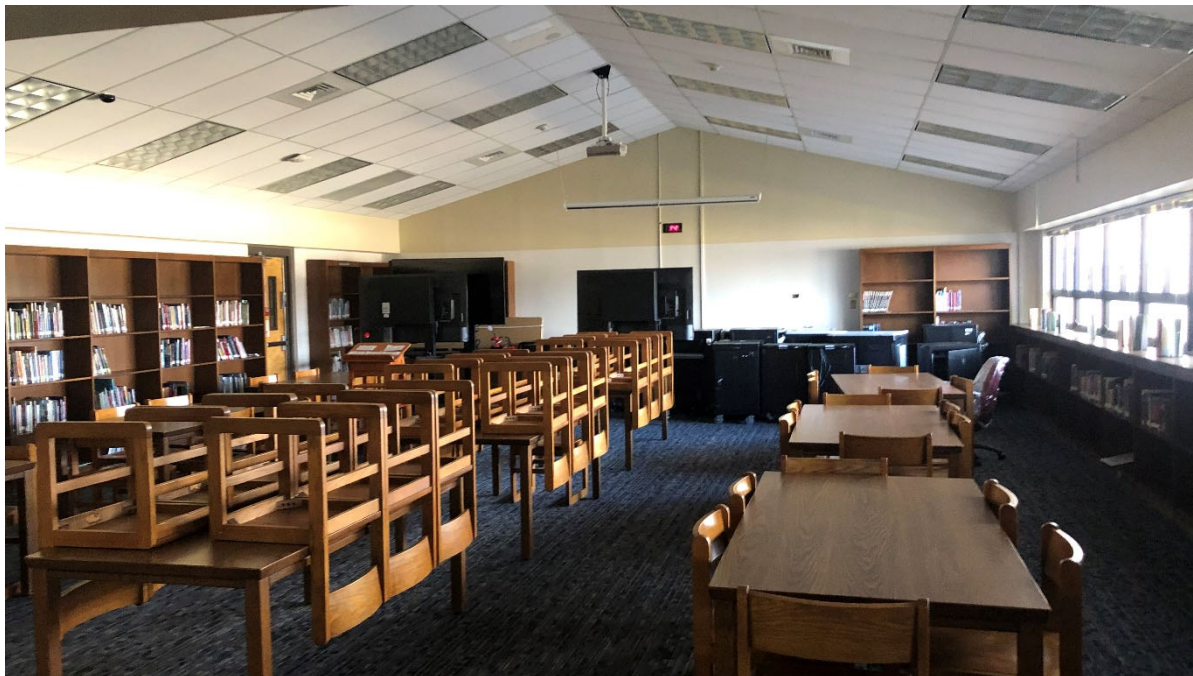
Media Center: Library is on second floor at main entry and has areas for different groups to meet. Furniture is bulky and not conducive to reconfiguration. A few pieces of furniture (not pictured) have been upgraded and are new.

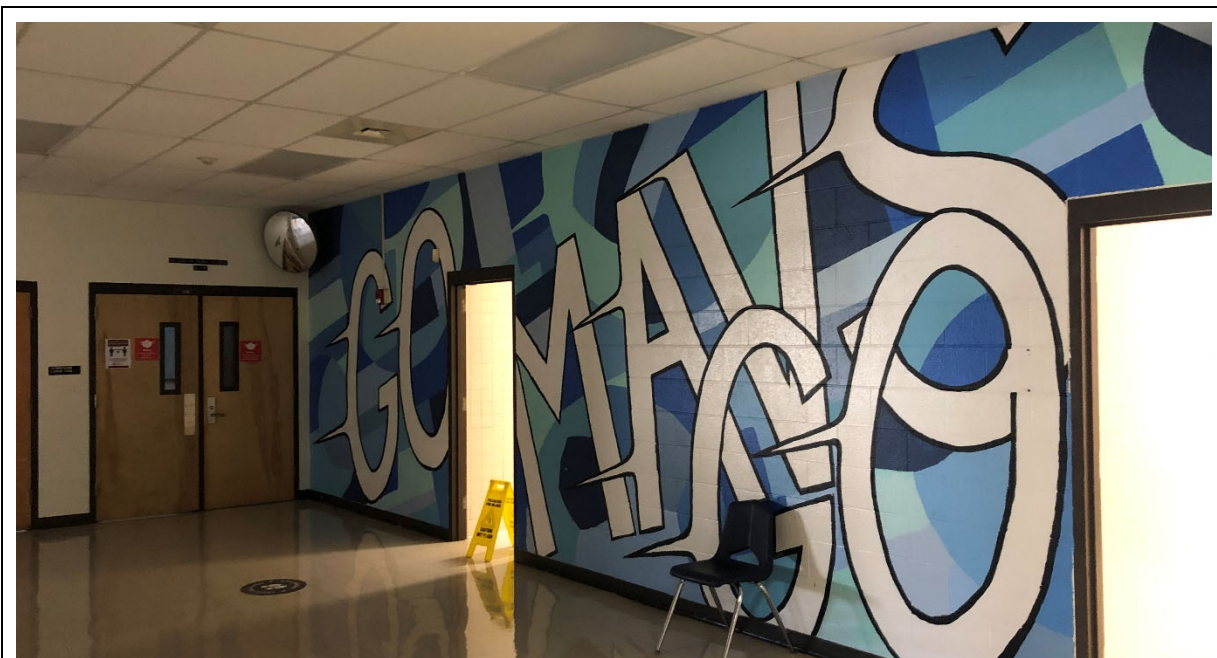
Murals throughout the school are in good condition and highlight school pride.

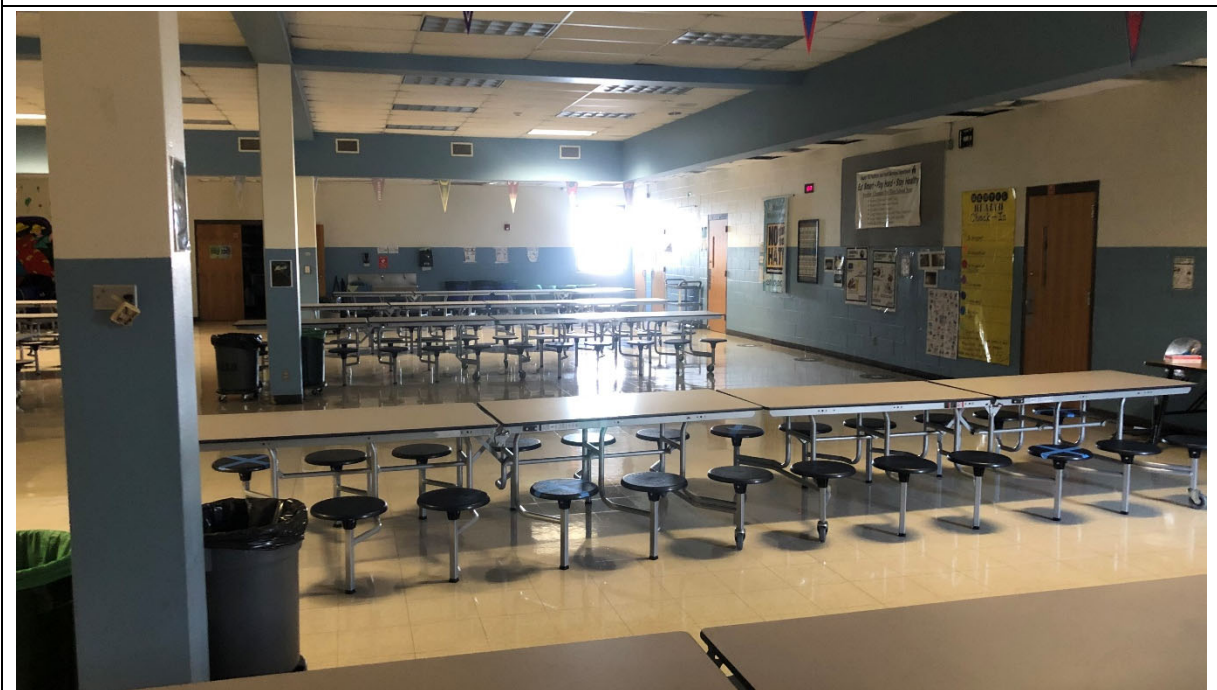
Cafeteria offers no flexibility in seating options and only a few windows allow for natural daylight. Cafeteria is undersized for campus capacity.

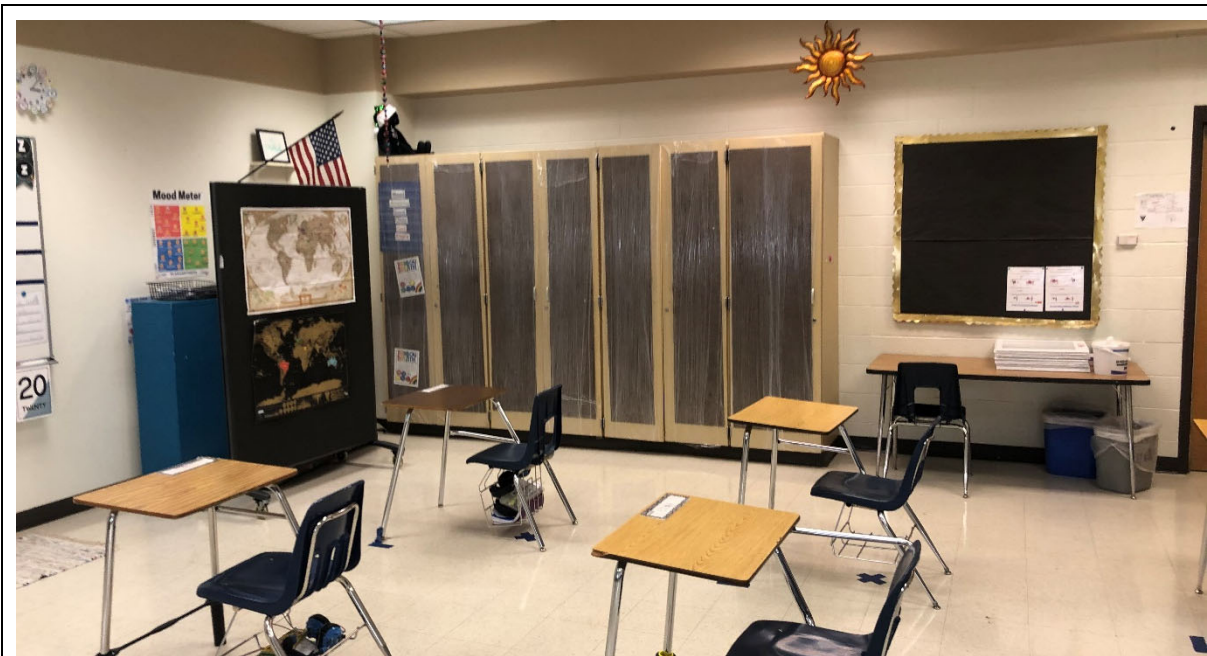
Studios are undersized and are on both sides of the double-loaded main corridor. There are no breakout or collaboration spaces provided near the studios.

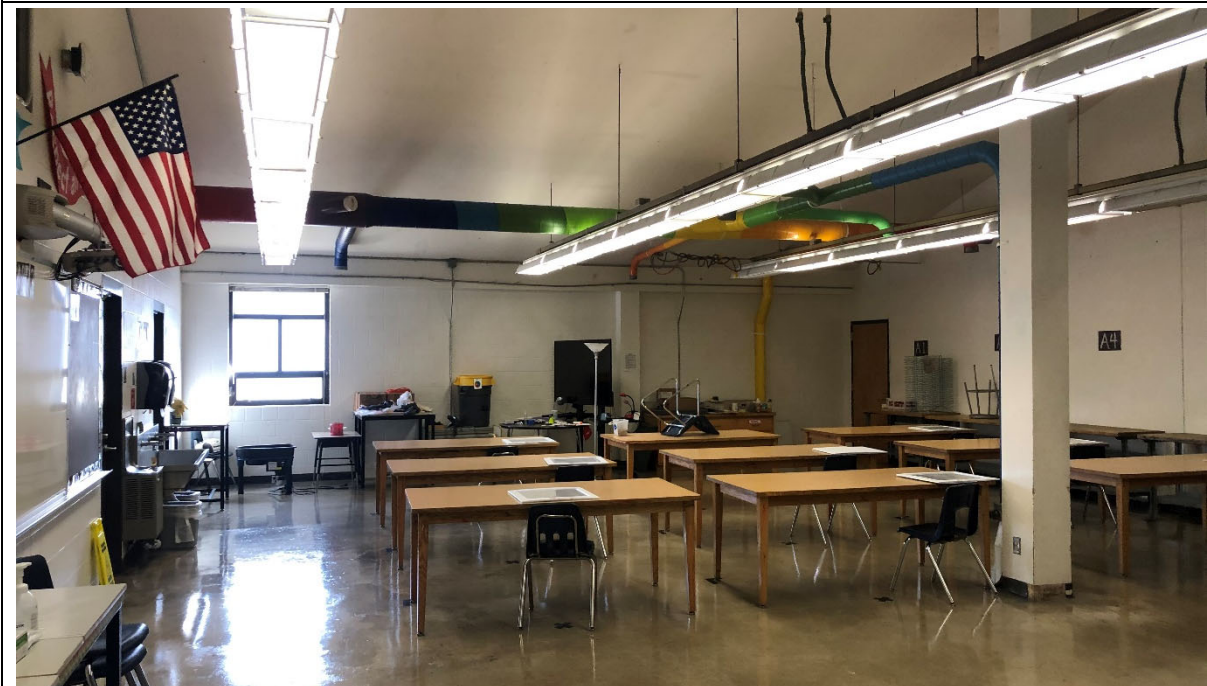
Visual art studio in CTE building is in adequate condition with needed support space.

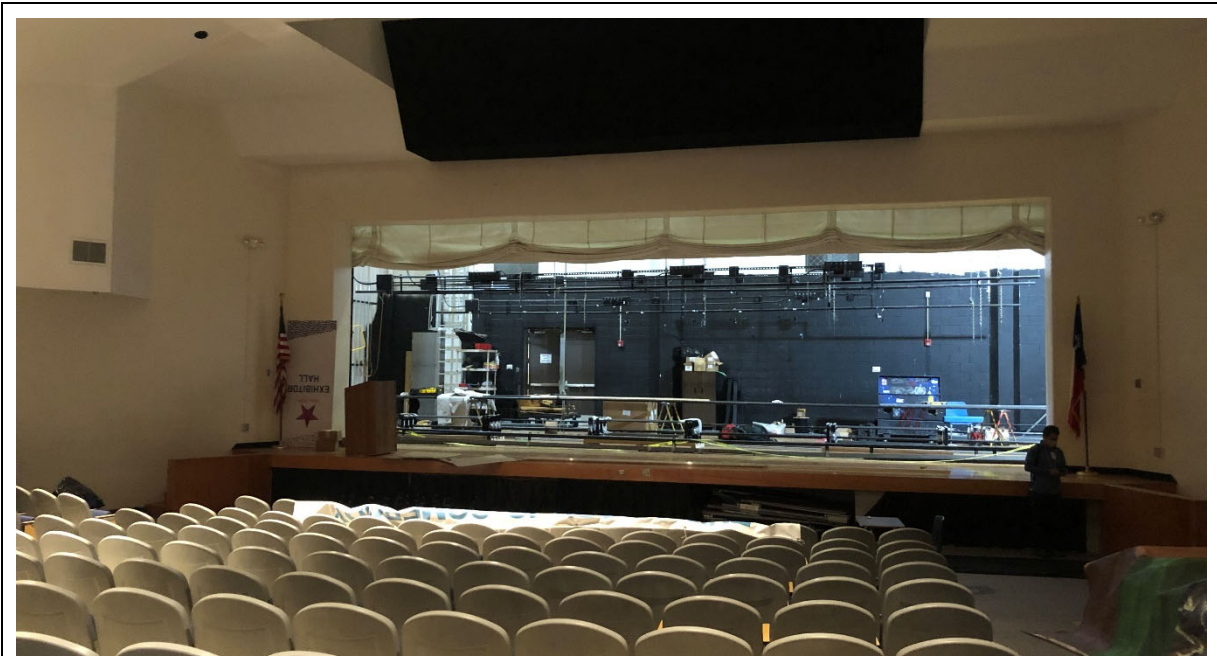
Auditorium is in satisfactory condition. Stage area does not have storage or a scene shop. There is no sink in the vicinity.

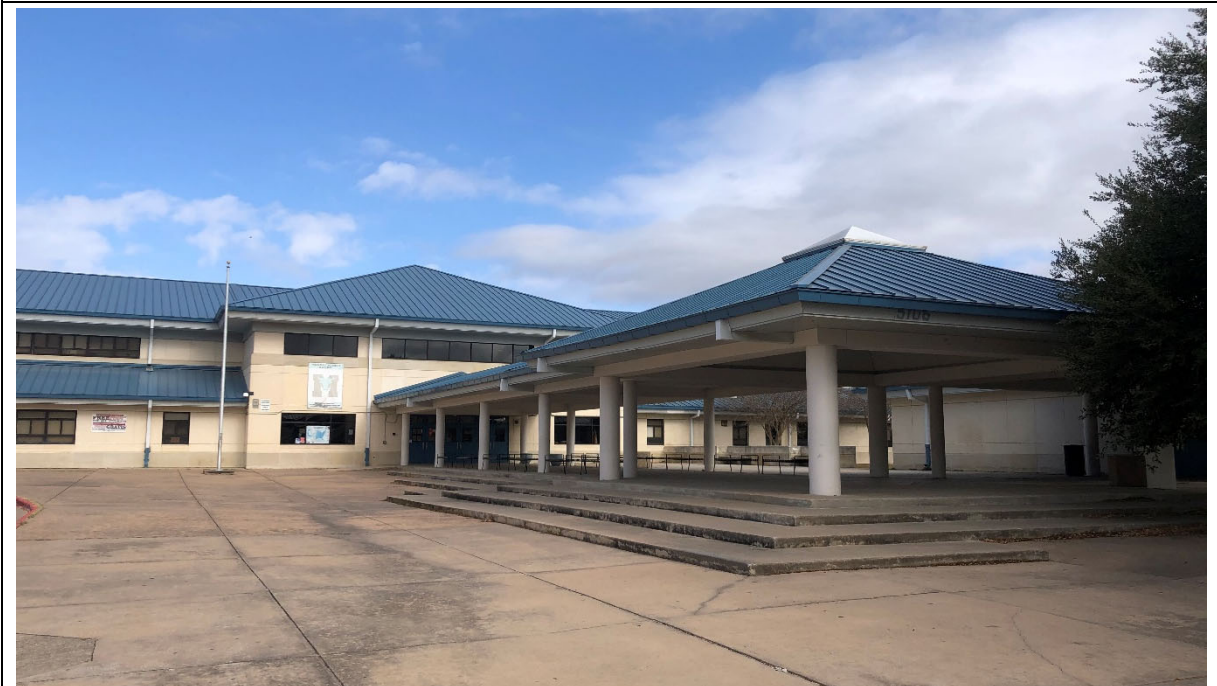
Main entry has covered canopy leading to fine arts building on the right. Glazing at main entry is limited to entry doors. There is hardscape all around the entry, which makes the entry feel unwelcoming.

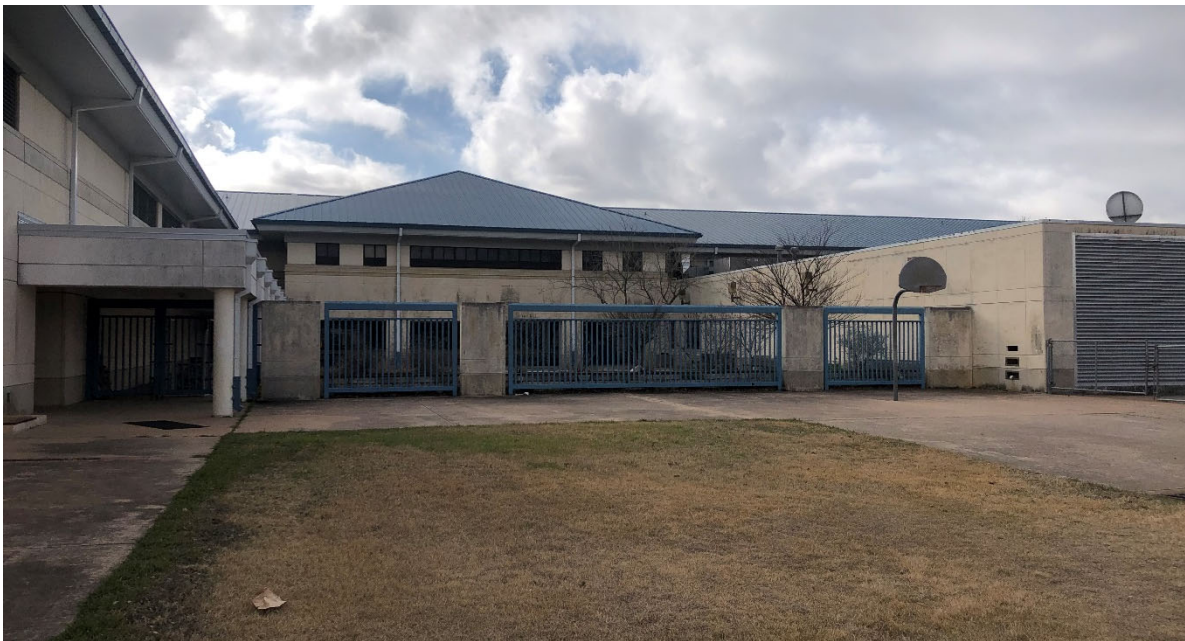
Secured courtyard in back of school is adequately sized but needs shade and updated furniture to function well.

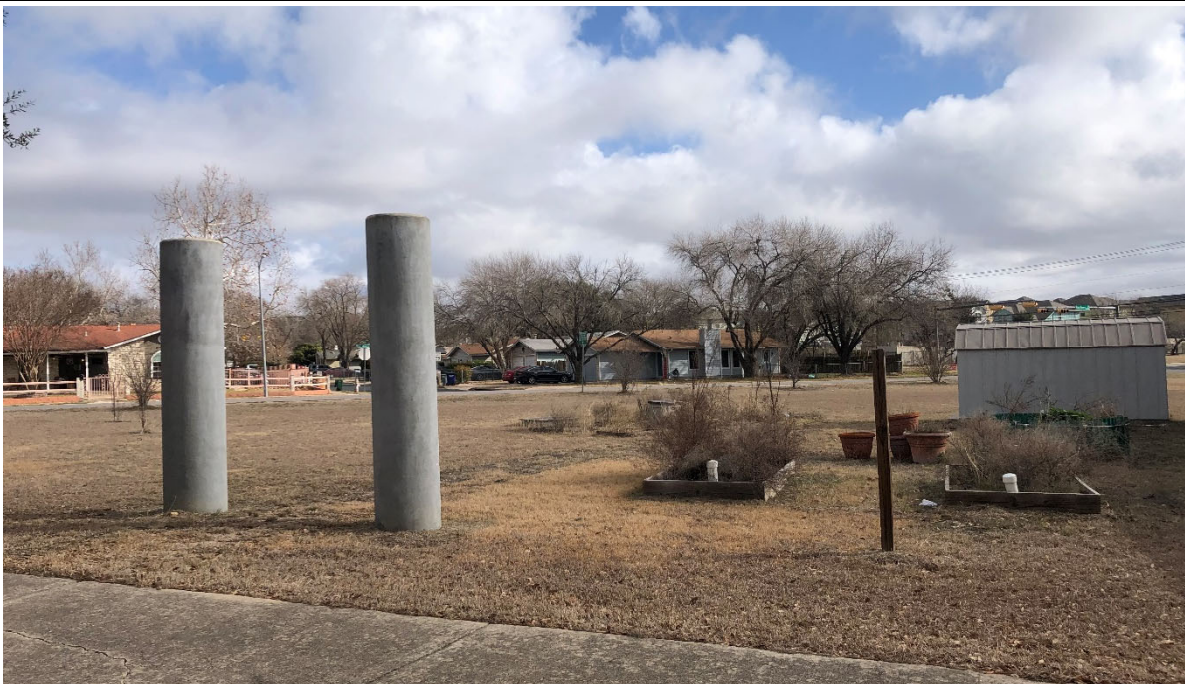
Pillars and garden are beloved by the school but require updates to function well.
