Educational Suitability Summary Report

Allison Elementary School

Date: 01/04/2021

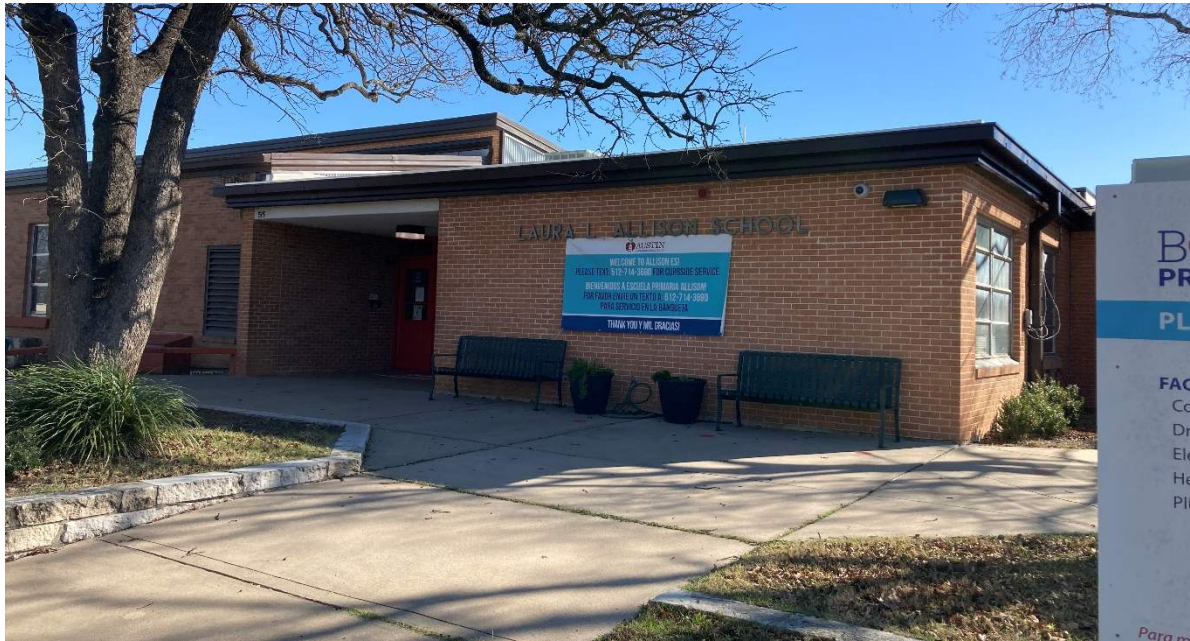
The main entry is small and difficult to access from the parking lot.

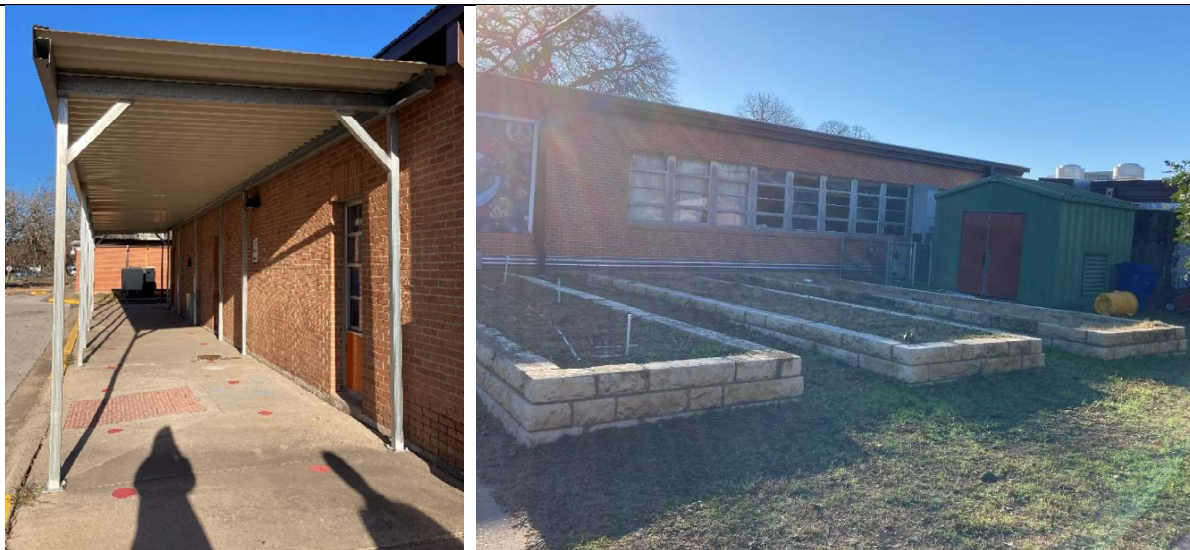
A single drop-off canopy for bus and vehicular traffic (left). The campus has large rows of planter beds with an adjacent dedicated storage shed, but no rainwater cistern (right).

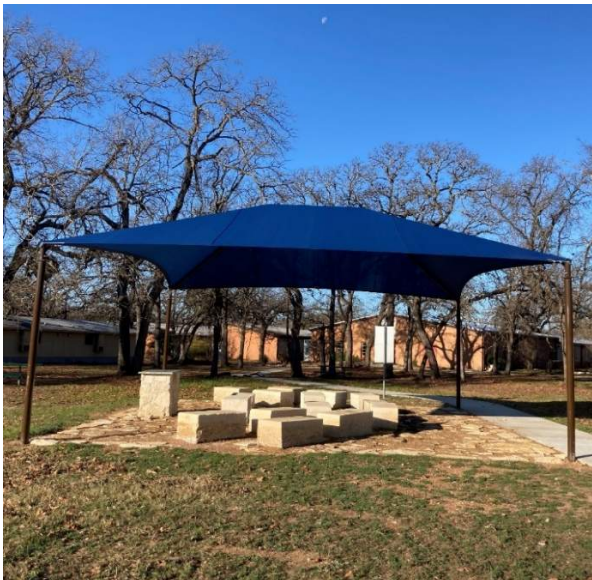
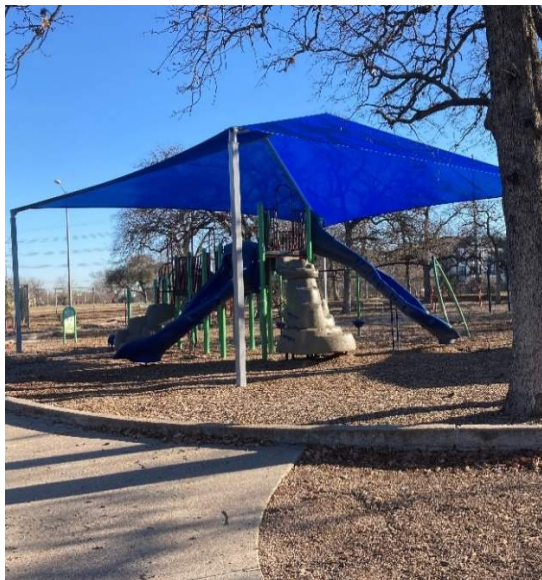
The outdoor studio is fully covered but is not adjacent to the interior learning spaces (left). The playground is fully covered and in good condition (right).

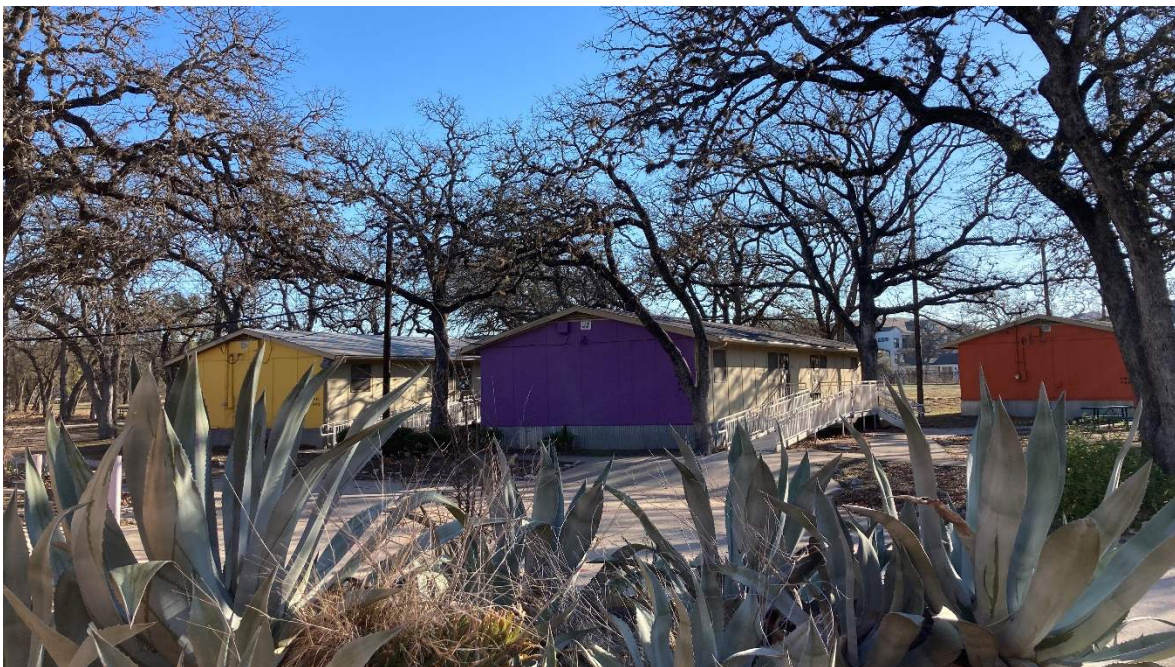
Many of the learning spaces, including the Life Skills studio, are in portables.

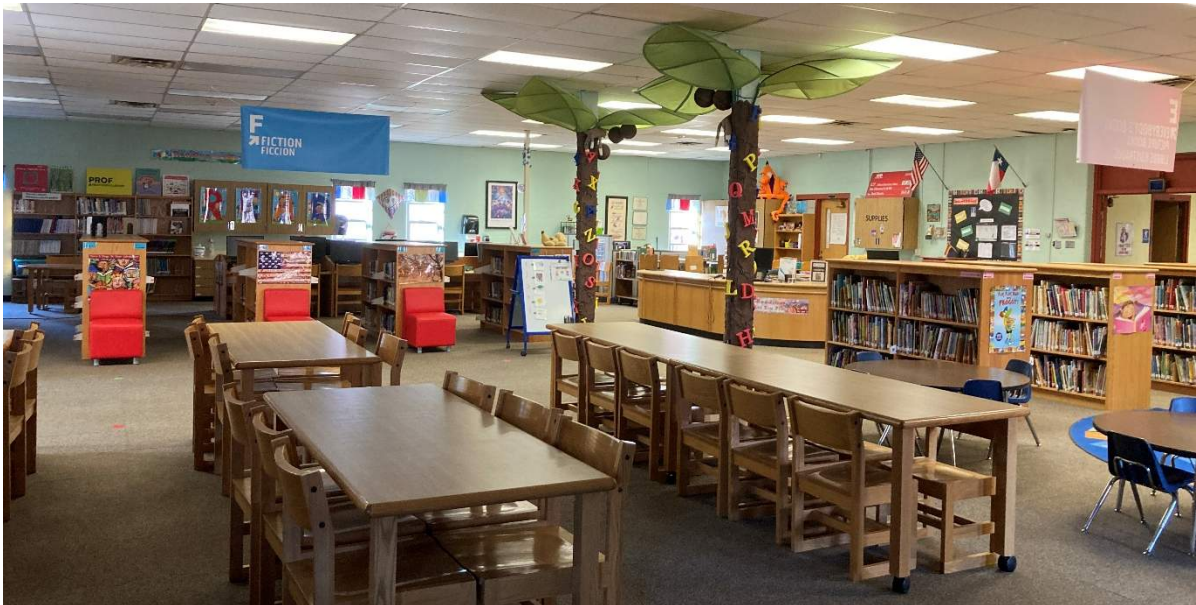
The media center is well-sized but needs technology upgrades and flexible furniture to fully support group work in various sizes.

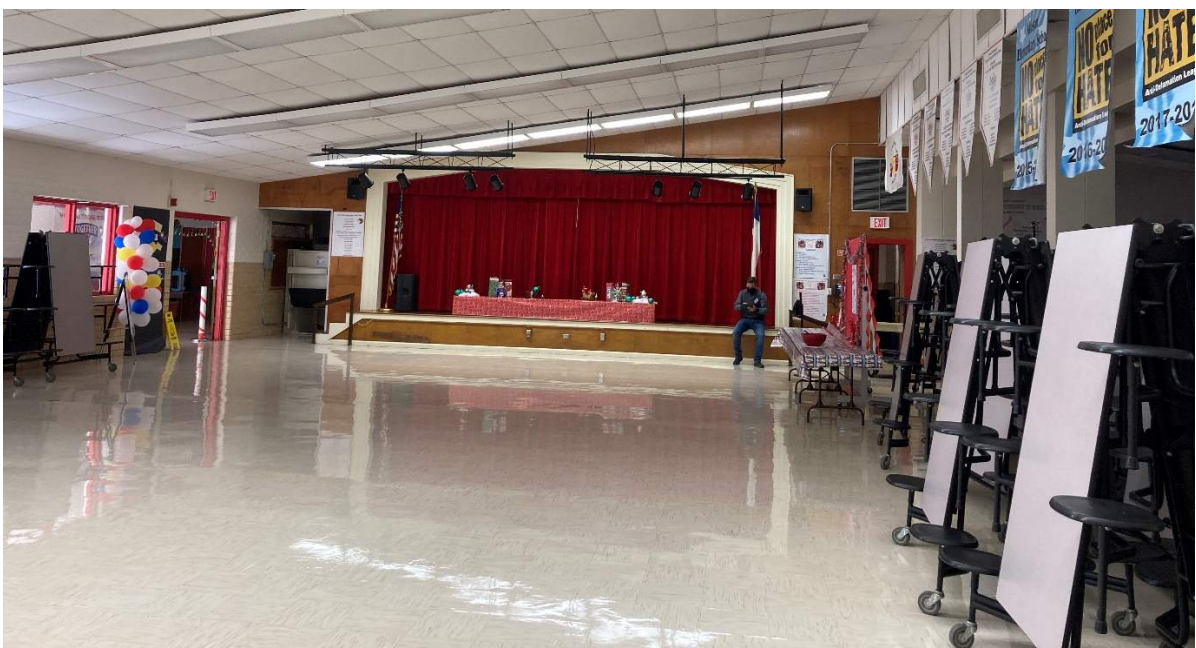
The cafeteria is undersized and has no outdoor dining available. No projector or screen is present. Only one seating type exists with fixed stools.

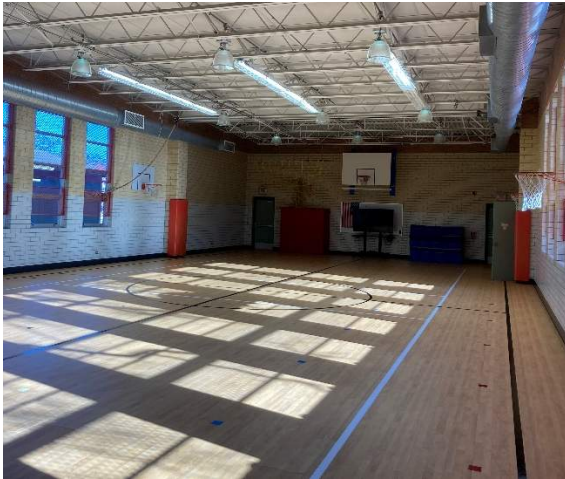
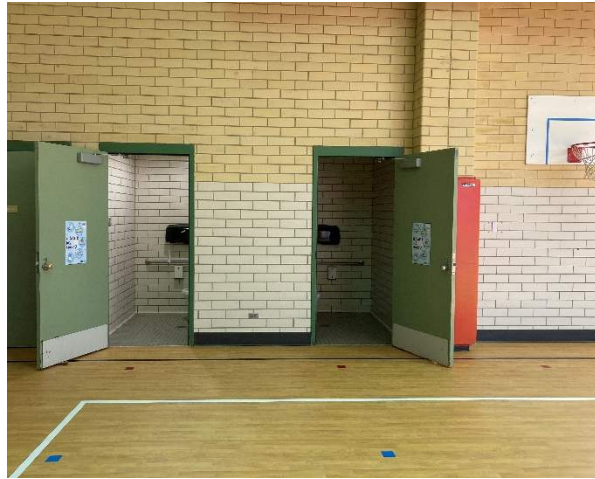
The gym floor appears to have been recently replaced, but additional renovations are needed. The ceiling is low with poor lighting, and restrooms are both undersized and open directly onto the athletic floor. No faculty toilet is present.

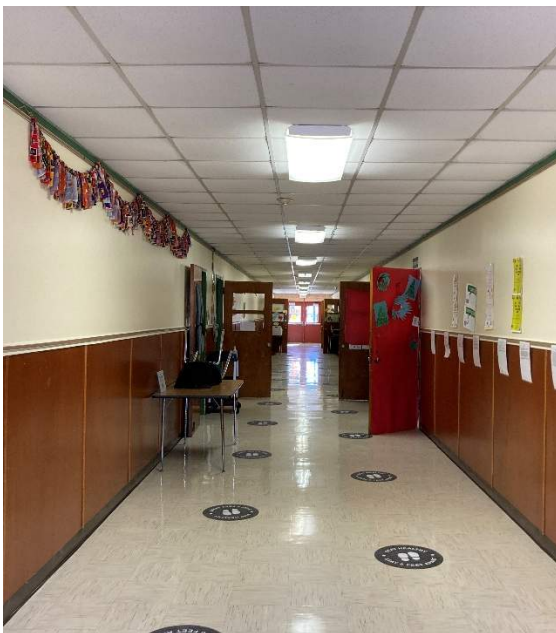
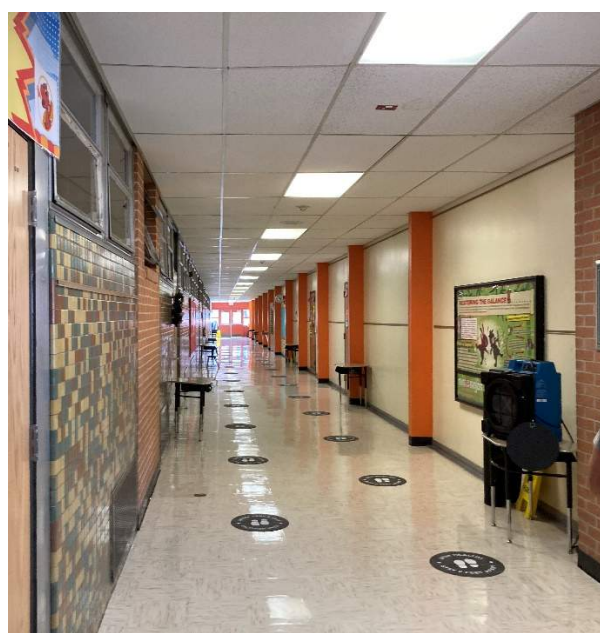
Academic corridors have poor visibility into the studios, and display areas are limited to 2D artifacts. Ceiling, lighting, and wall paneling are dated.

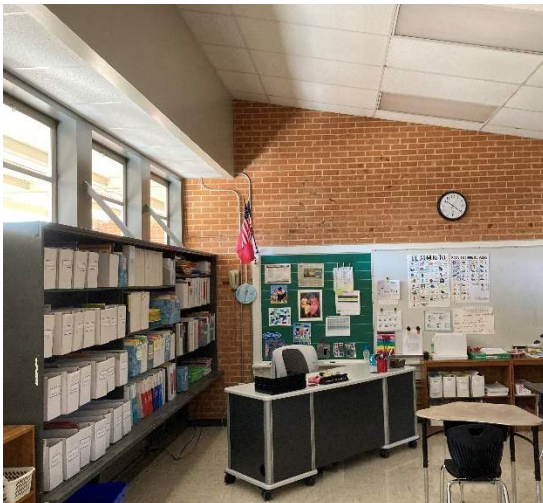
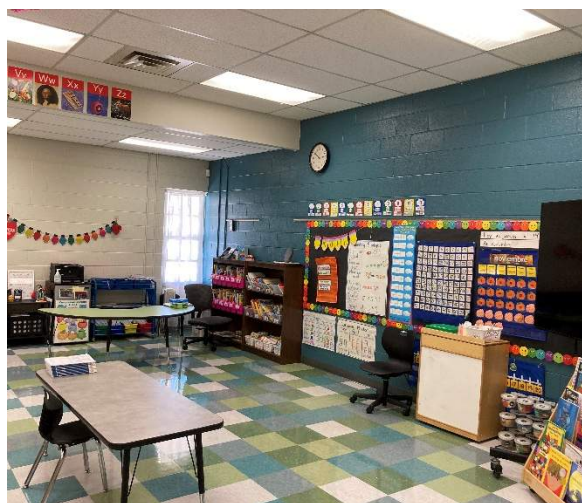
Transparency is limited in the studios. Furniture is outdated and difficult to reconfigure.

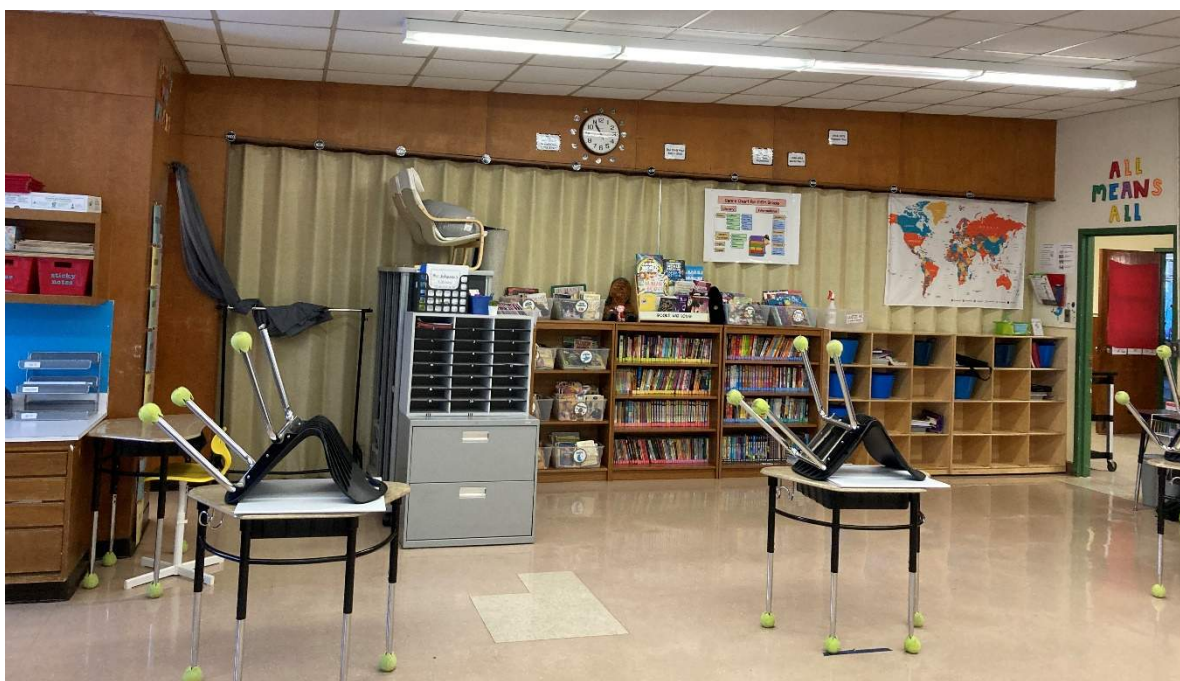
Accordion wall only exist in some studios but are outdated and not utilized.
