## **Educational Suitability Summary Report**

Blackshear Elementary School

Date: 01/14/2021

Perkins&amp;Will

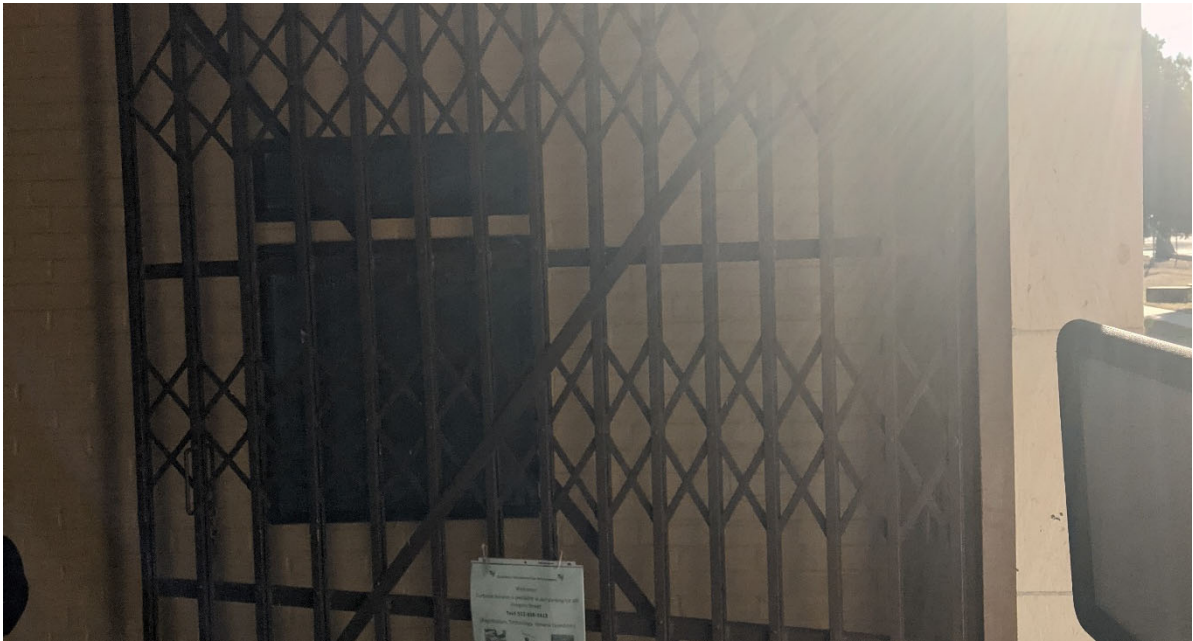
*Old iron gate at front entry is not used and is not inviting to visitors.*

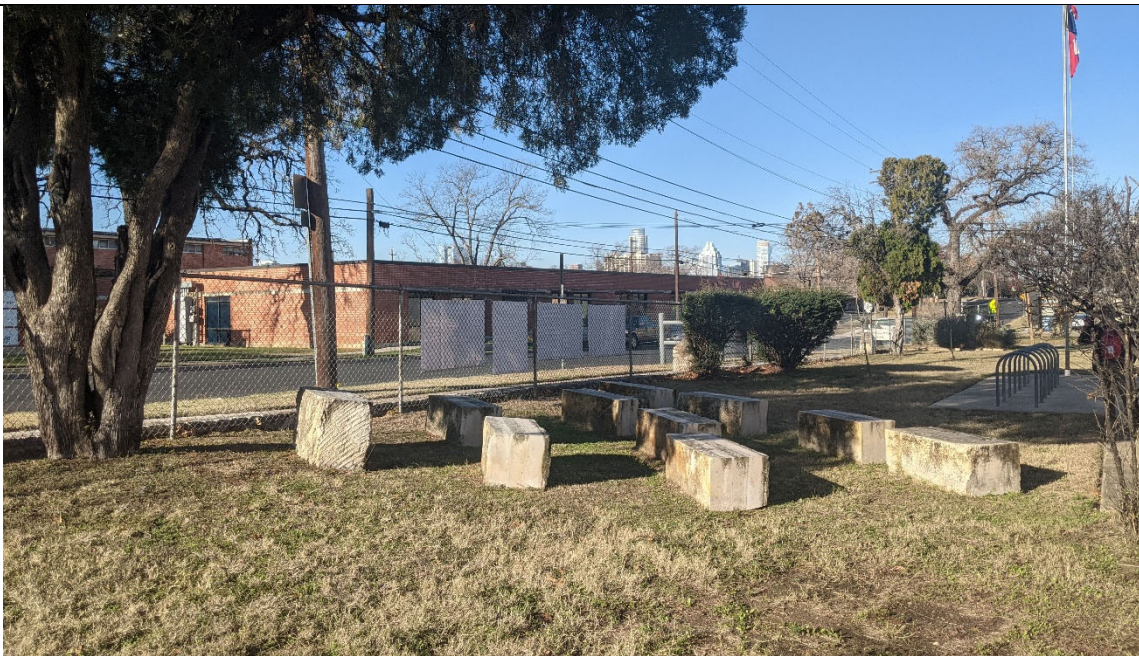
*Chain-link fence is not visually pleasing and does not promote the campus as an inviting place. Exterior spaces need landscaping. Outdoor learning space needs further development to function well. Limestone blocks are too large for smaller student seating.*

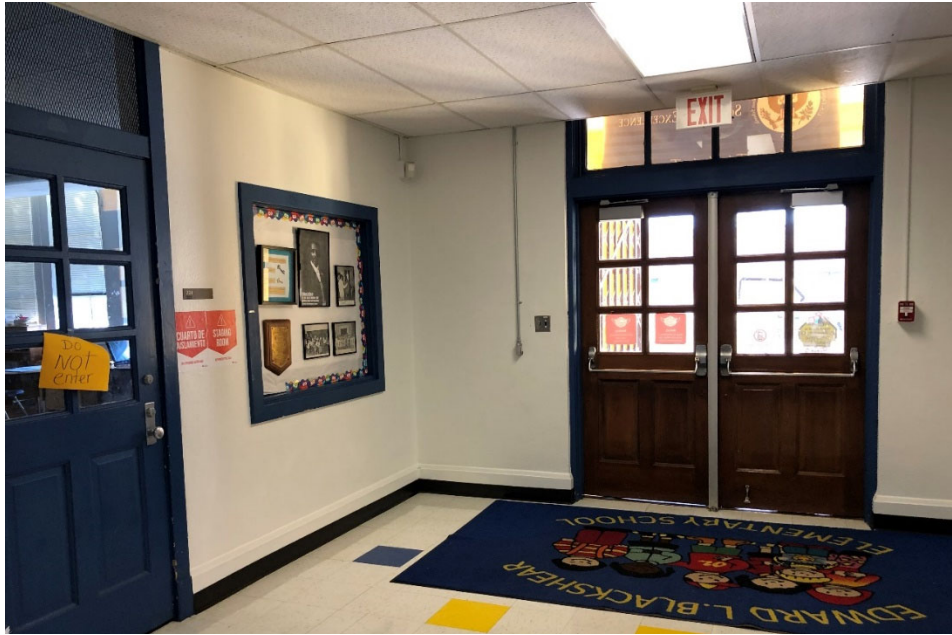
The main entry is small with a low ceiling and does not feel welcoming as an elementary school. The entry lacks a secure vestibule and is far from the main office. This layout allows visitors to enter without supervision.

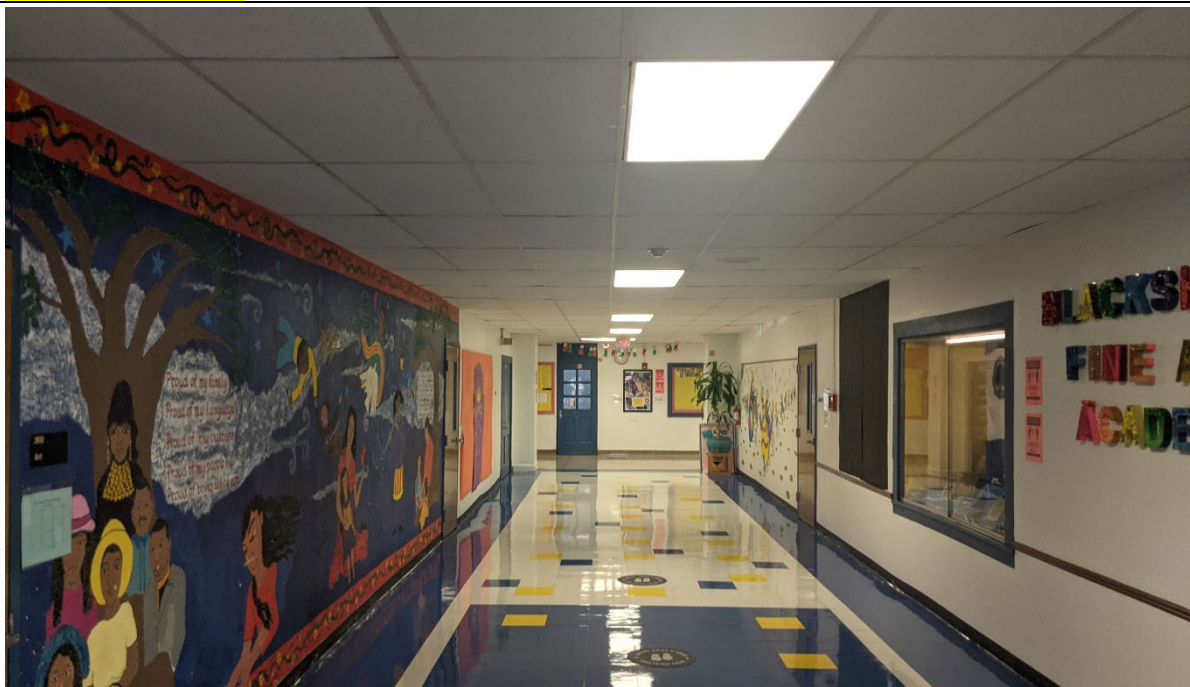
The main corridor is wide and has murals and displays to promote school pride. The lighting is dim and could use upgrades.

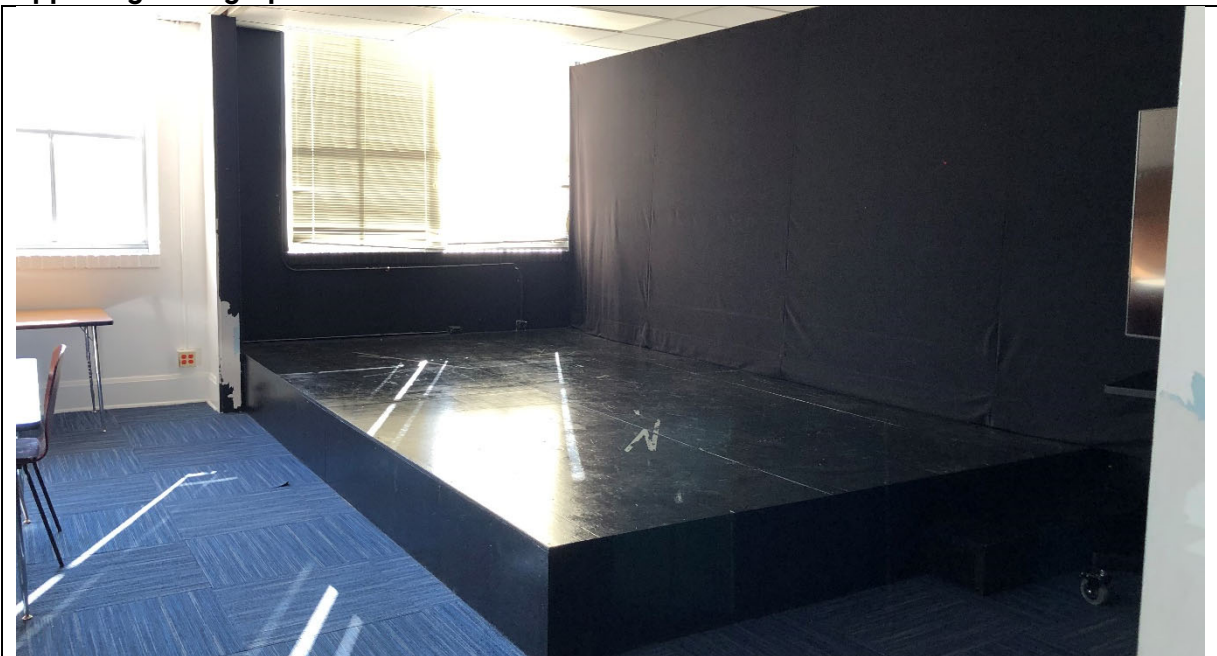
*One of the studios is used as a flex space for performance practice. Makeshift stage was created with attempt to soundproof with carpet tile (not fully adhered) and fabric wall.*

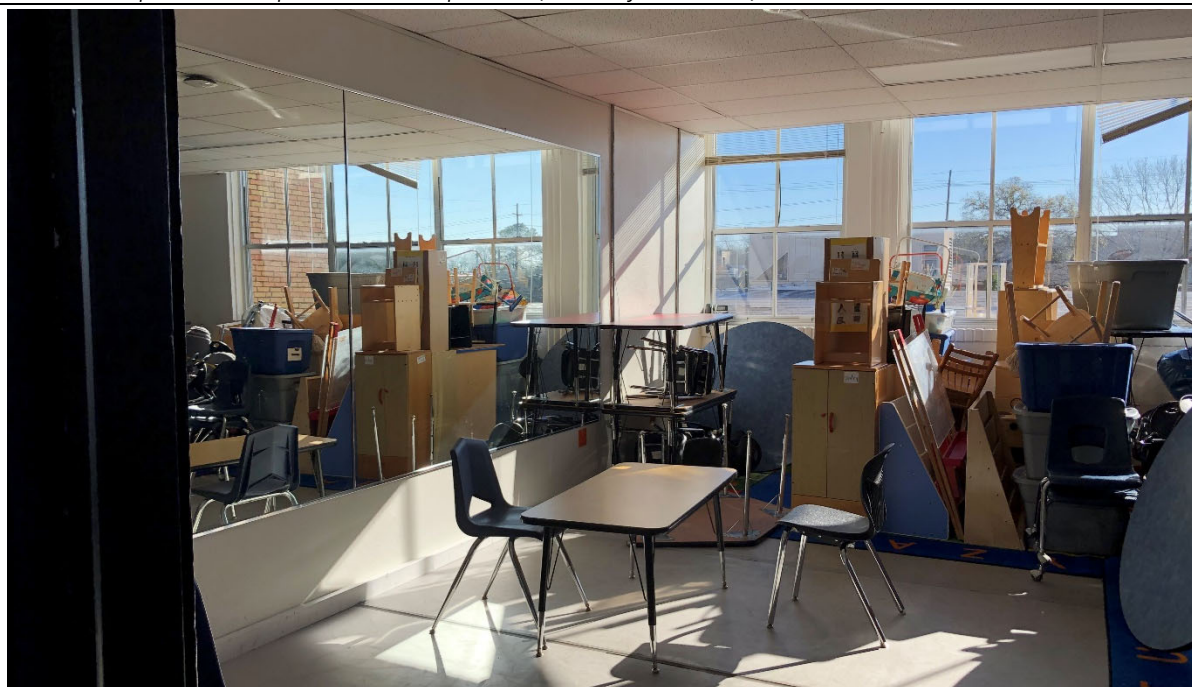
*Typical studio is being used as flex space for dance class. Storage within studio is an outcome of COVID-19 protocols and does not represent the room under normal use.*

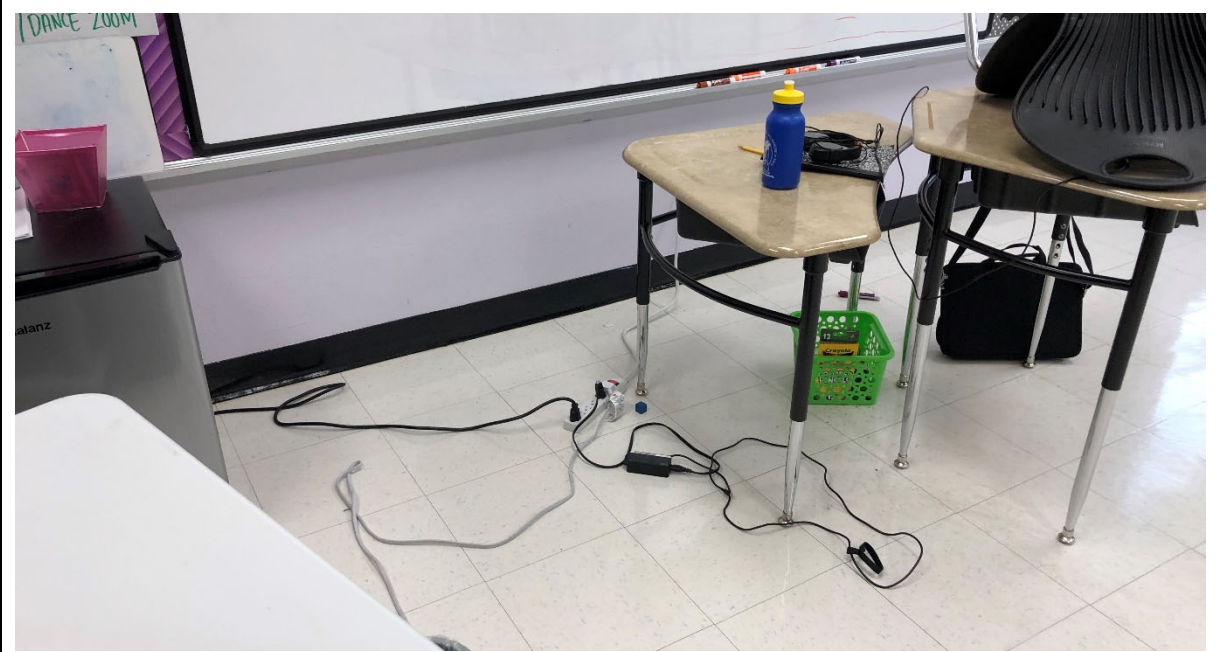
*Typical studio device connections include extension cords and power strips.*

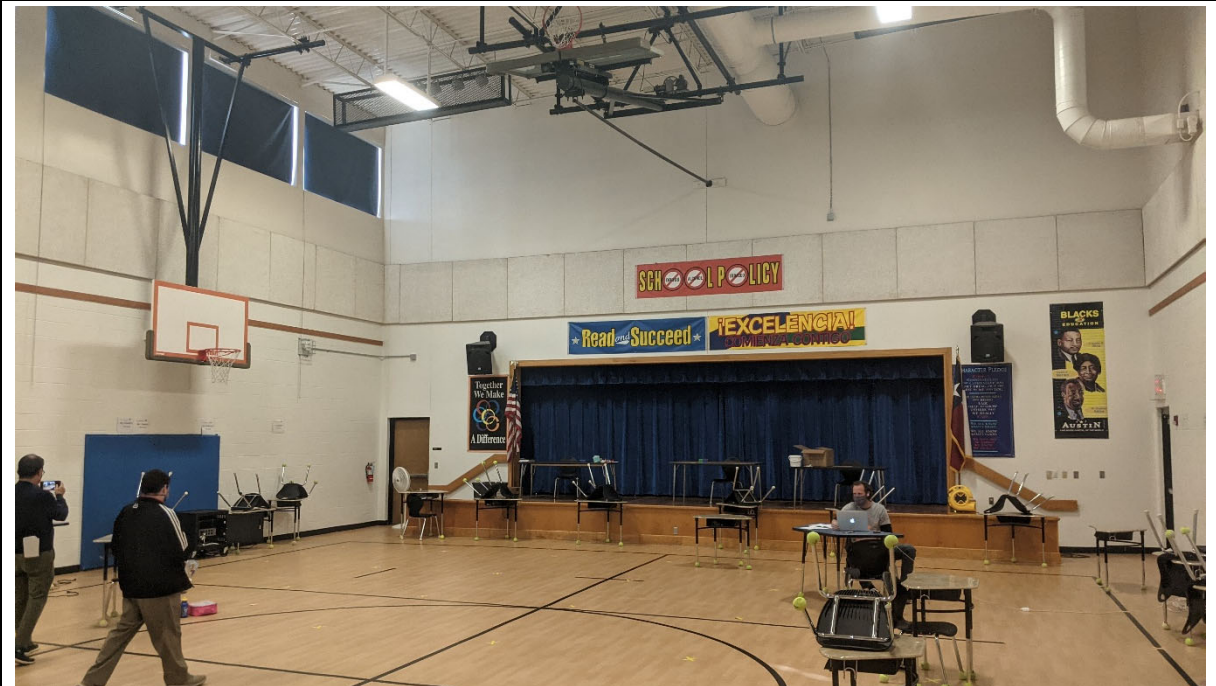
Flooring and equipment in gym appears to be in good condition. The arrangement of support spaces is configured well, but storage space is small. Gym office door opens into the corridor but has a window for visibility into the gym.

*Gym and stage area both appear in good condition.*

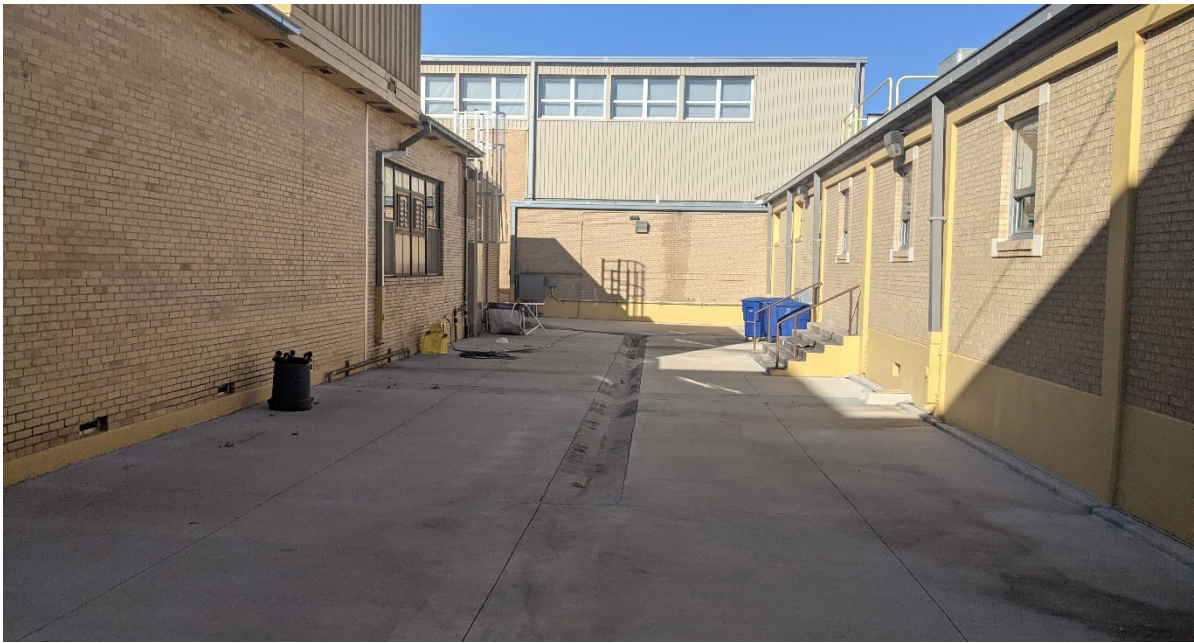
*Outdoor space between cafeteria and studio wing needs development to be utilized as a gathering place. The staff expressed the need for shading of this space.*

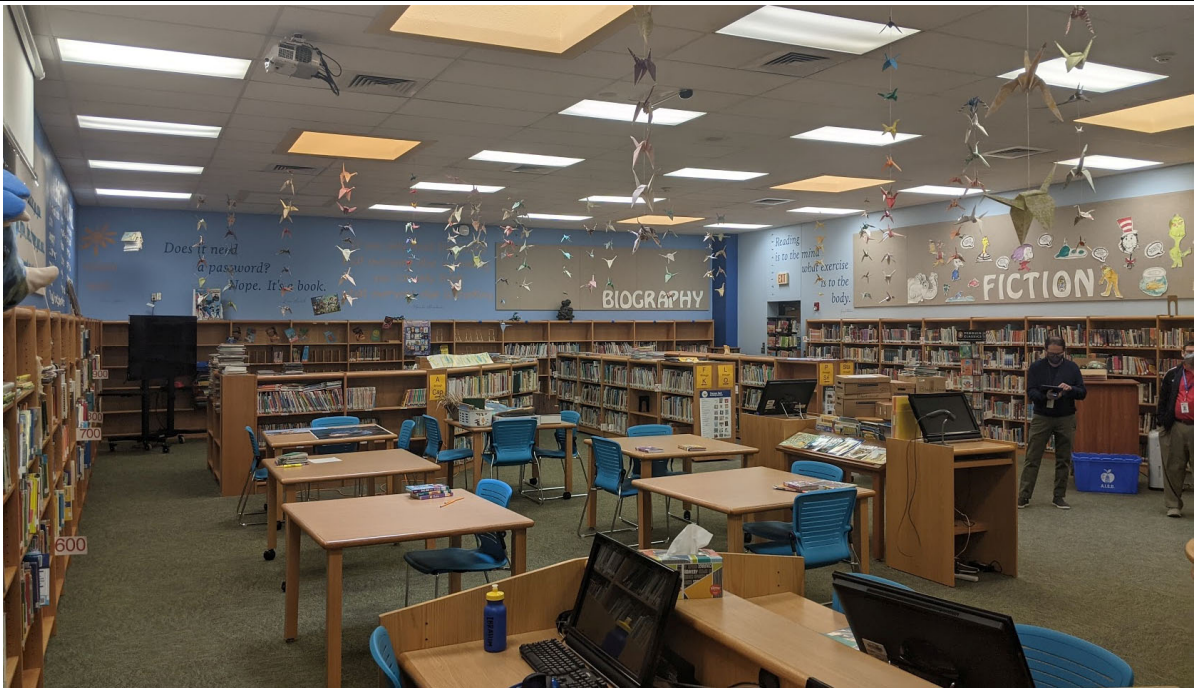
Library is not easily accessible to visitors and cannot be accessed for after-hours functions without accessing other parts of the building. The library has no access to natural light. The library is limited in supporting larger groups and does not have any breakout rooms for student collaboration.

*Library does not support large groups and has no natural light.*

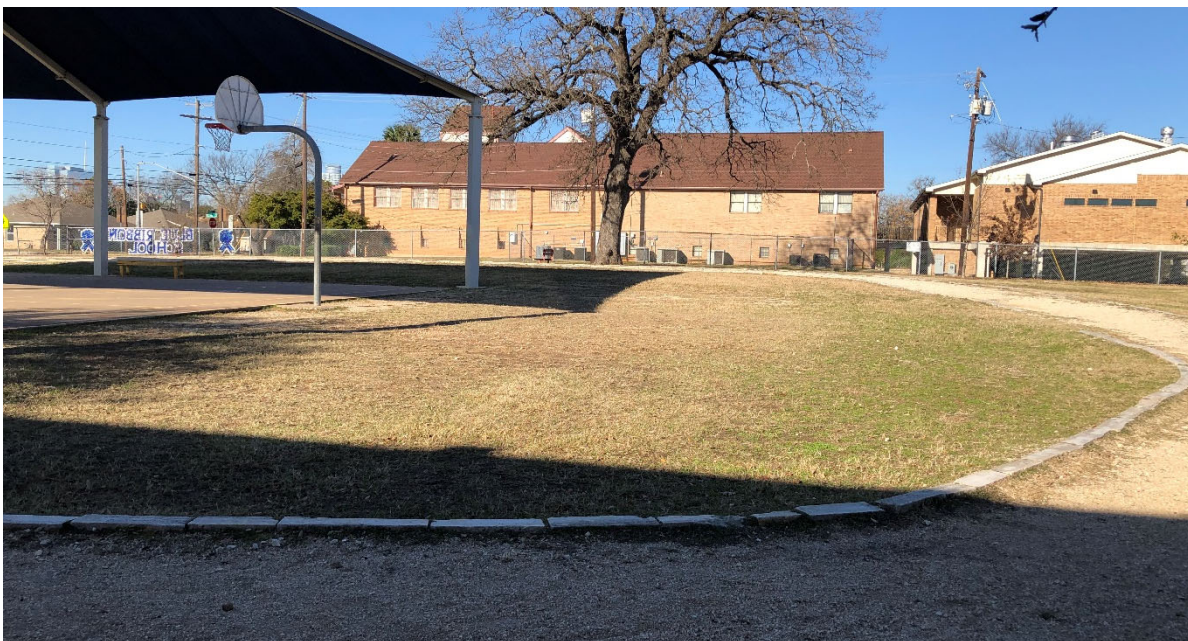
*Small grass field area is too small for field sports. Campus has another open area, but it is far from gym and near the pre-K wing.*

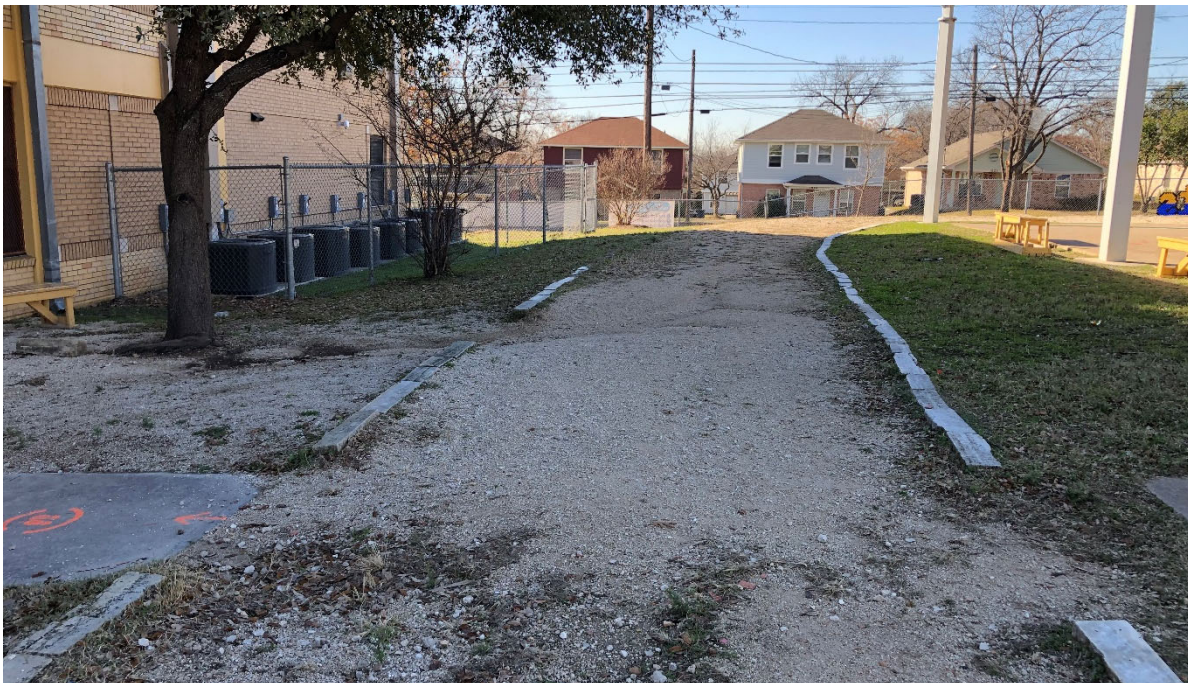
Storage is insufficient for garden space. Alcoves to exterior doorway are used for storing gardening equipment. Walking path has been eroded by rain and poses trip hazards. There is not adequate space for field sports.

*Track surface is eroding from rain runoff and is a hazard for users. The District Project Manager noted that this will be addressed in an upcoming improvement project.*
