Educational Suitability Summary Report

Blazier Elementary School (Primary and Intermediate Site)

Date: 12/21/2020

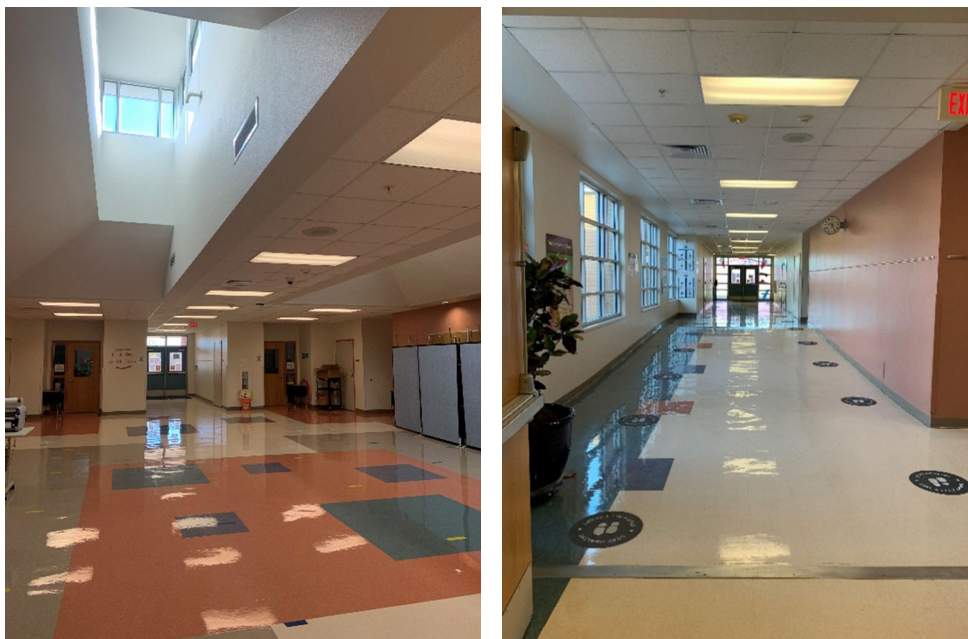
Common Areas (Primary): Learning neighborhoods and wide corridors have natural light.

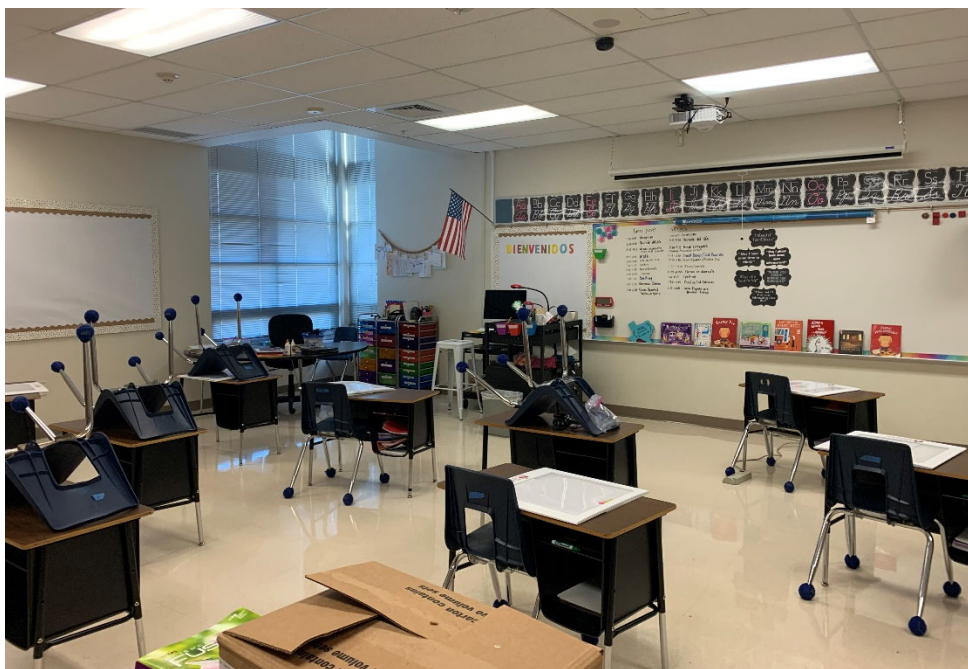
Studios (Primary): Most furniture is not reconfigurable or easily movable.

While the intermediate building conforms to current district standards, the primary building has outdated furniture. Studios have standard desks with unattached chairs. There are not multiple options for teaching spaces and the desks are bulky and difficult to move. The original building's cafeteria has standard cafeteria tables with attached stools only. No furniture was observed in the primary building's open collaboration areas or neighborhoods.

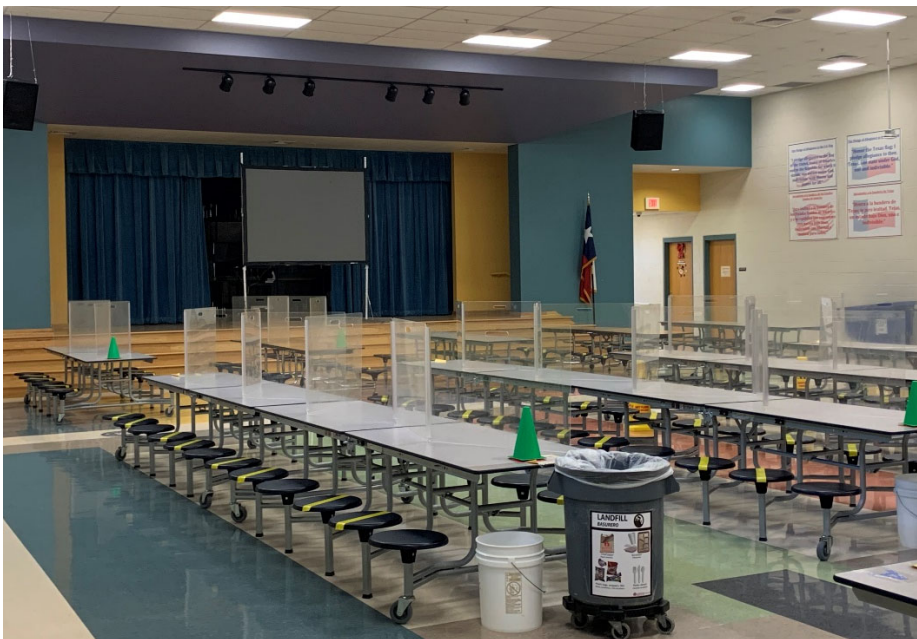
Cafeteria (Primary): Cafeteria has only one type of seating option.

The intermediate building meets the district standards. The primary building has no outdoor dining and only one seating option.

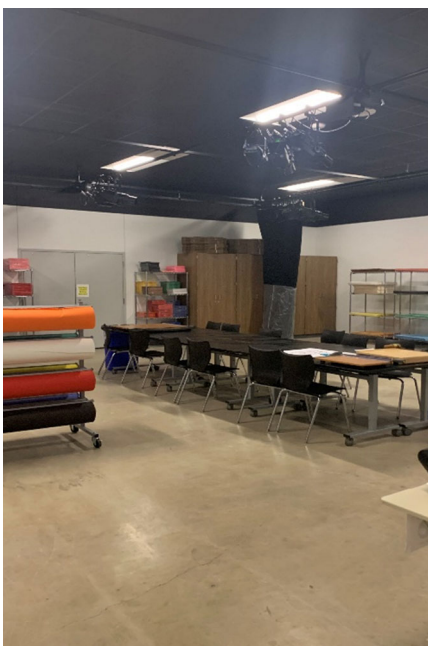
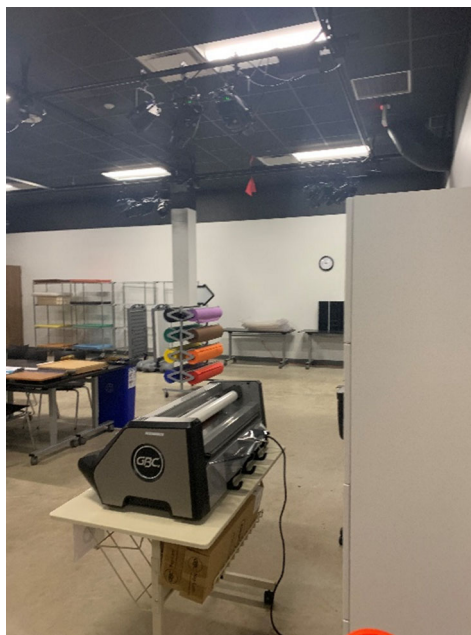
Blackbox (Intermediate): Lack of storage areas. Blackbox currently used as storage/workroom.

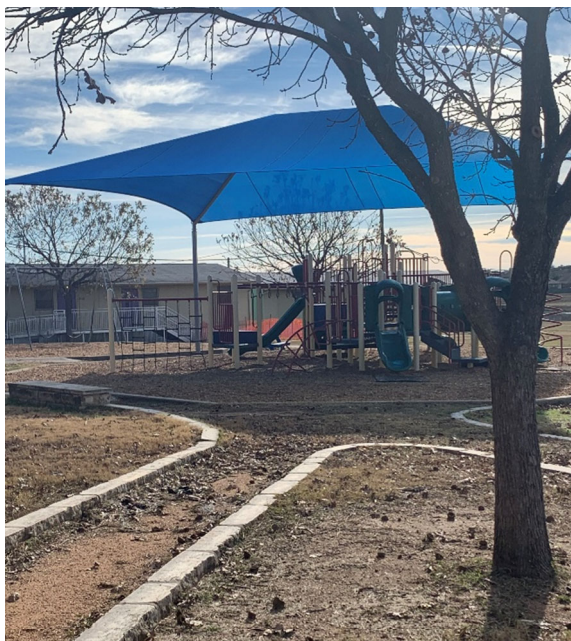
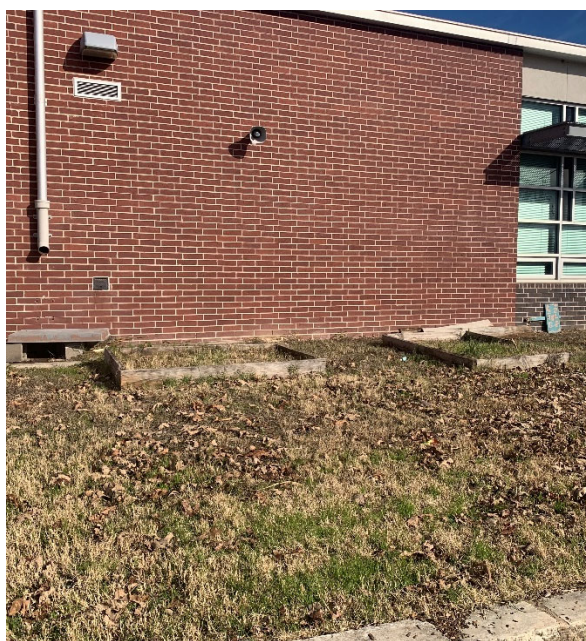
Exterior (Primary): Covered playground; community garden beds are undersized and not maintained well.

The intermediate building meets current district standards. The primary building does not have an outdoor studio and the gardens are small and not well-maintained. Two small water cisterns were observed on the primary building site.

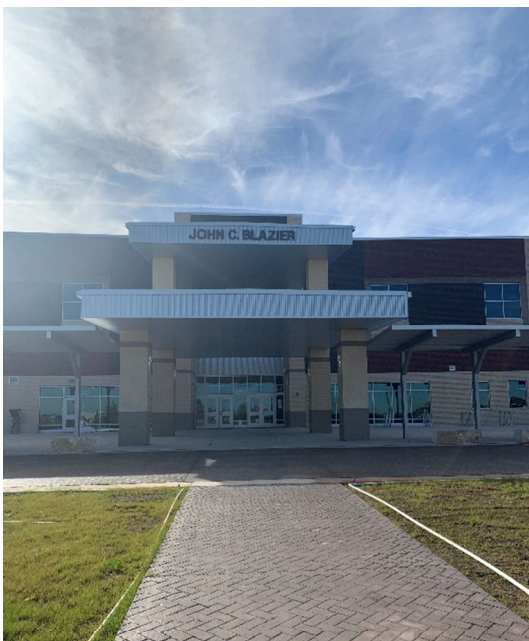
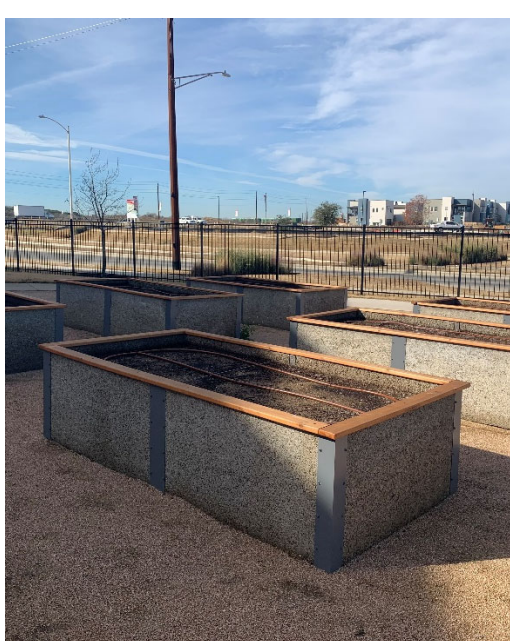
Exterior (Intermediate): Covered walkway at entry; raised community garden beds.

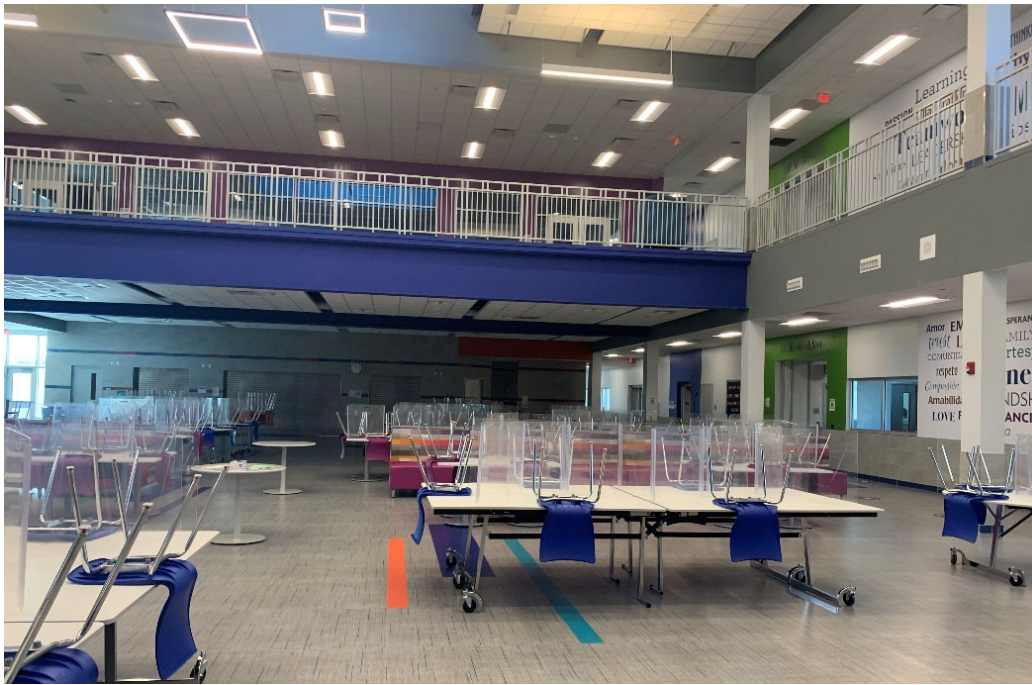
Cafeteria (Intermediate): Cafeteria has a variety of seating options.

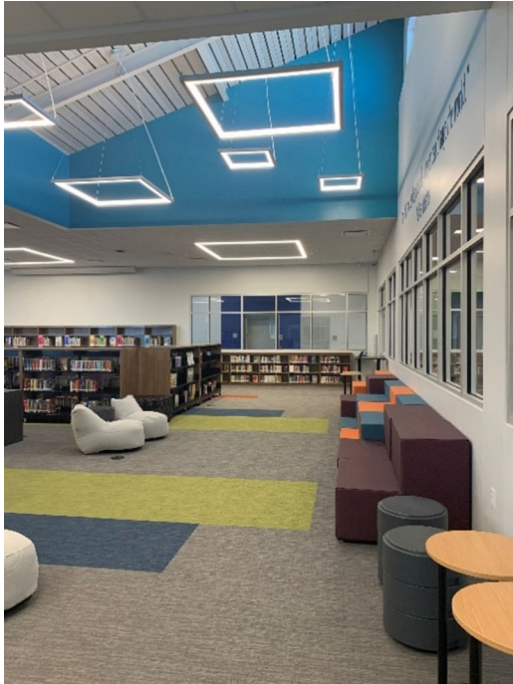
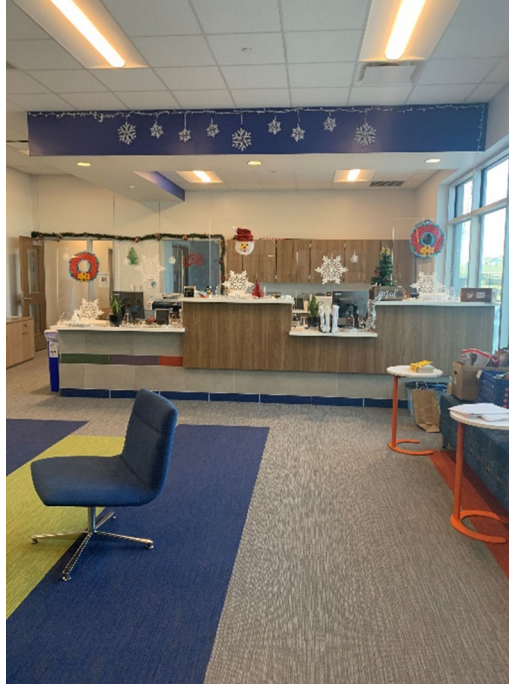
*Media Center (Intermediate, left): Transparency and flexible seating in the media center.
Reception (Intermediate, right): Welcoming reception space in the administrative area.*

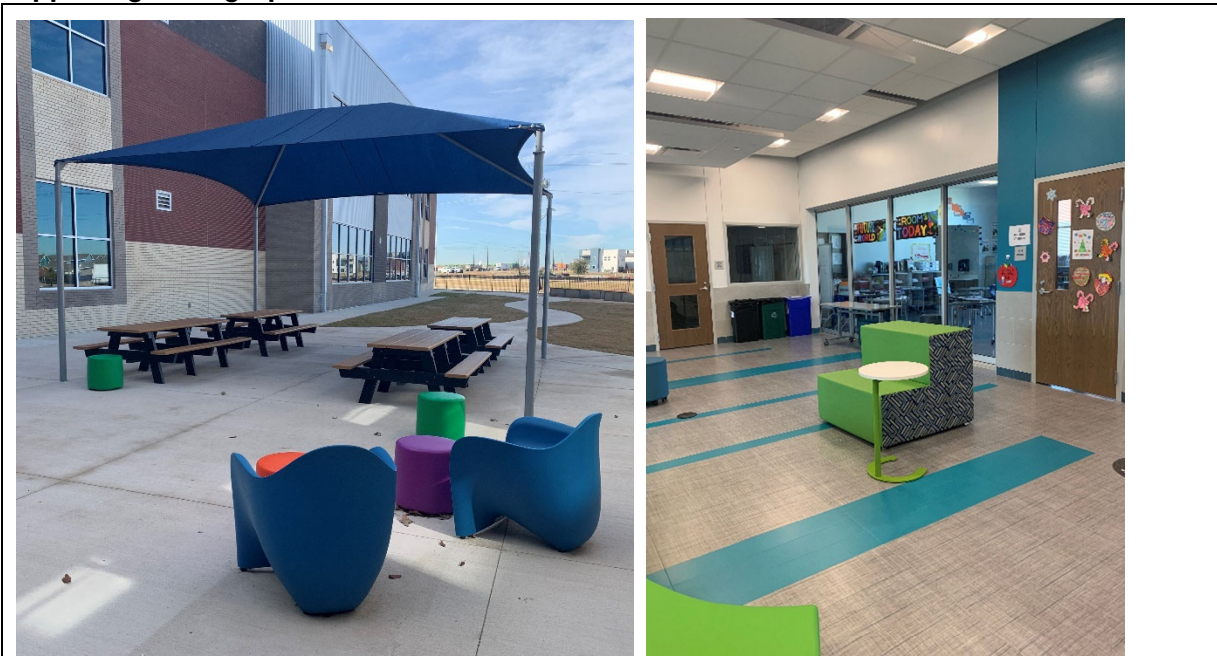
Outdoor Studio/Collaboration Space (Intermediate): Covered outdoor studio; open collaboration space with transparency between learning spaces.

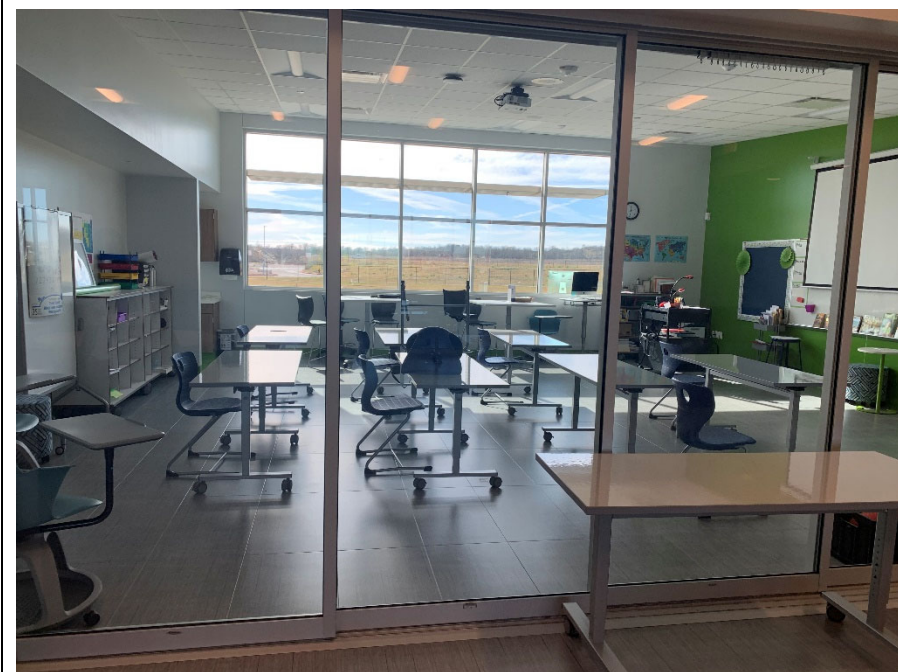
Studio (Intermediate): Studios have a variety of furniture, movable glass walls and plenty of natural light.
