Educational Suitability Summary Report

Cowan Elementary School

Date: 01/05/2021

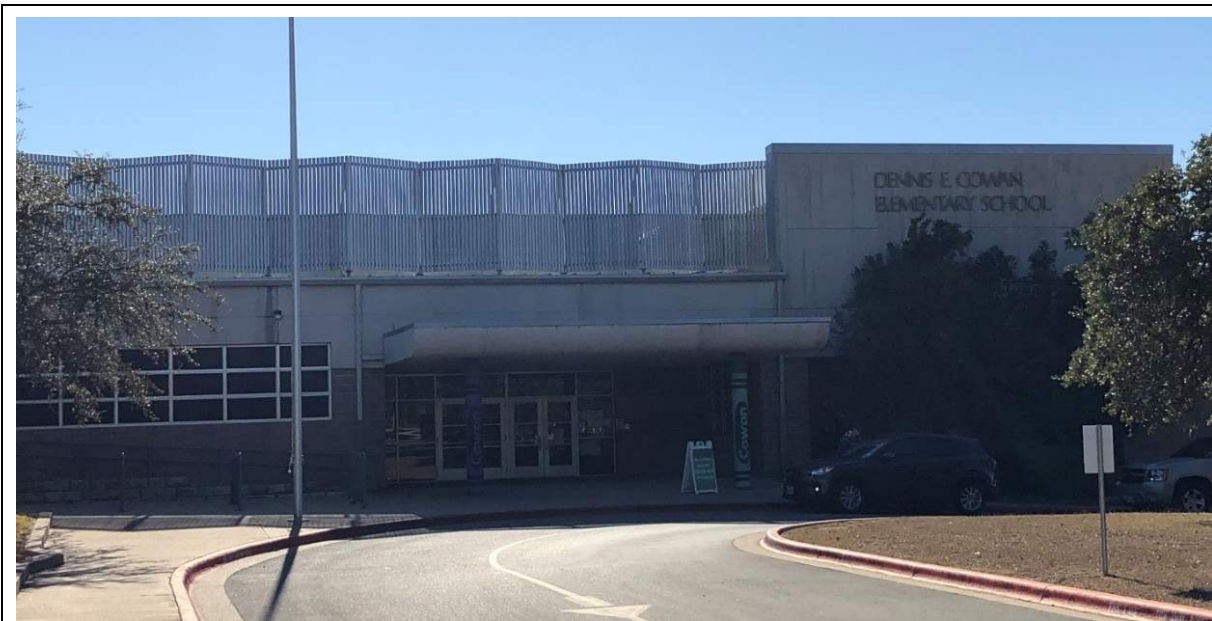
Entry has iconic crayon columns. Bus and car drop-off and pickup are separate and away from parking. Canopy does not sufficiently protect children from rain.

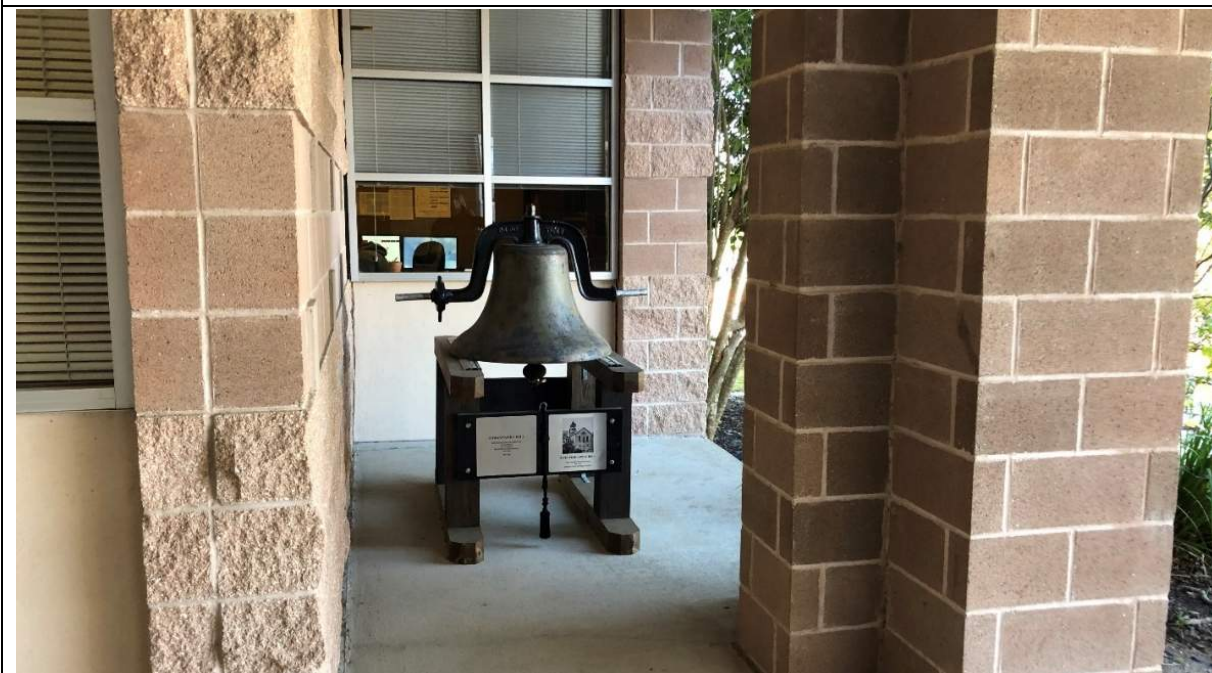
Historical relics are on display where visitors and students can view them.

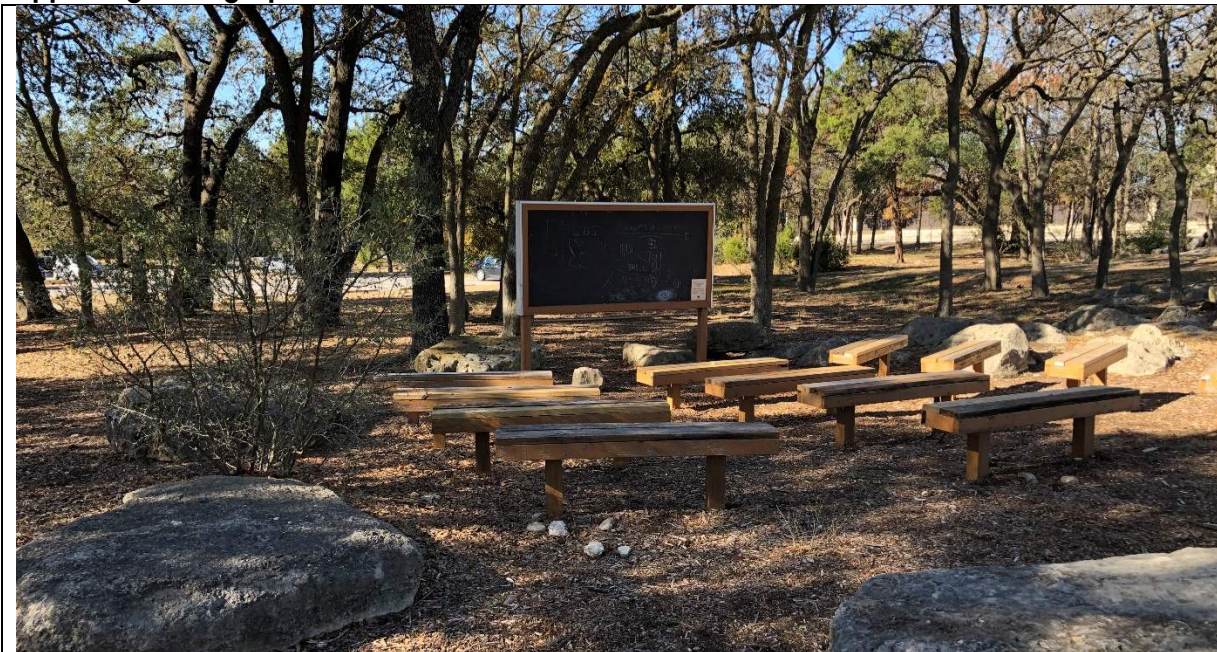
Outdoor learning space has bench seating and chalkboard display. Shade provided only from trees.

There is an outdoor studio space that has limited shade provided by tree canopy. Outdoor studio space seating requires some repairs. Access to this area involves crossing traffic paths and is a safety concern. [REDACTED] Playscapes are shaded. No gardens or natural learning opportunities are present.

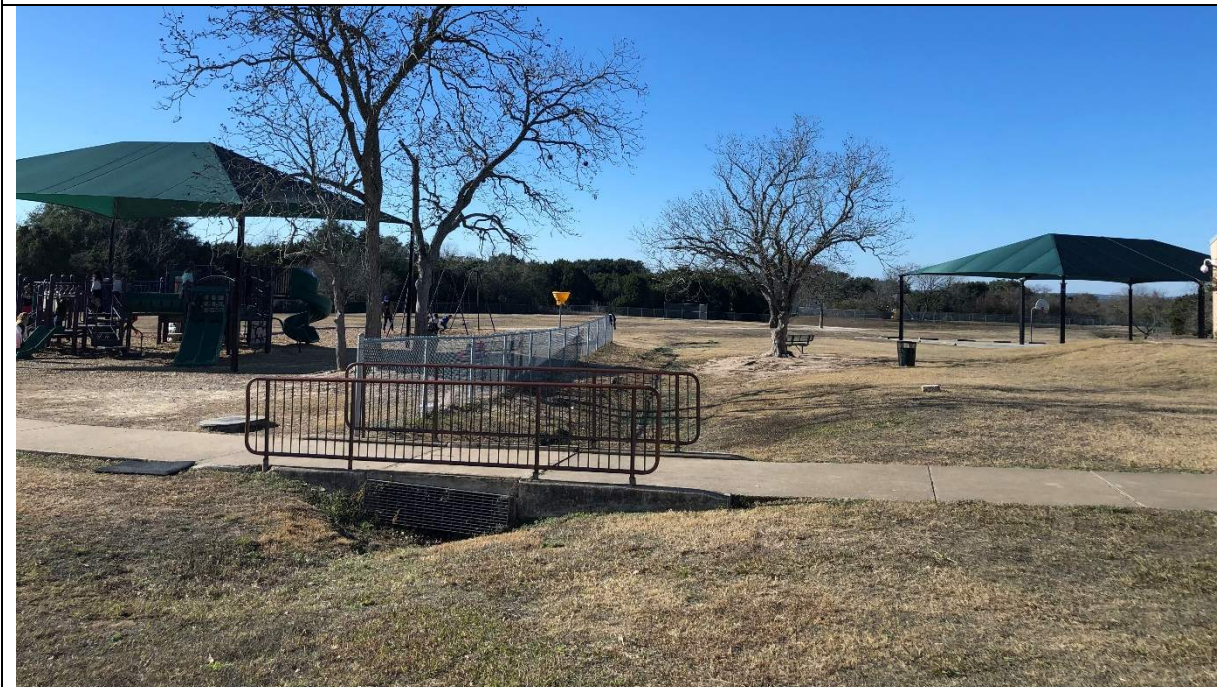
Play areas are fully covered by shade structures.

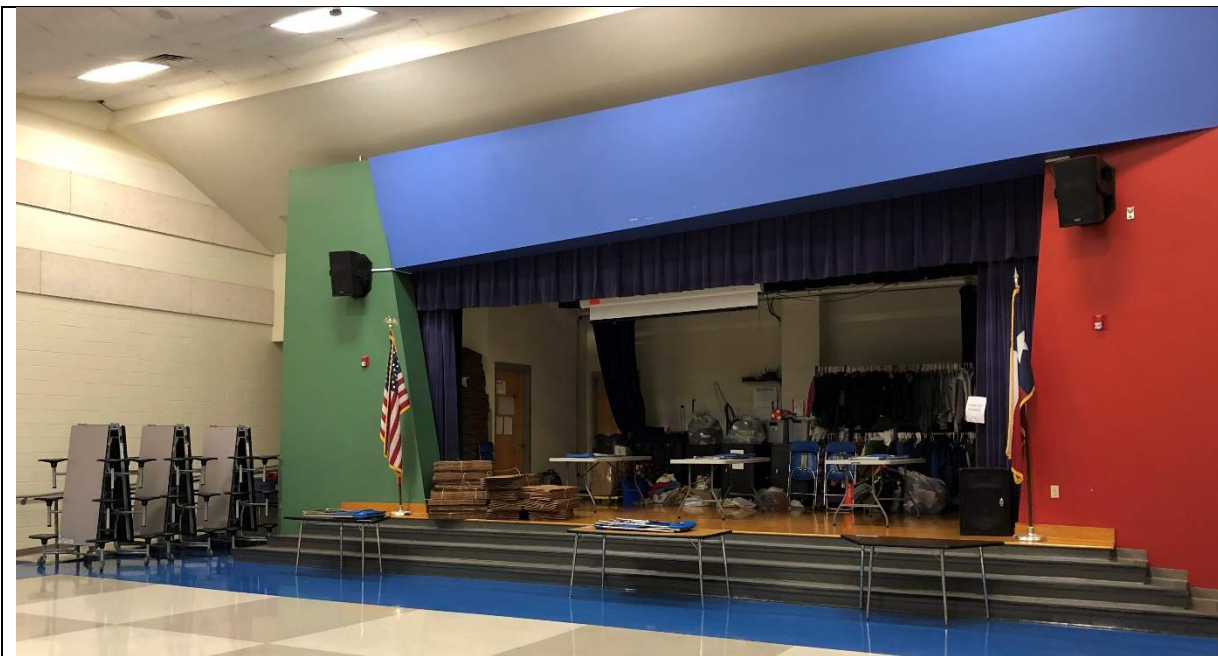
Music and performance spaces are in good condition but currently being used to accommodate additional storage during COVID-19 protocols. Capacity to assemble all students at once is a concern for staff.

Music room is adequately sized. Performance space needs A/V updates.

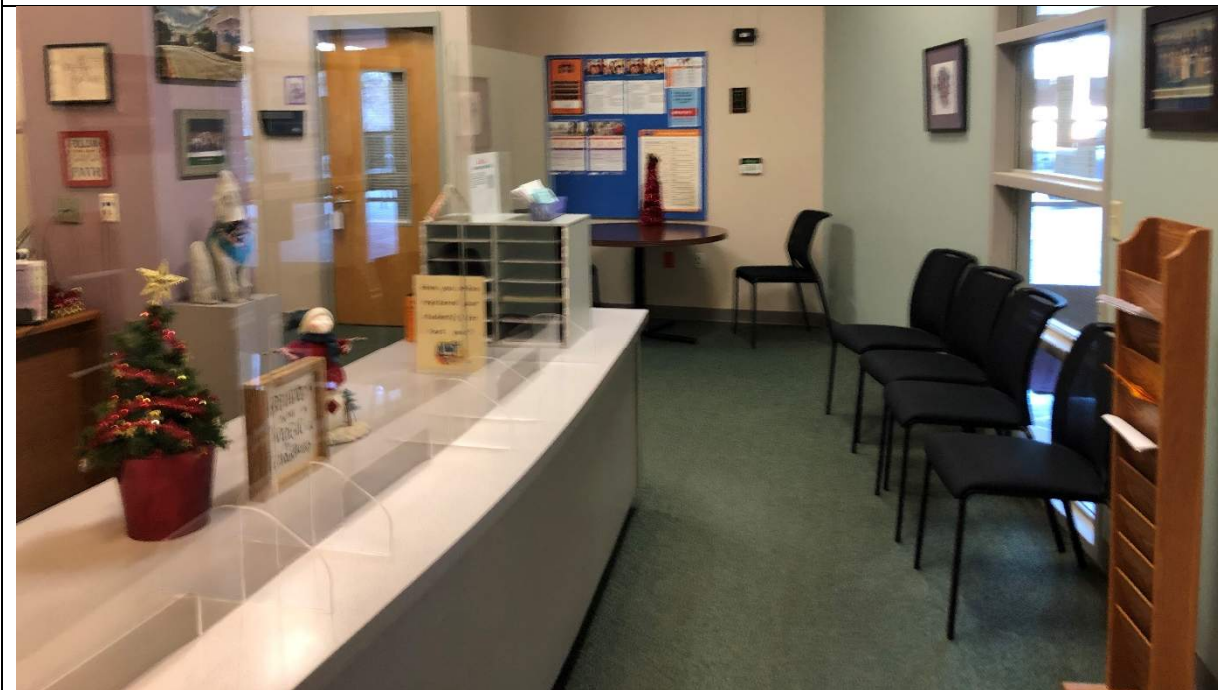
Administration space is small with limited seating.

Administrative office is close to entry with clear visibility. Size is small with minimal seating and no digital display. Entry is welcoming with artwork and significant historical identifiers. Overall, the office atmosphere is not welcoming, but the school reports this is an outcome of Covid protocols and safety measures. There are acoustic issues between offices.

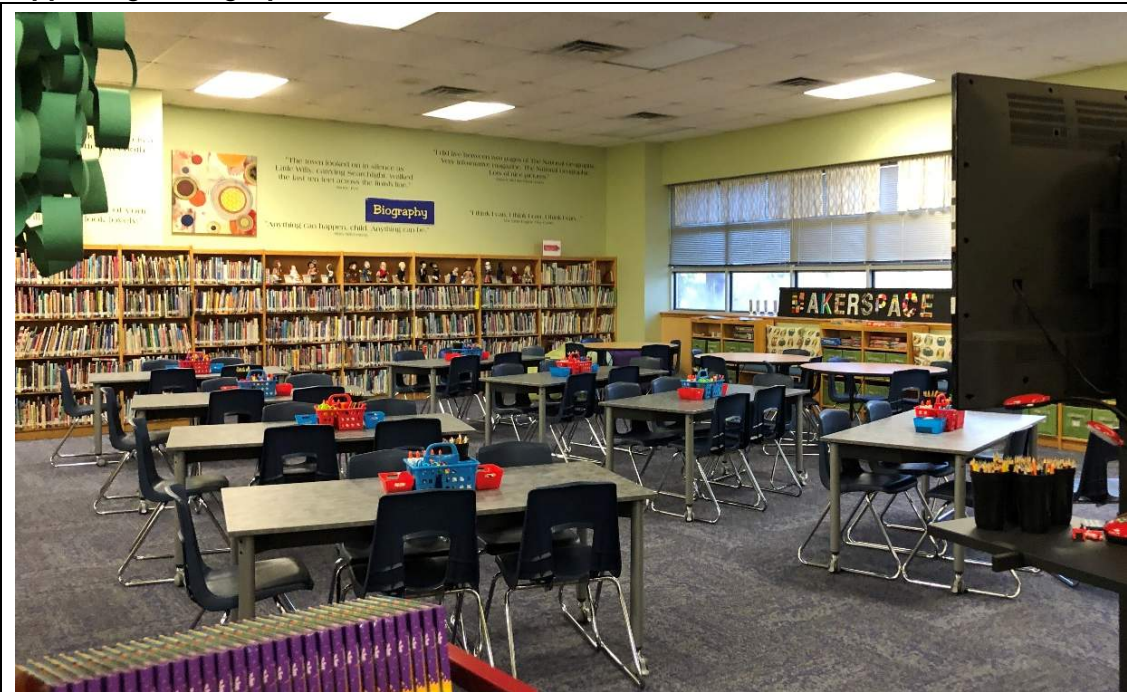
Media Center: There are reconfigurable tables and chairs for various group sizes.

Library does not have any enclosed study rooms, but furniture is flexible to meet various learning group sizes. Library can be accessed for after-hours events and meetings.

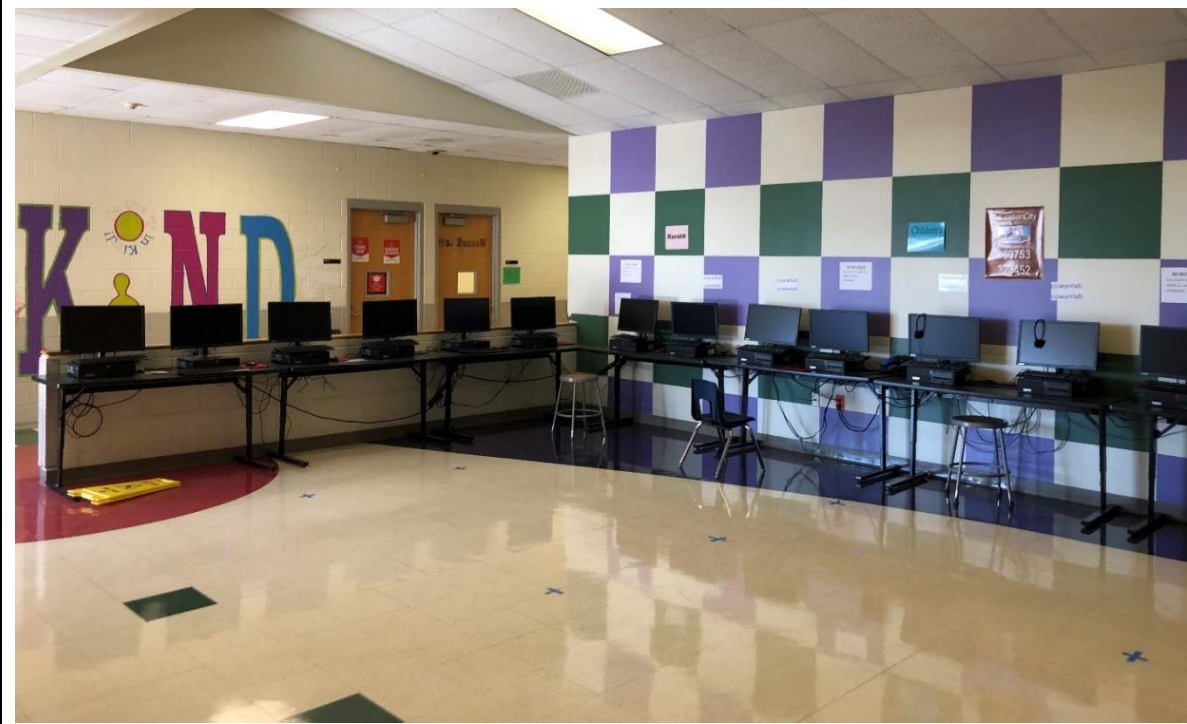
Computer lab is open to corridor; no dedicated room.

A more robust computer lab is desired to incorporate STEAM projects and curriculum. The current setup is in the corridor and not enclosed as a dedicated room. Science space is lacking, and there is not enough space for science fair and lab uses. The G/T program also needs space options available

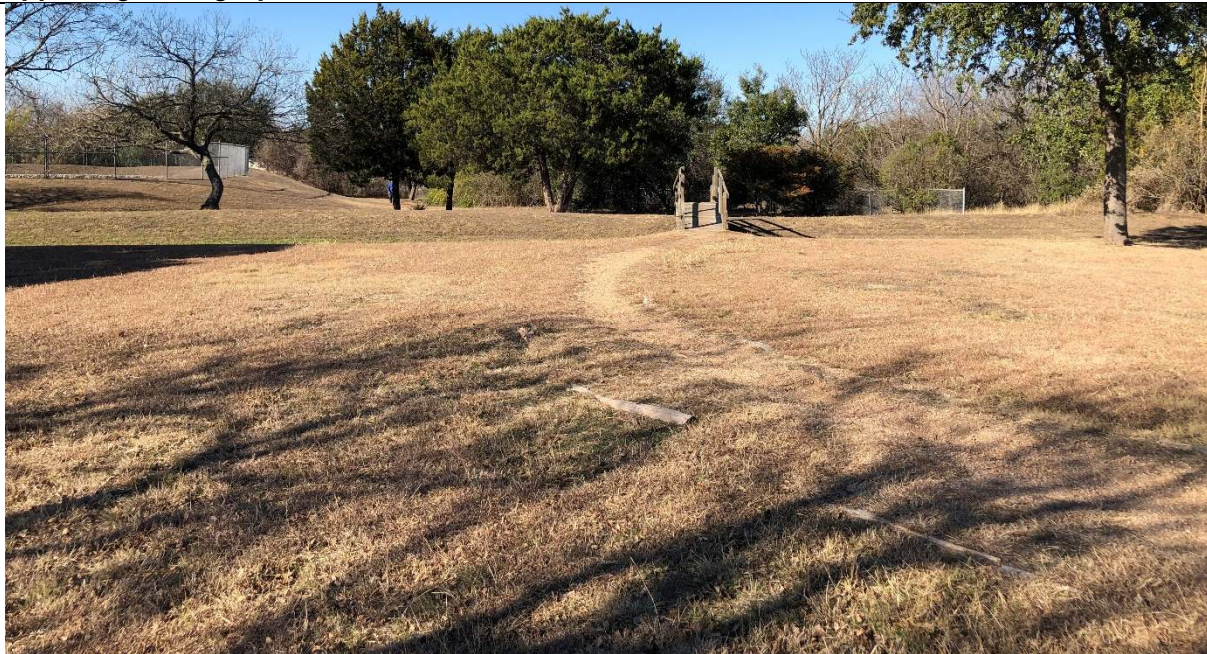
Neighborhood walking path connects Westgate to campus [REDACTED]

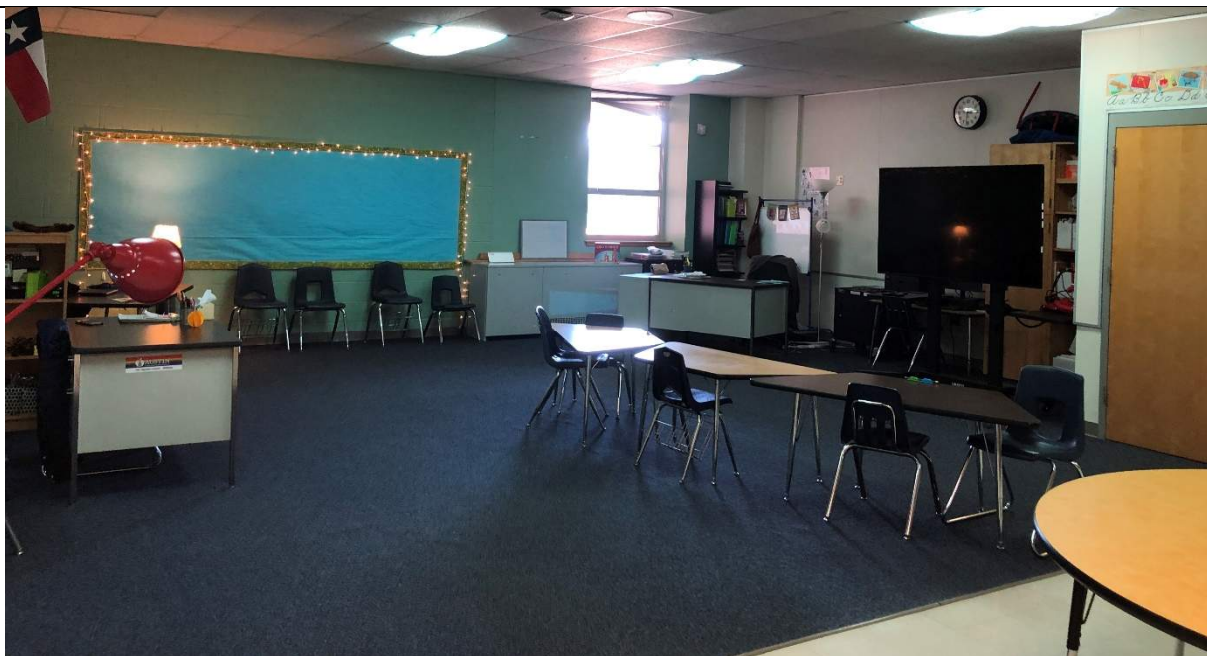
Typical studios have minimal natural light and access to outdoor views.

Staff provided feedback that there was a sewage smell in fifth-grade wing and office. All studios have windows. Some windows are small providing limited outdoor views and limited access to natural light.
