Educational Suitability Summary Report

Davis Elementary School

Date: 01/04/2021

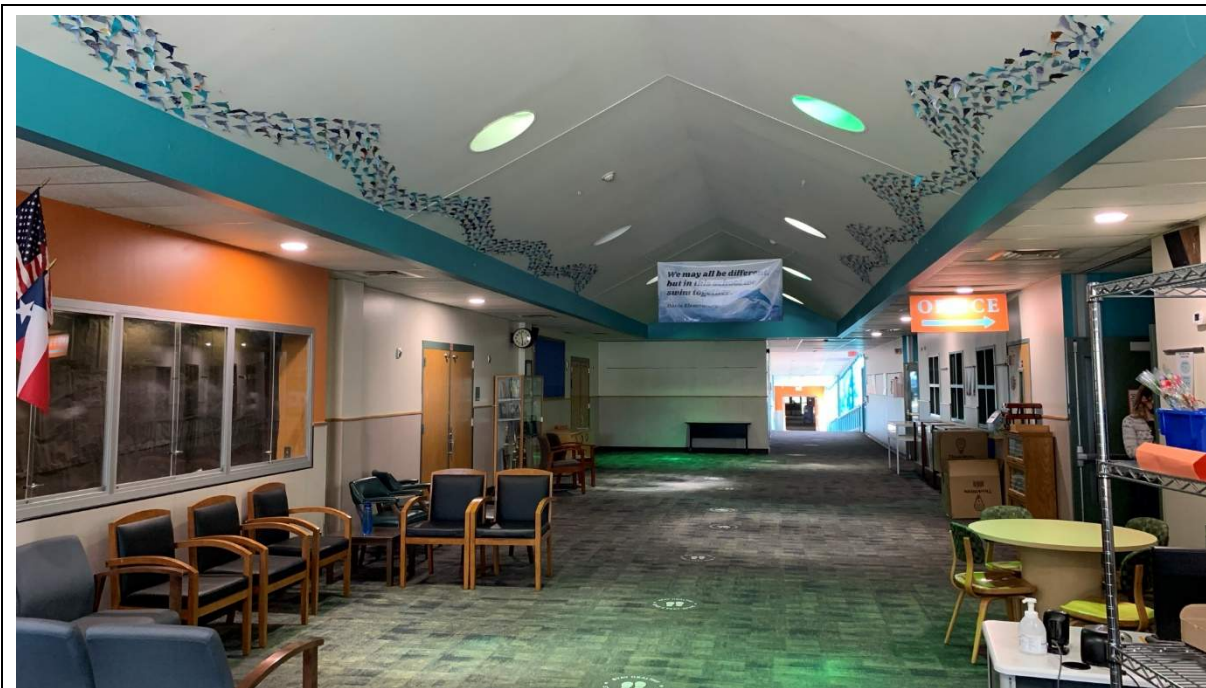
There is no secure vestibule at the main entry. Windows to the reception area provide some visibility to the corridor. There are opportunities for display throughout the campus.

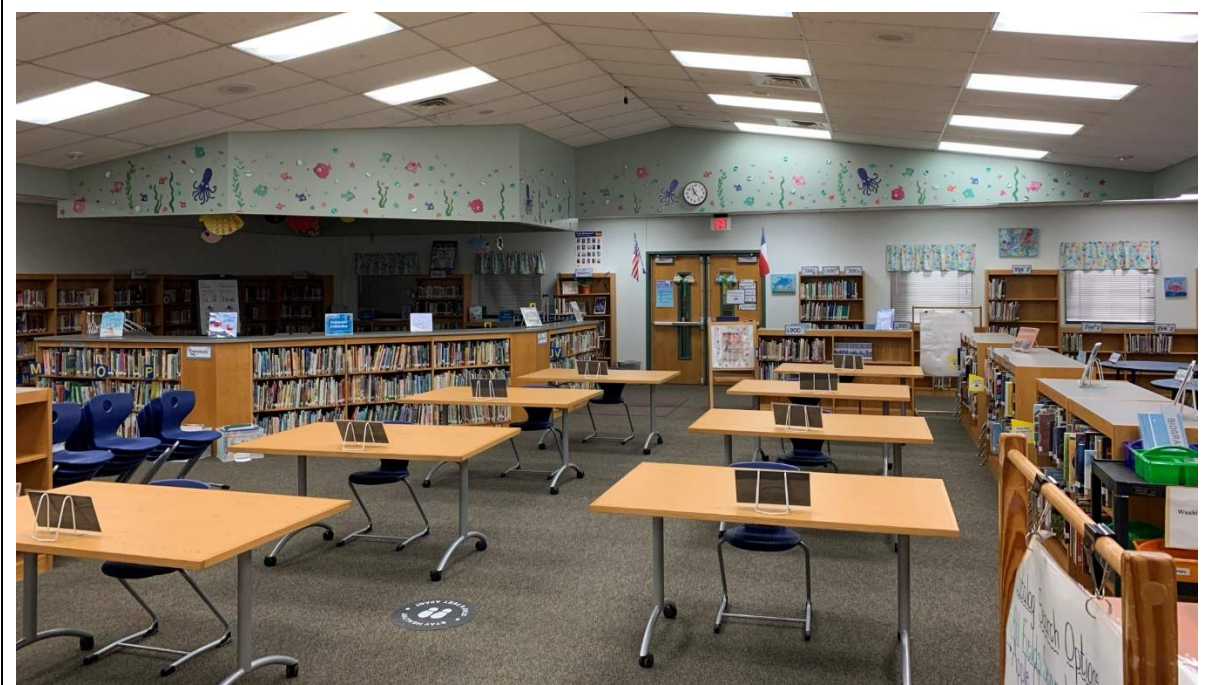
The library is centralized on campus and has good visibility. Furniture is flexible but the stacks are cumbersome to move and make reconfiguration difficult.

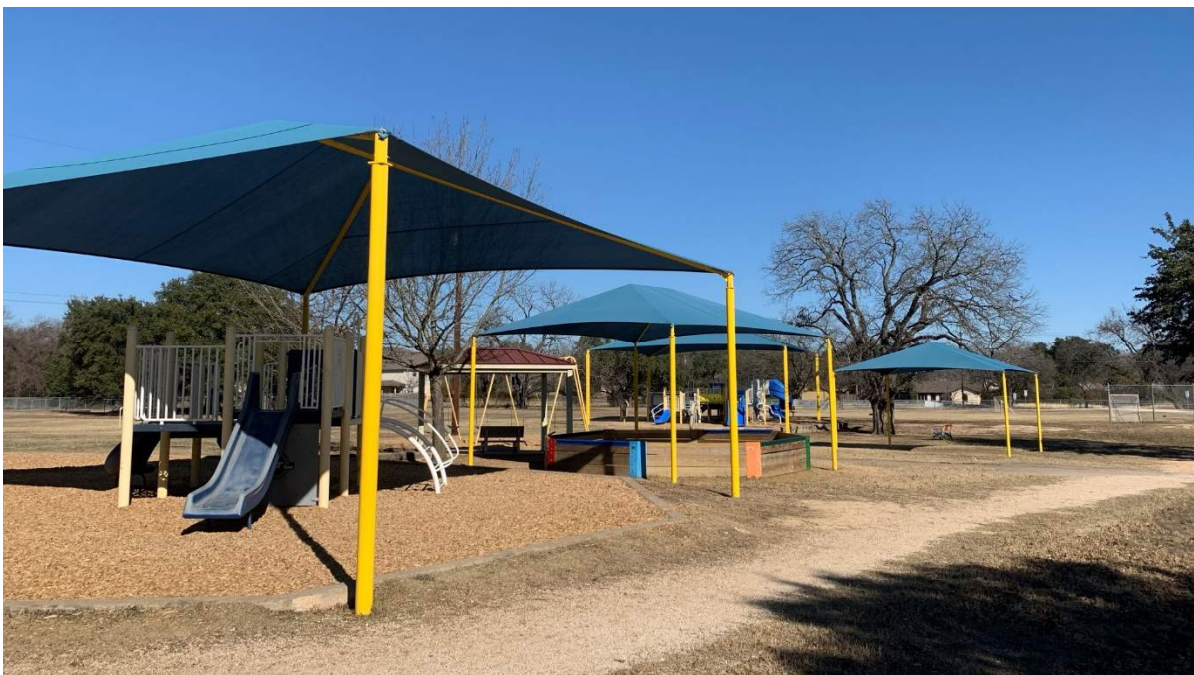
All playgrounds are in good condition and have shade structures, as does the paved outdoor court.

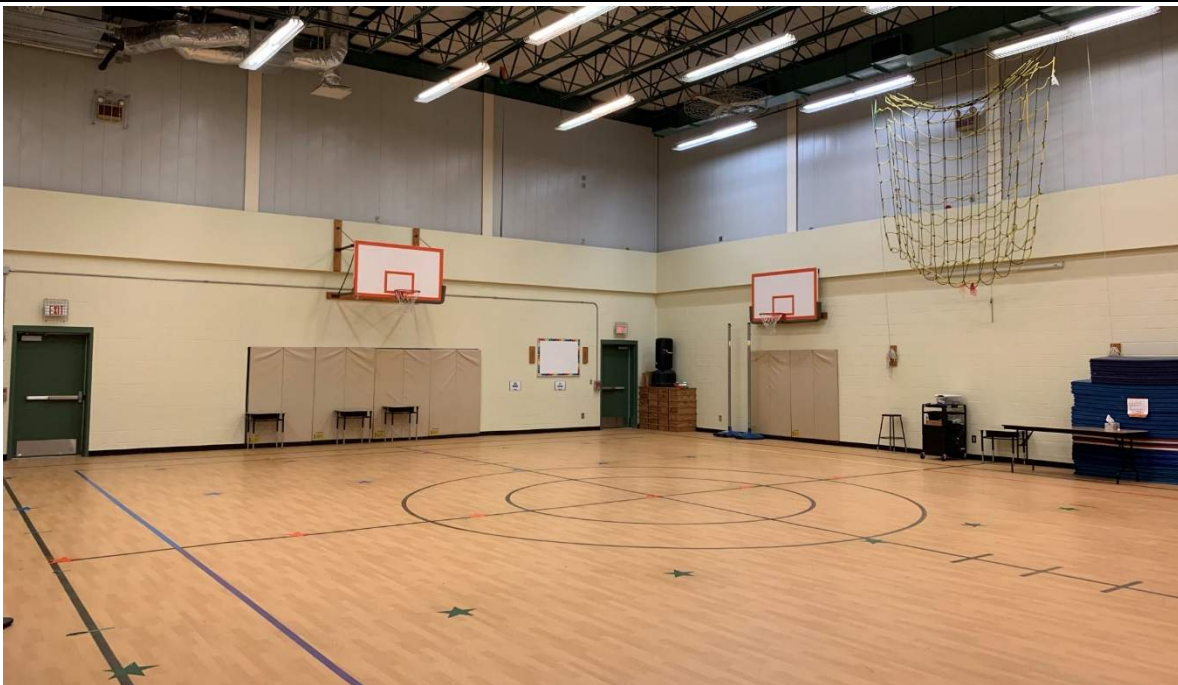
The gym is not well-connected with the outdoor activity areas but can be secured from the rest of the campus for after-hours functions.

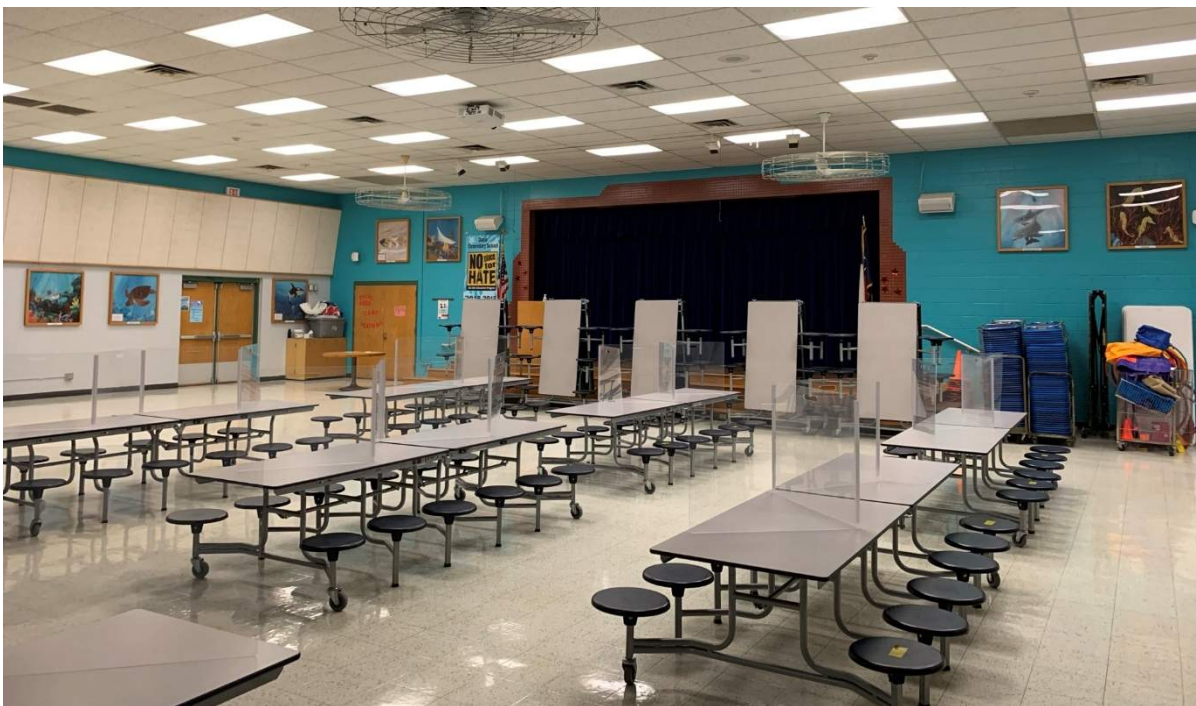
Cafeteria is adequately sized but only has one seating option. It is not connected to the outdoor areas but shares an operable wall with the gym.

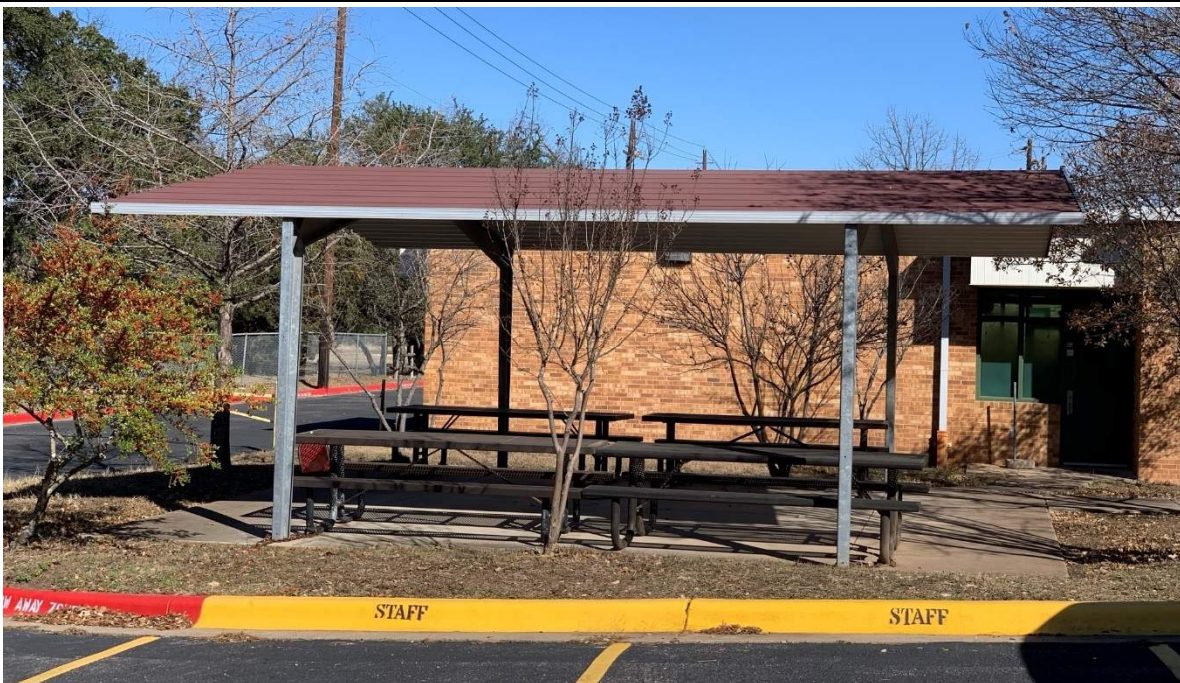
A few areas for outdoor studios around campus but they are disconnected and in average condition.

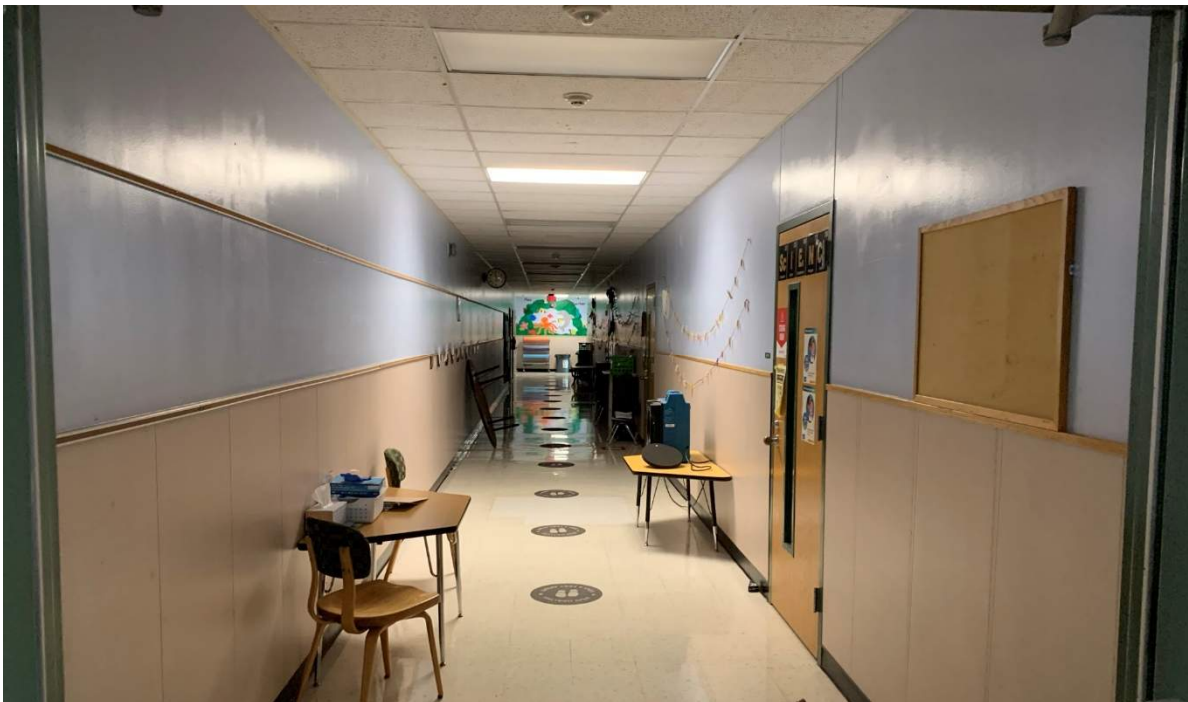
Interior corridors vary in width, but some are narrow and more difficult to navigate and lack natural lighting.

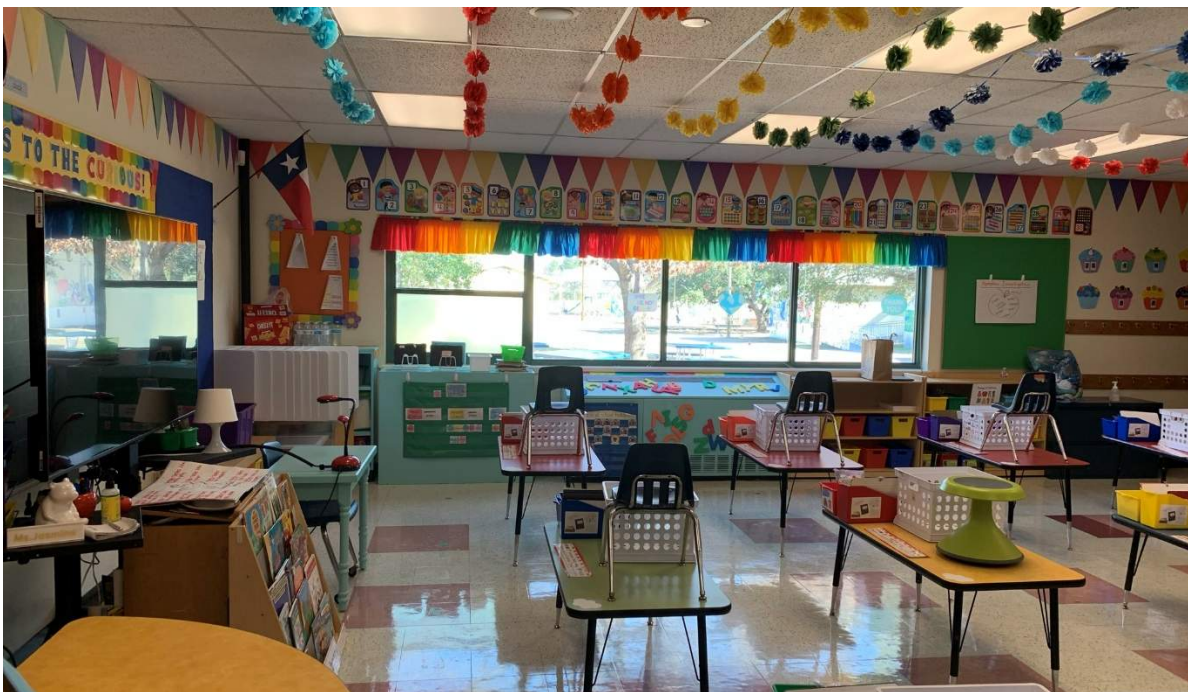
All studios have access to natural light and views and have blinds to control daylighting.

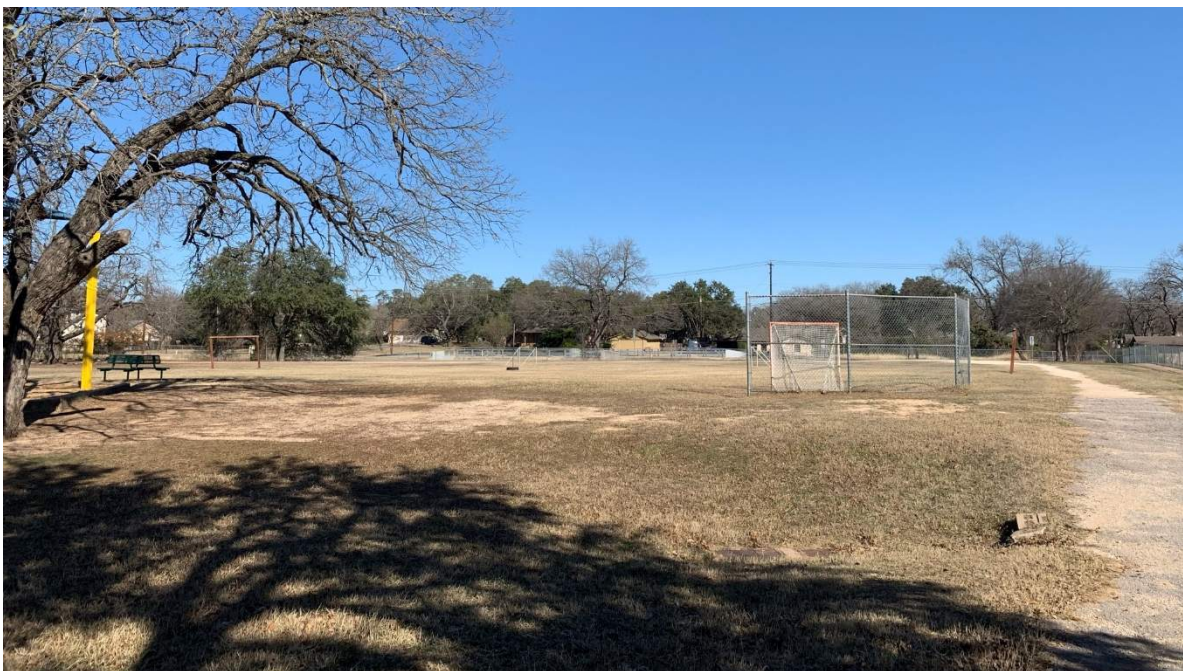
Grass playfields and a walking trail are present and well-connected to the building.

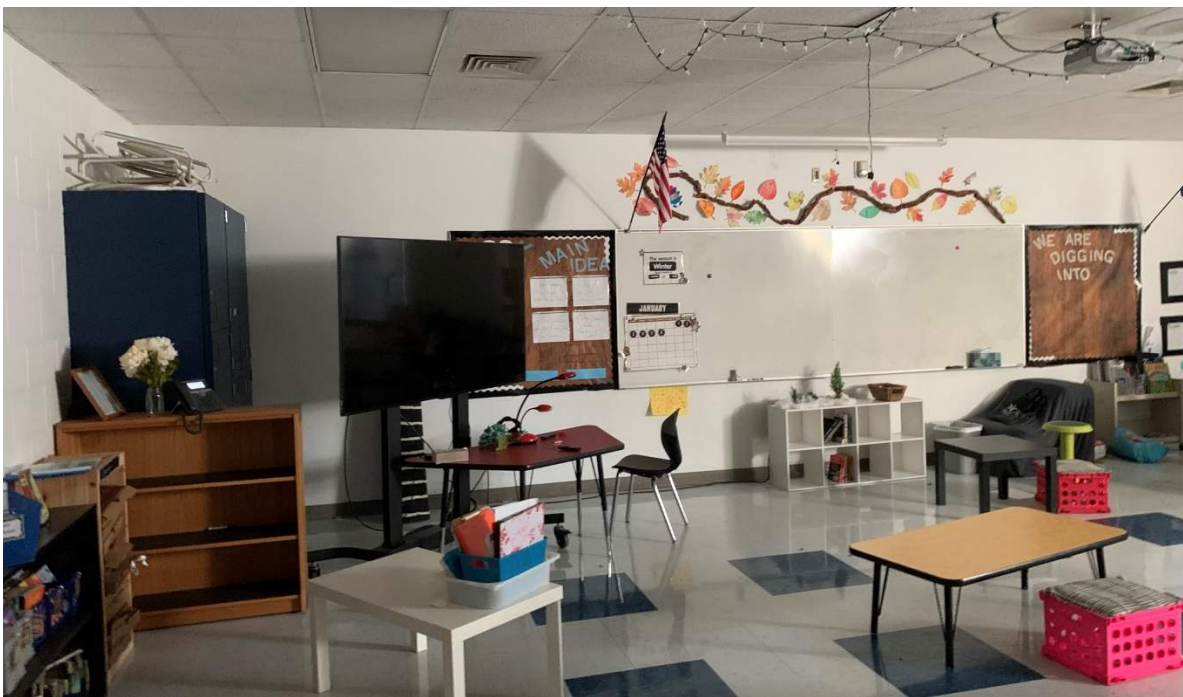
Furniture is sized appropriately per grade level but is a mix of old and new and some teacher-provided items. Projectors and mobile TVs are present in most studios.
