## Educational Suitability Summary Report

Govalle Elementary School

Date: 01/05/2021

**Score 94% Very Satisfactory**

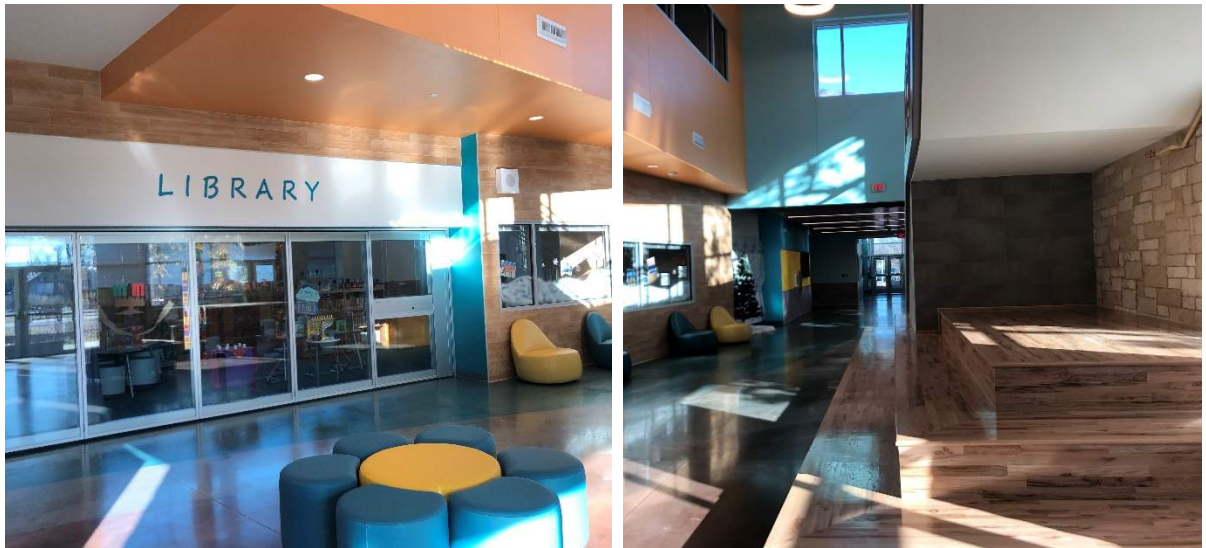
*Library is located off main corridor near entry. A moveable glass partition can open the Library up to the corridor where additional informal seating is located. The main corridor is daylit and has a generous amount of space for informal interaction.*

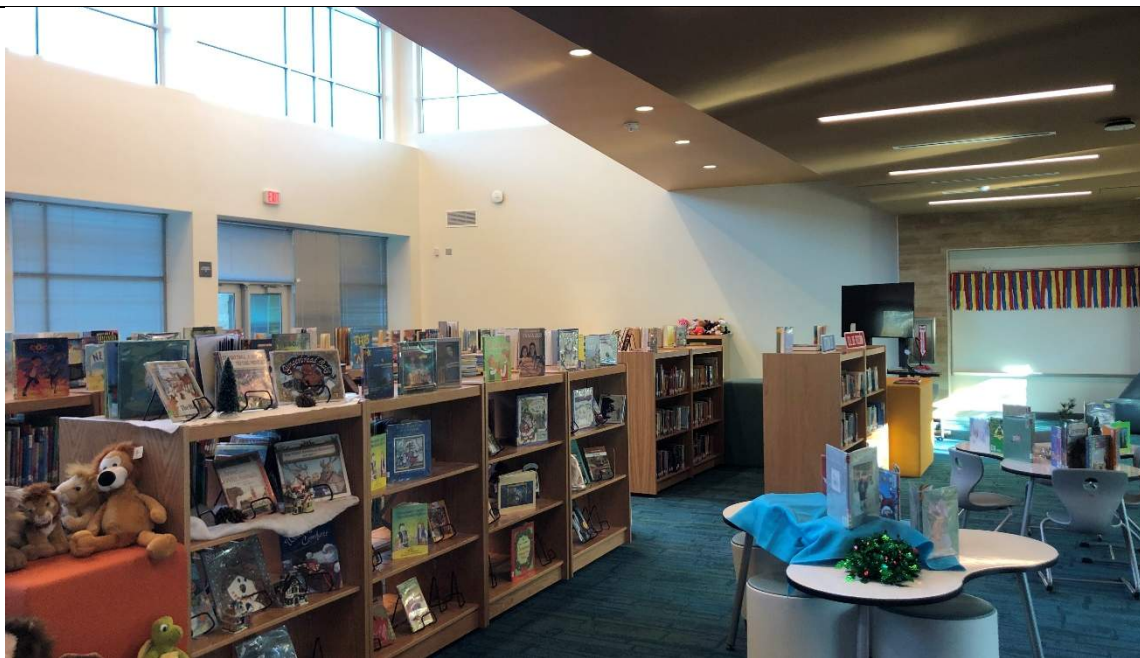
*Media center has different types of flexible seating and small nooks for individual reading. Doors (shown beyond) open to a secured courtyard with shade and seating.*

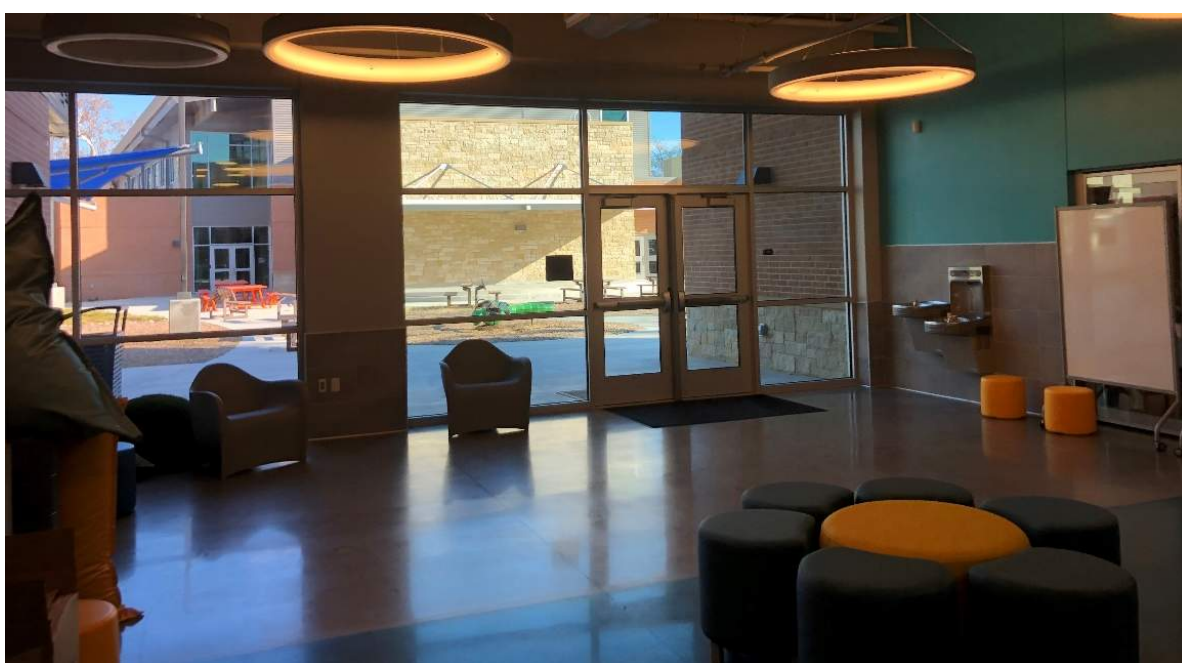
*Learning neighborhood collaboration space has excellent daylight and flexible furniture.*

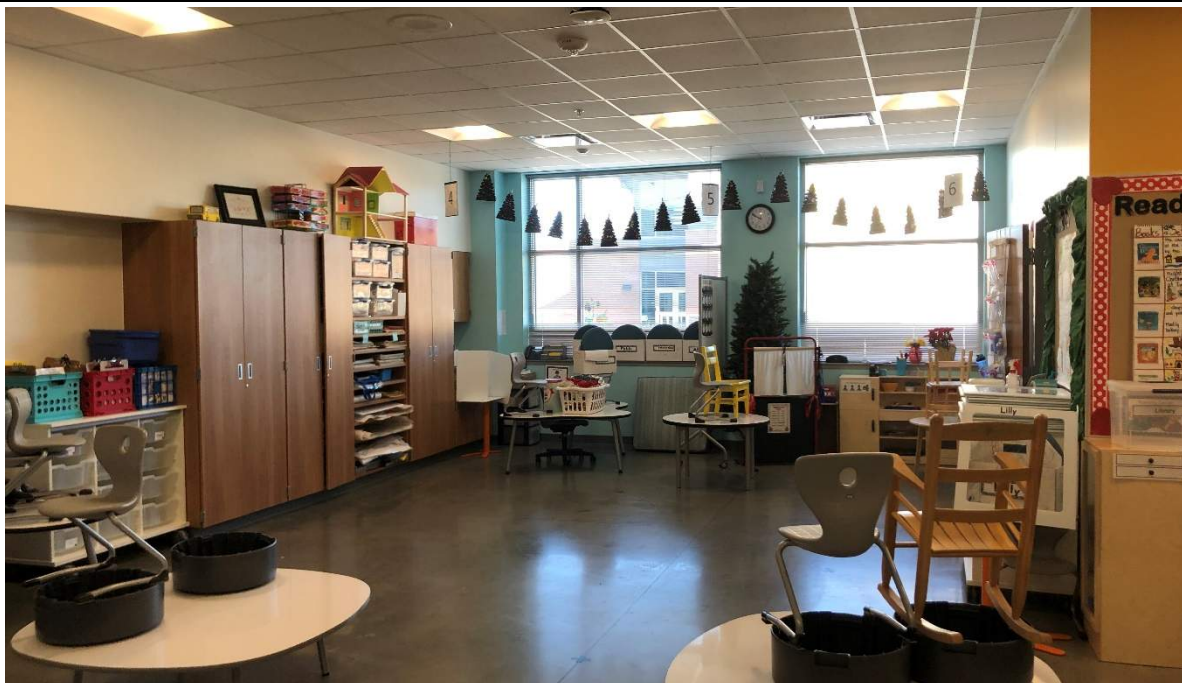
*Typical studio has flexible furniture, casework storage and excellent daylight/views.*

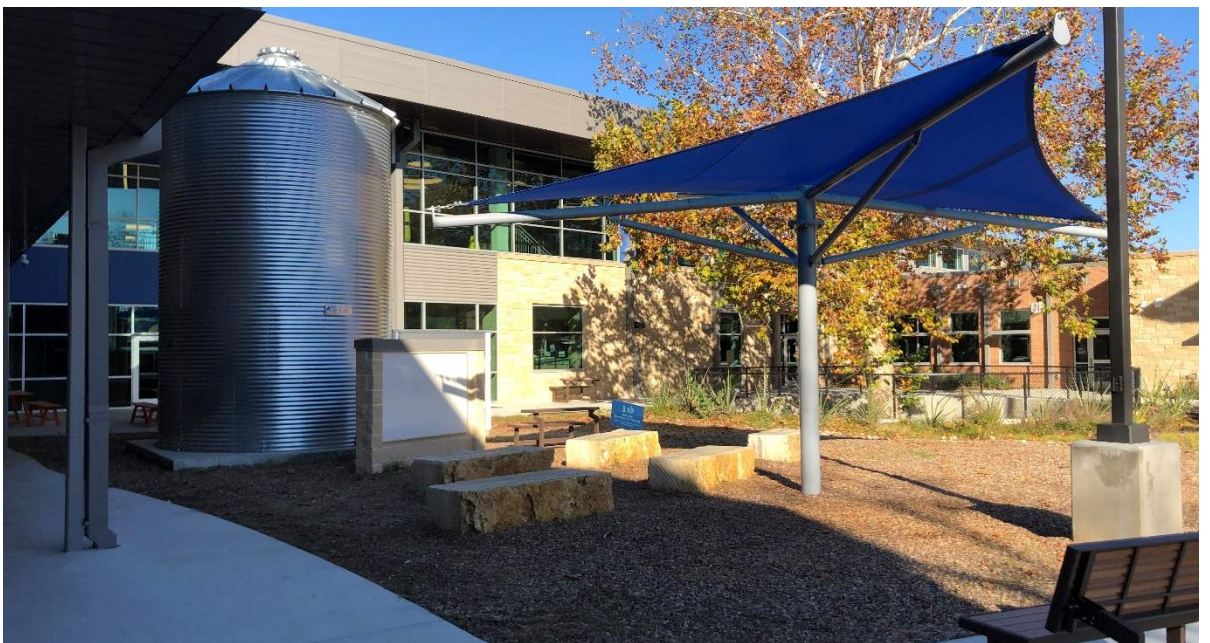
*Outdoor teaching space adjacent to collaboration space has some shade and a whiteboard.*

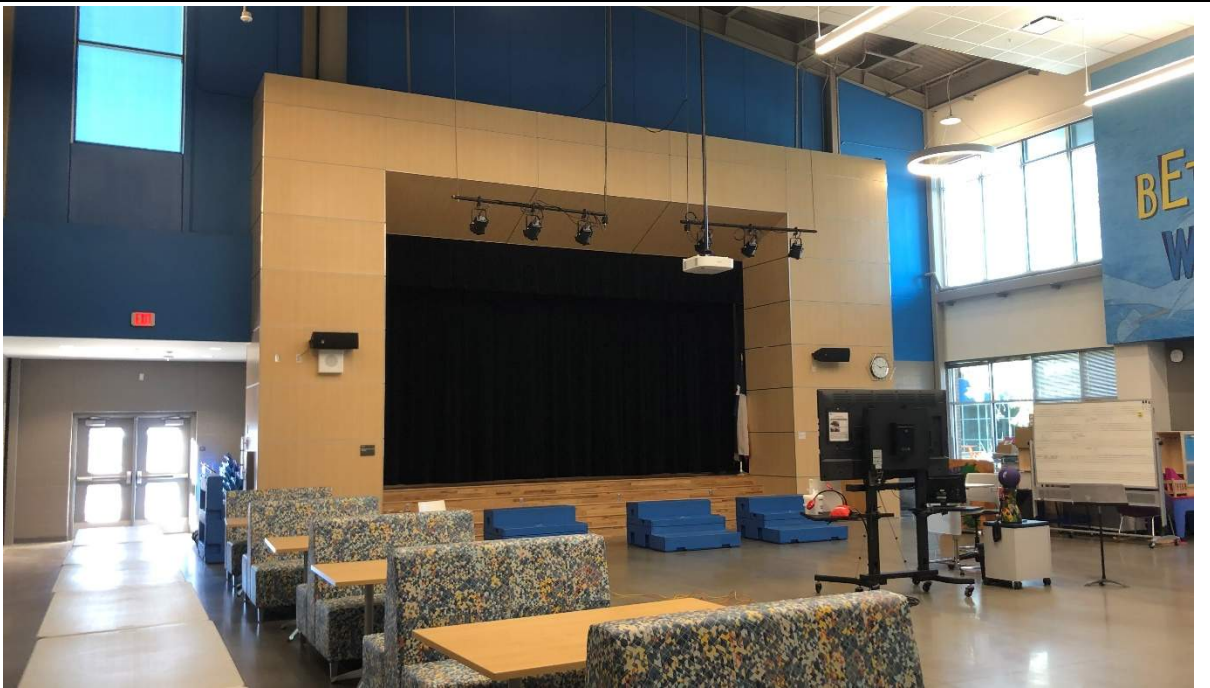
*Cafetorium has movable partition between gym and cafeteria. All program elements are appropriately sized per Ed Spec. Stage A/V is new and satisfactory.*

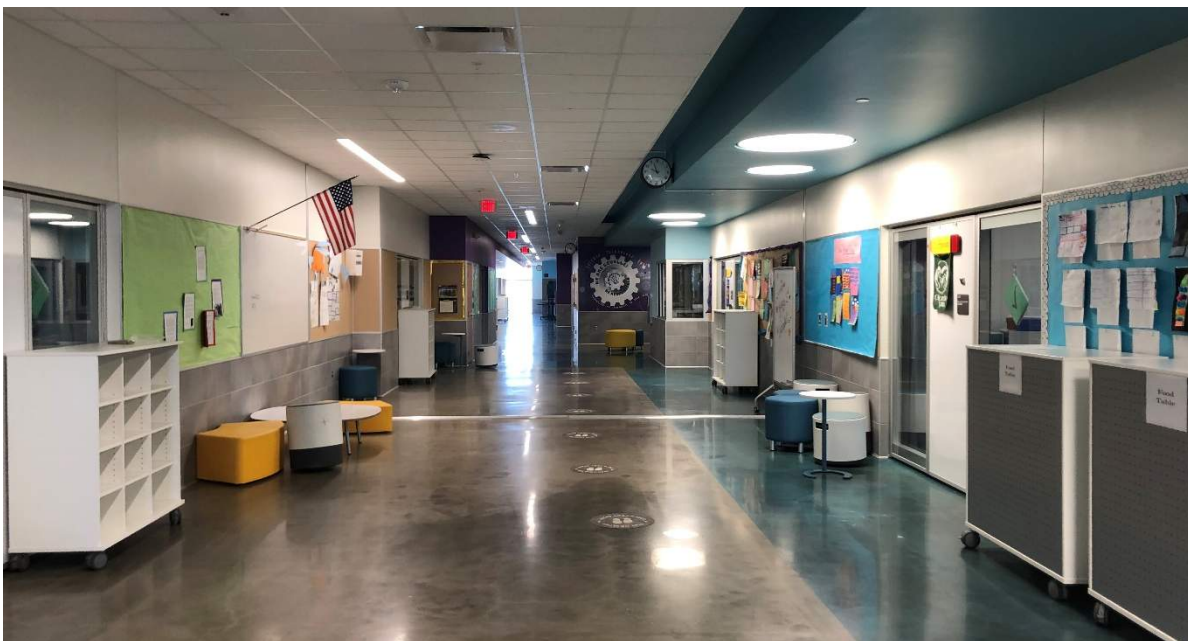
*Hallway in learning neighborhoods is wide enough with flexible furniture to allow small groups to meet. Glass in the studios to the hallway allows for passive supervision of students.*

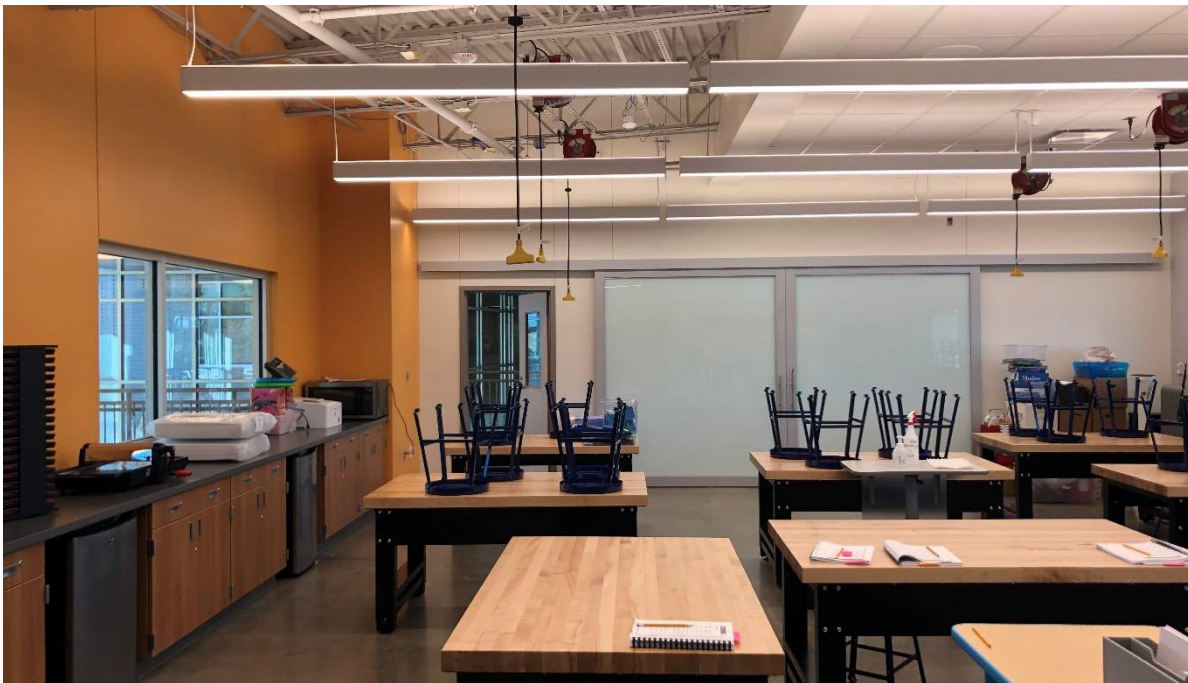
*Maker space on second floor provides power for a variety of activities. Large sliding doors open the room to a large commons area.*

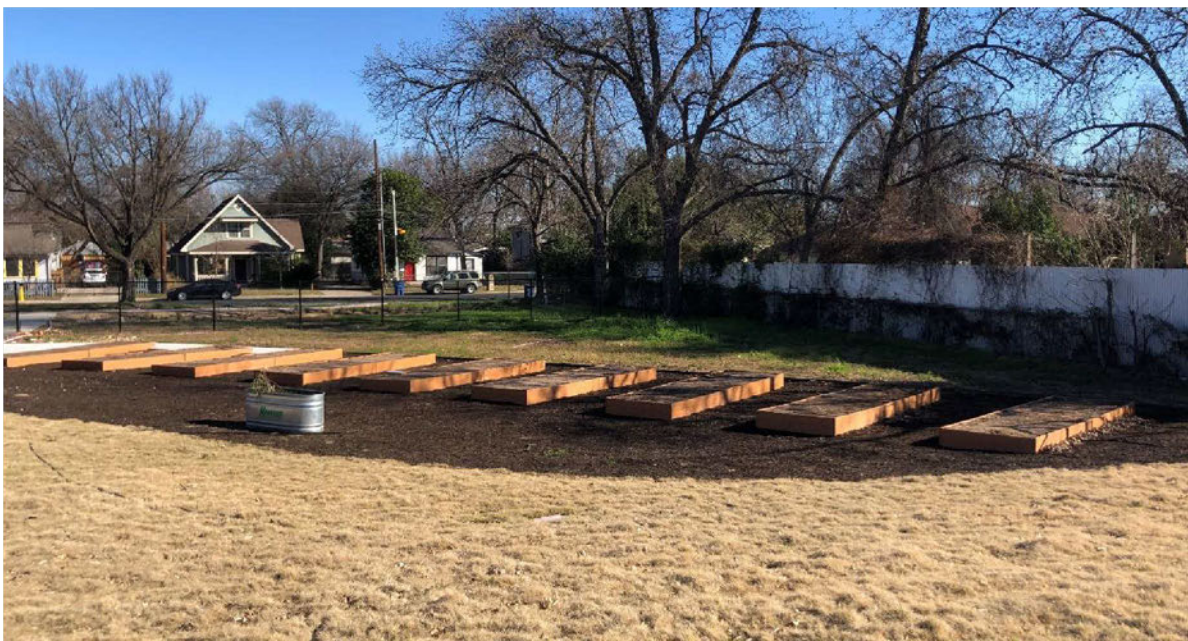
*Outdoor gardens with an additional outdoor classroom space adjacent. This space is far removed from studios.*

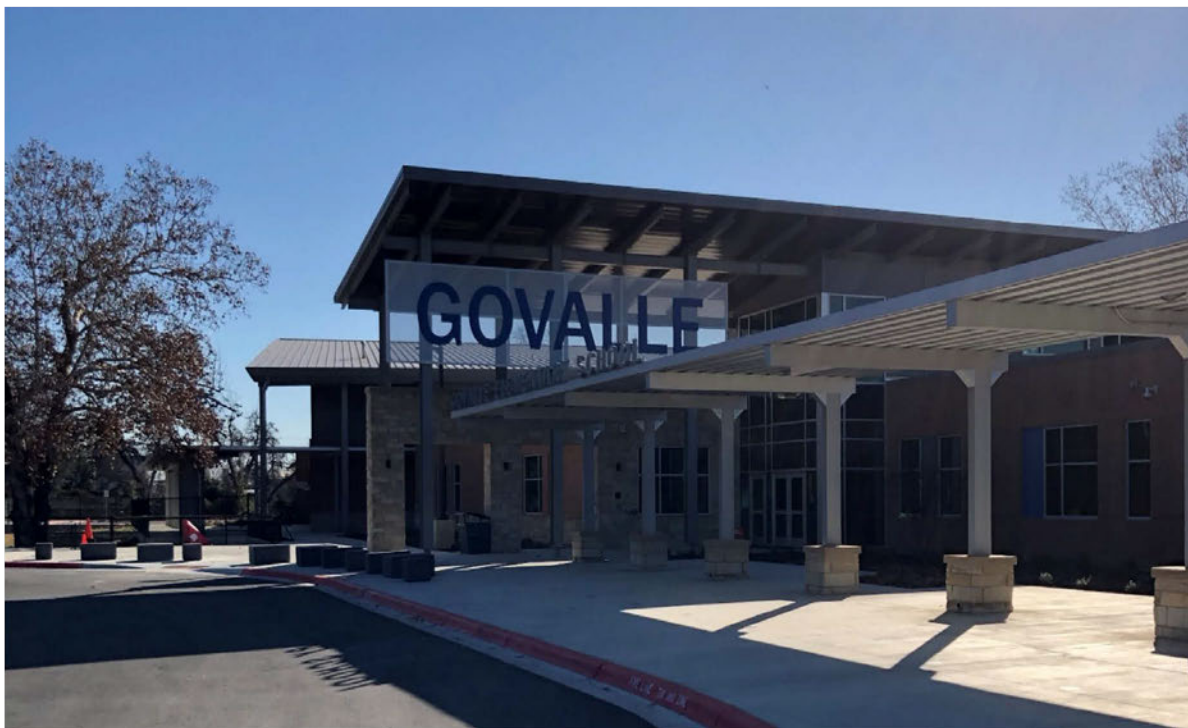
*Entry has generous overhang and lower canopy for weather protection at pickup and drop-off.*
