Educational Suitability Summary Report

Graham Elementary School

Date: 01/07/2021

Score 57% Average

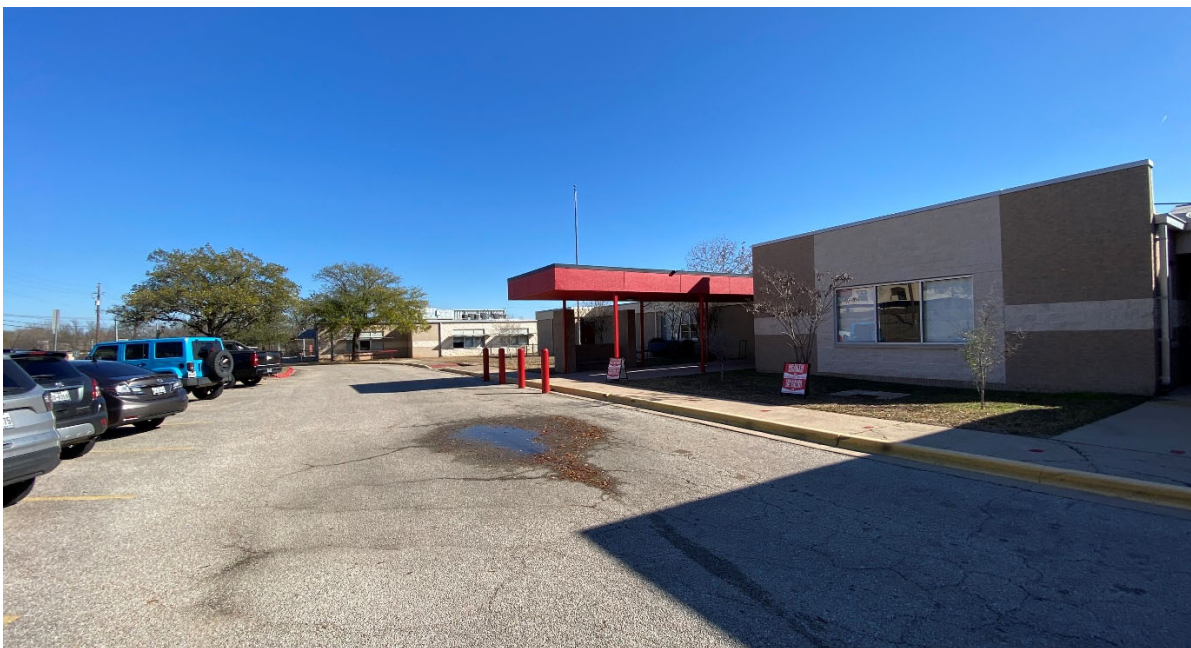
Bus drop-off at main entry has a proper overhang for waiting students. School exterior is in good condition, but appearance is aged by weather-faded colors.

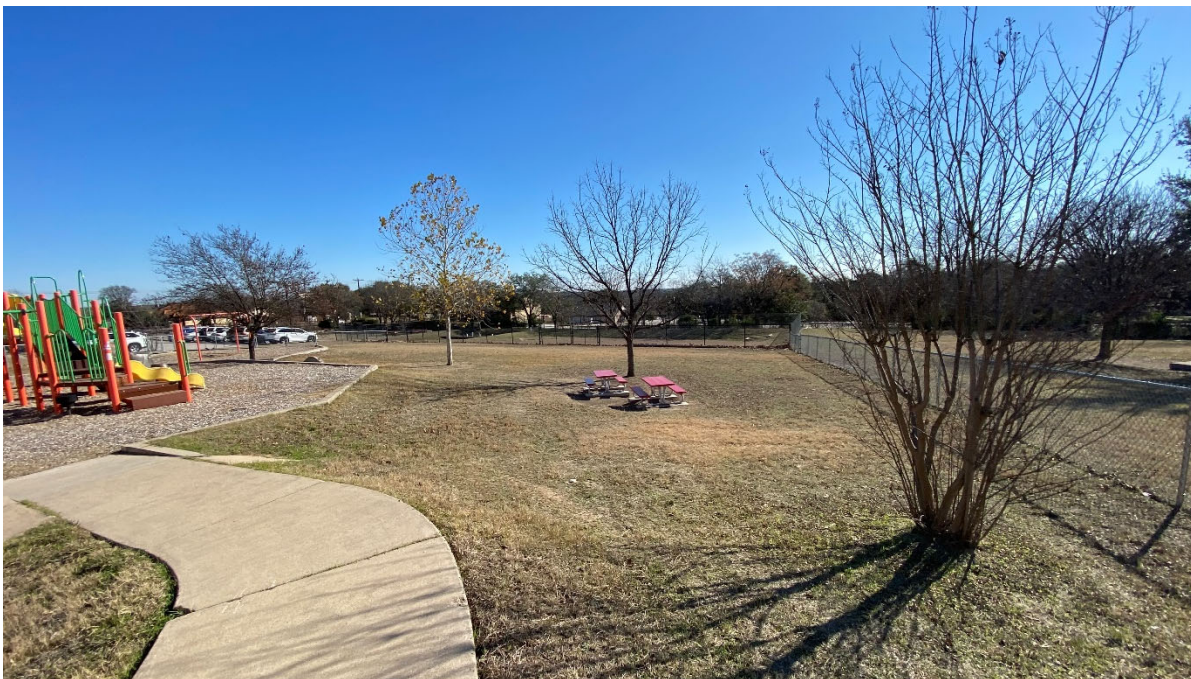
Playscapes are in good condition but not shaded. There are a few picnic tables, but they are not dedicated outdoor learning studios.

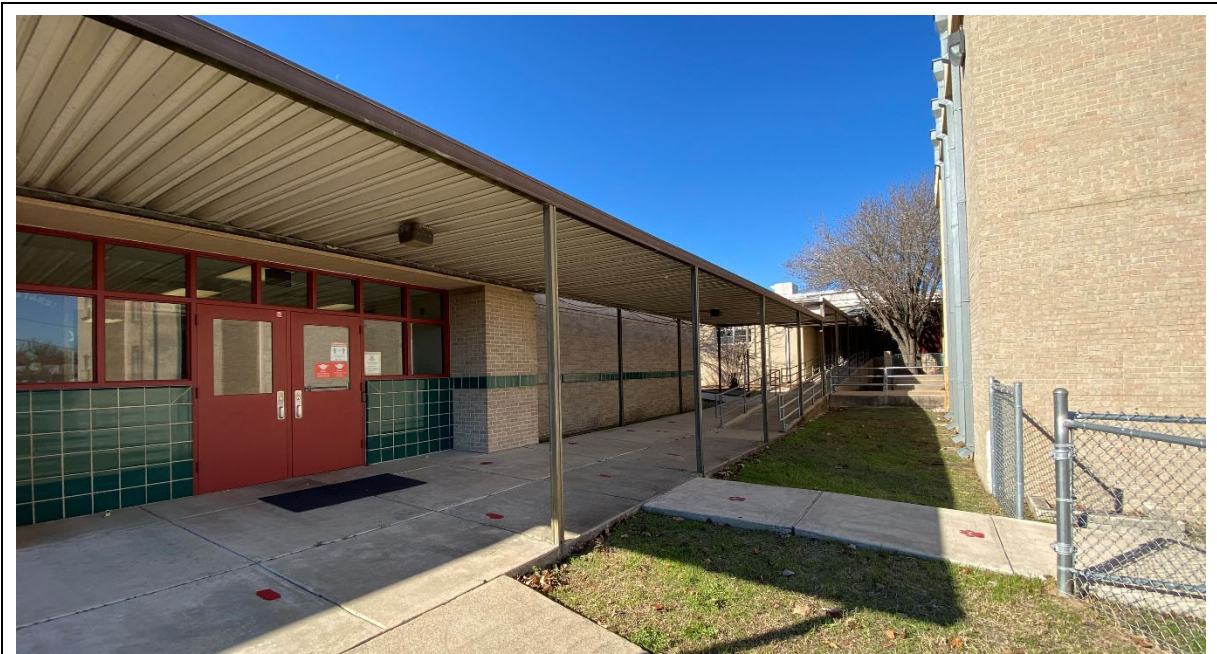
Exterior covered path to annex studio buildings.

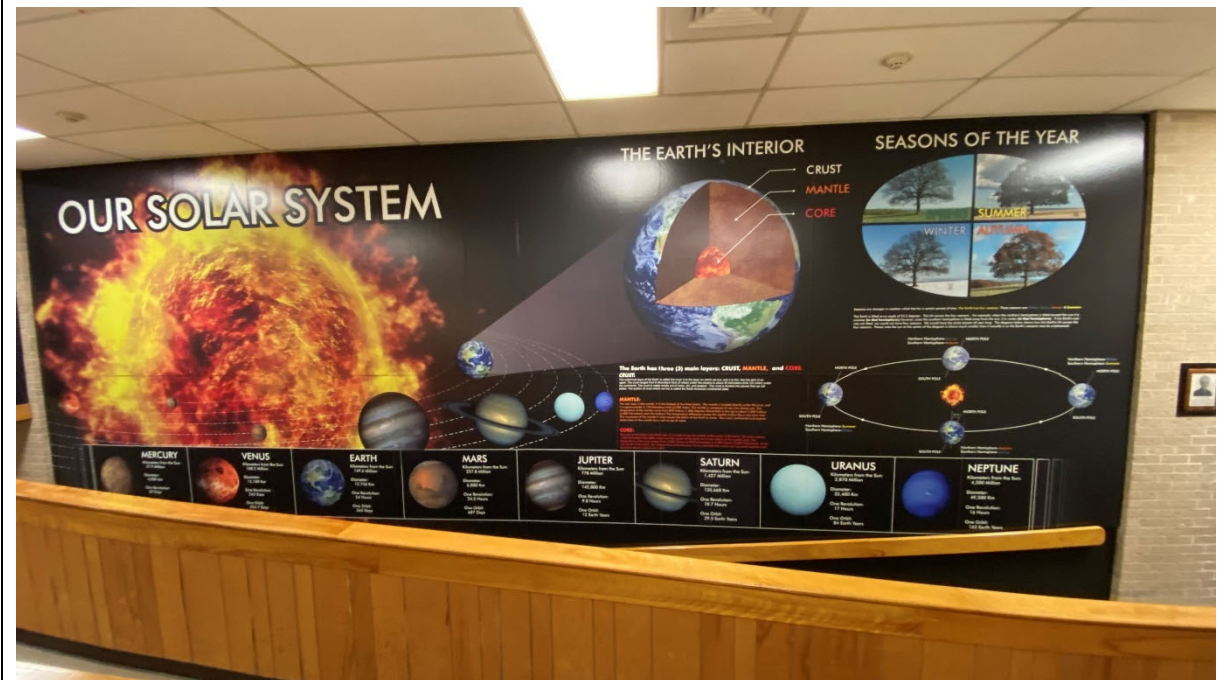
Unique wall graphics are educational and act as wayfinding for the main building.

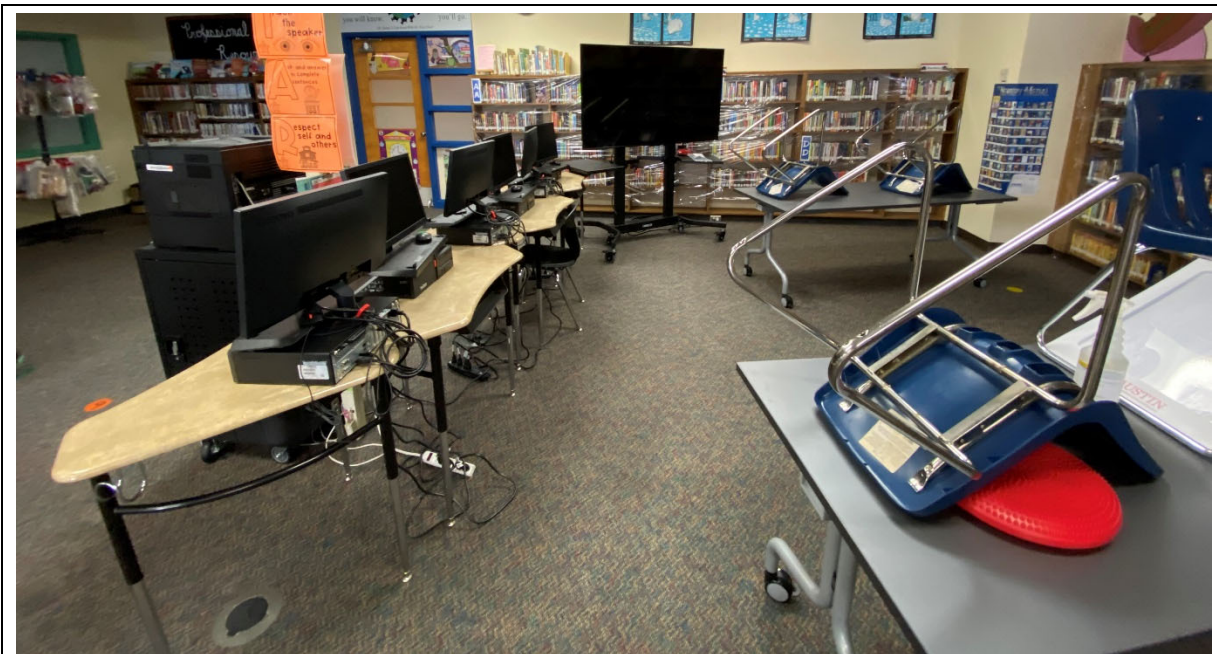
Media center has a mix of old and new furniture. Tables are easily reconfigurable, but the space is too small for multiple groups or quiet study.

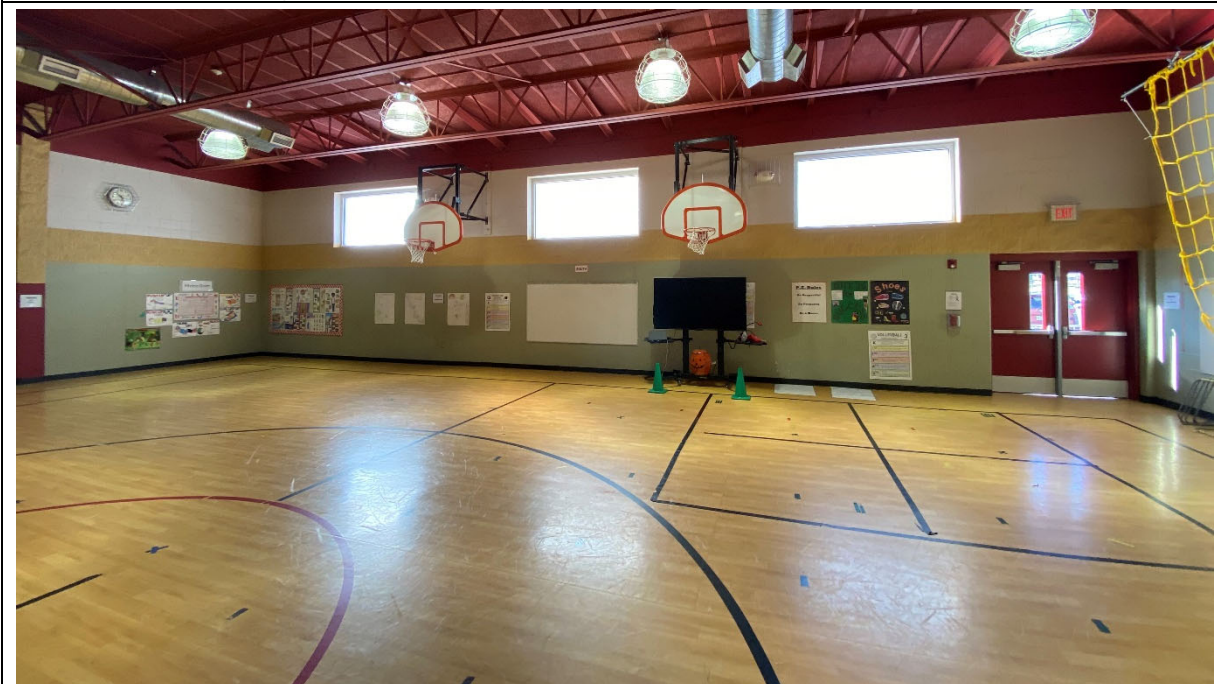
Gym has updated flooring and access to natural light. No projector screen, but there is a portable screen and a projector on a cart.

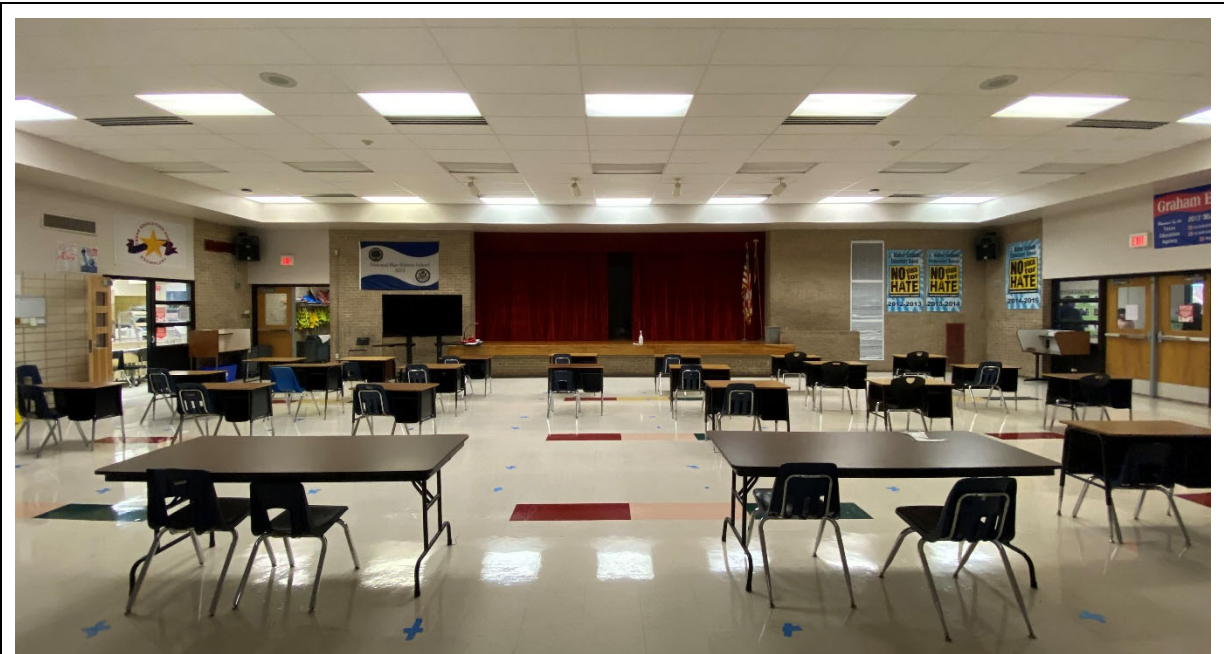
Cafeteria lacks natural lighting and access to outdoor seating. Dining commons and stage size is adequate, but the stage lacks storage. (Due to COVID restrictions, the cafeteria is not in its typical arrangement in this photo.)

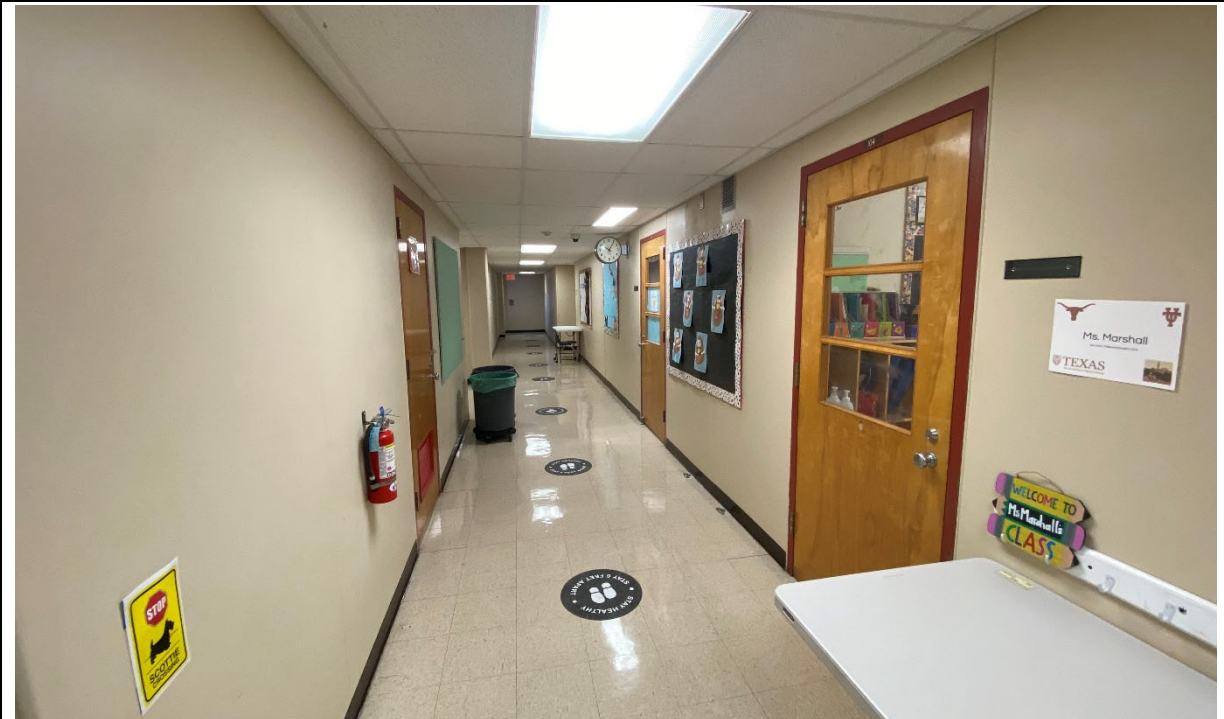
Original building corridors are small and lack natural daylight. Transparency between studios and corridors is inadequate.

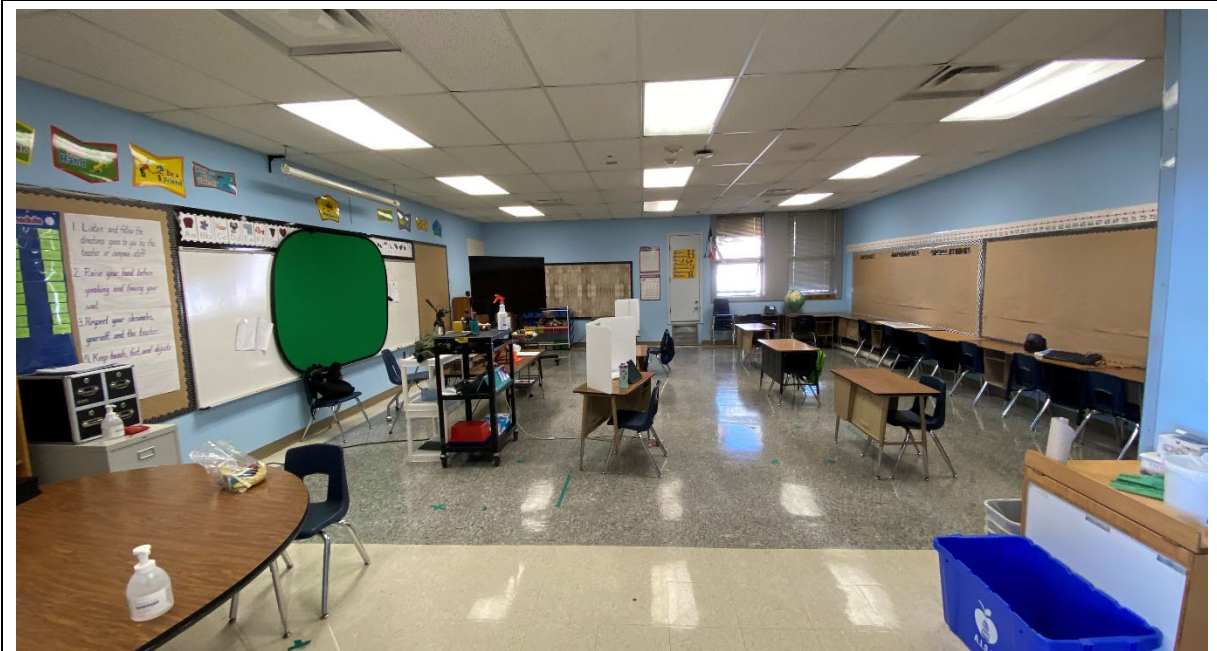
Studios in the newer annex buildings are larger than original building, and all have access to natural light. There is limited storage available.

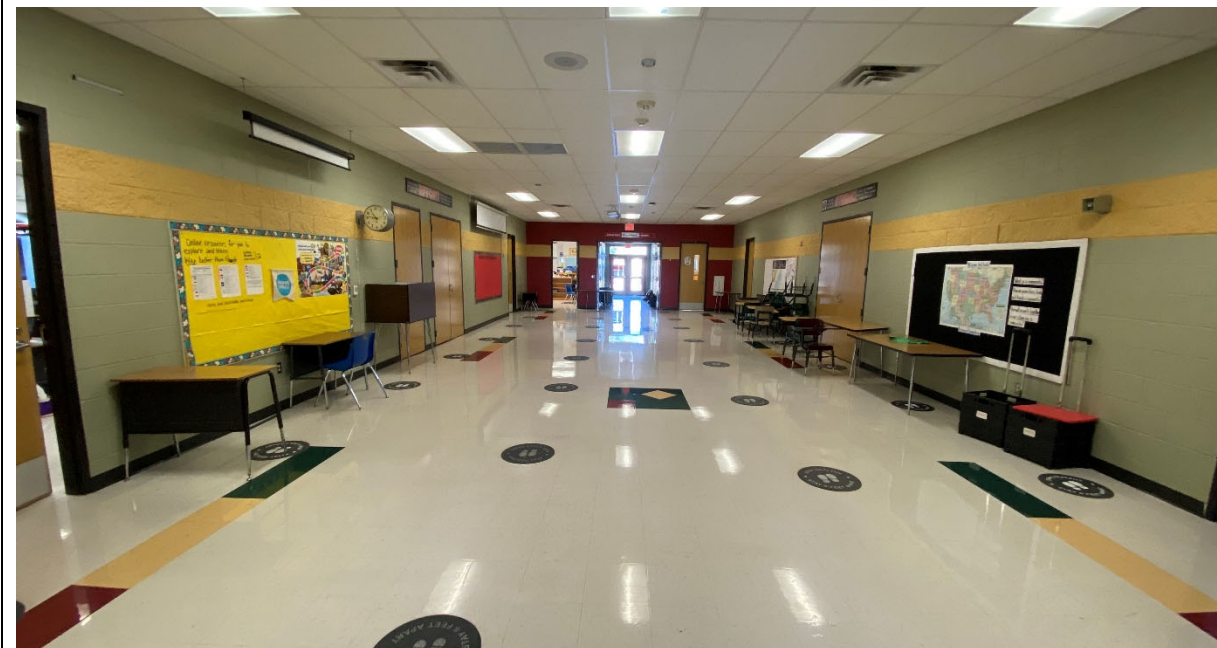
The newest annex building has a central collaboration space for the surrounding studios. This space also functions as the main circulation for the building. There is limited transparency into the studios.
