Educational Suitability Summary Report

Guerrero Thompson Elementary School

Date: 2/12/2021

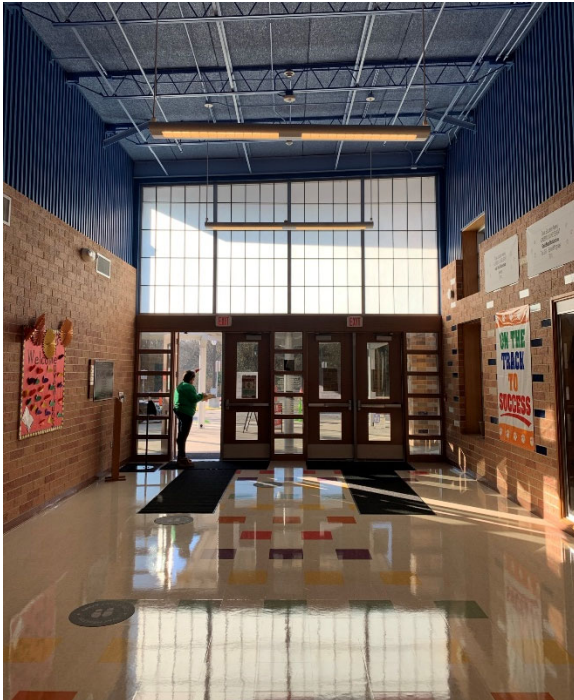
Entry has a secure vestibule and adequate visibility to the reception area.

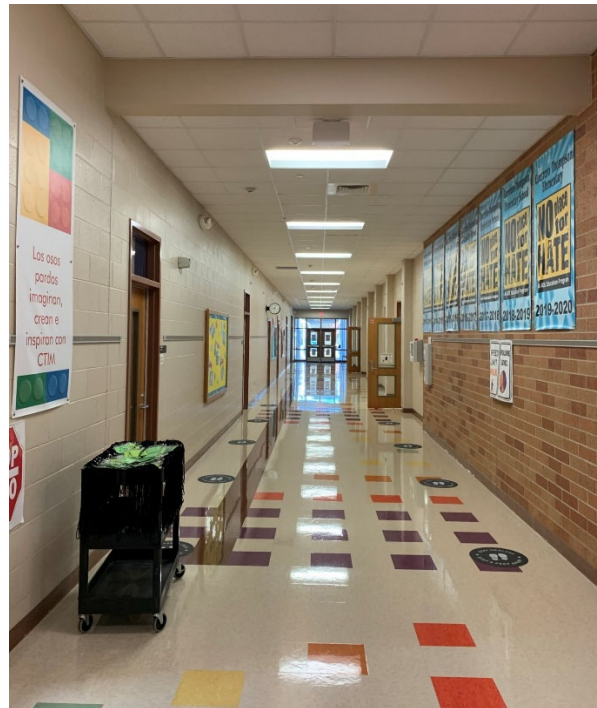
General Building: Most corridors are approximately 12 feet on average.

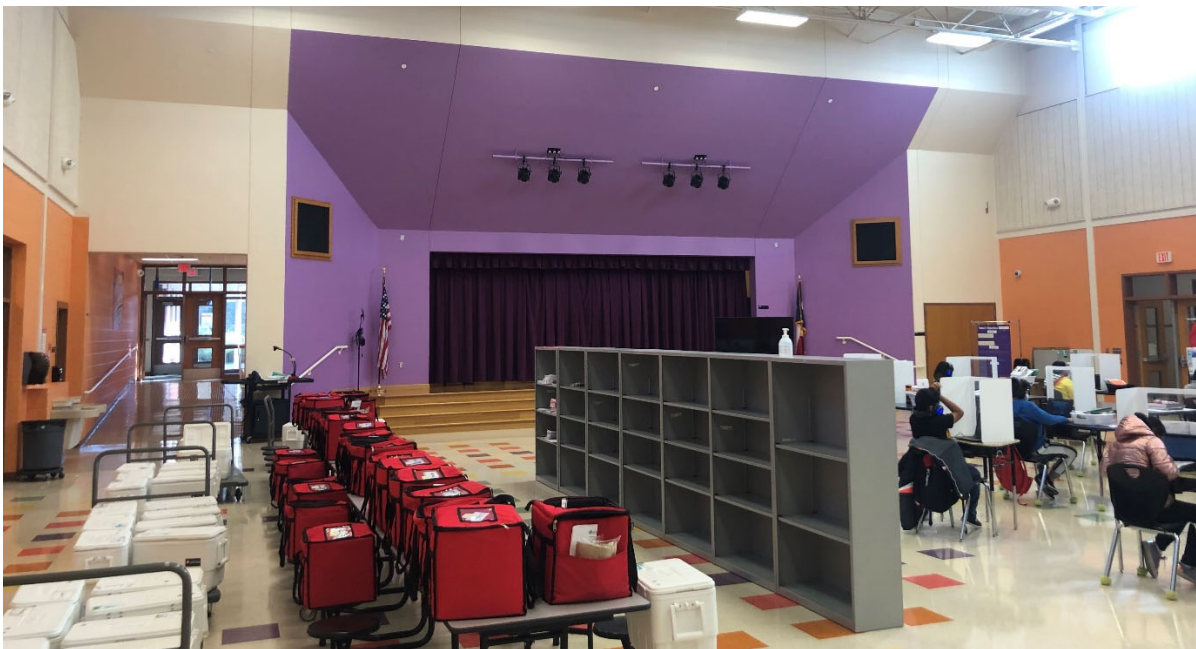
Food Services: The cafeteria is adequately sized (currently set up for COVID-19 protocols) with appropriate support spaces and is connected to the gym with an operable wall.

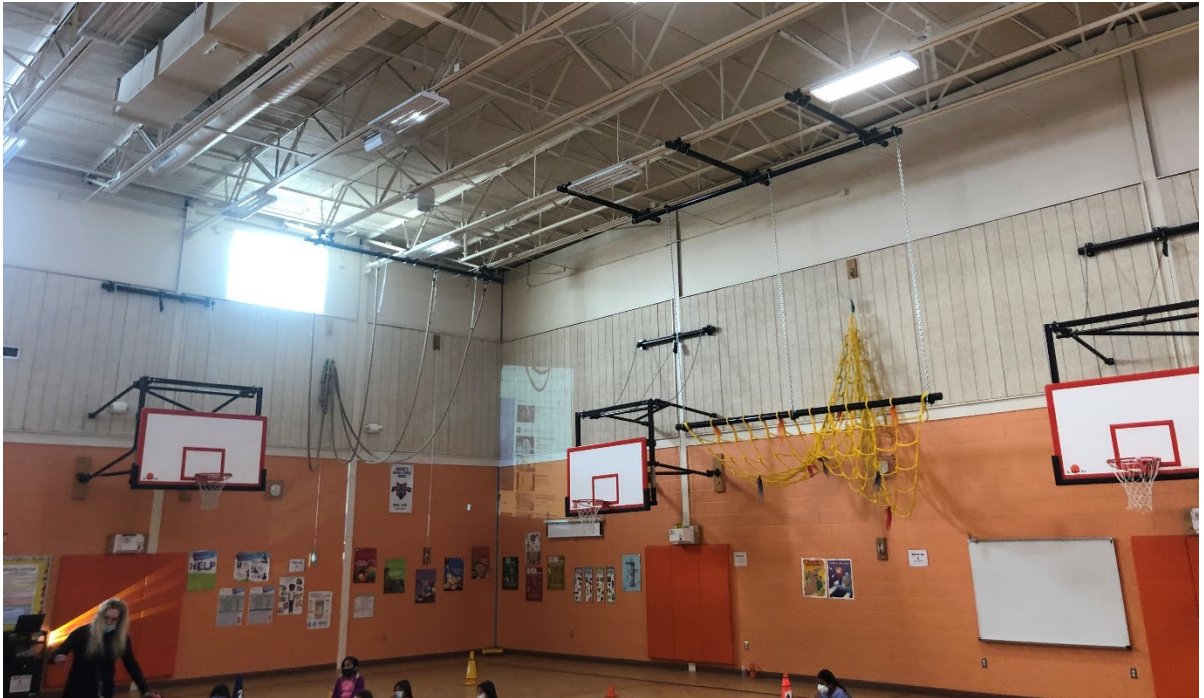
PE and Wellness: The gym is adequately sized with appropriate storage. The projection screen is undersized for the space but is supplemented by whiteboards.

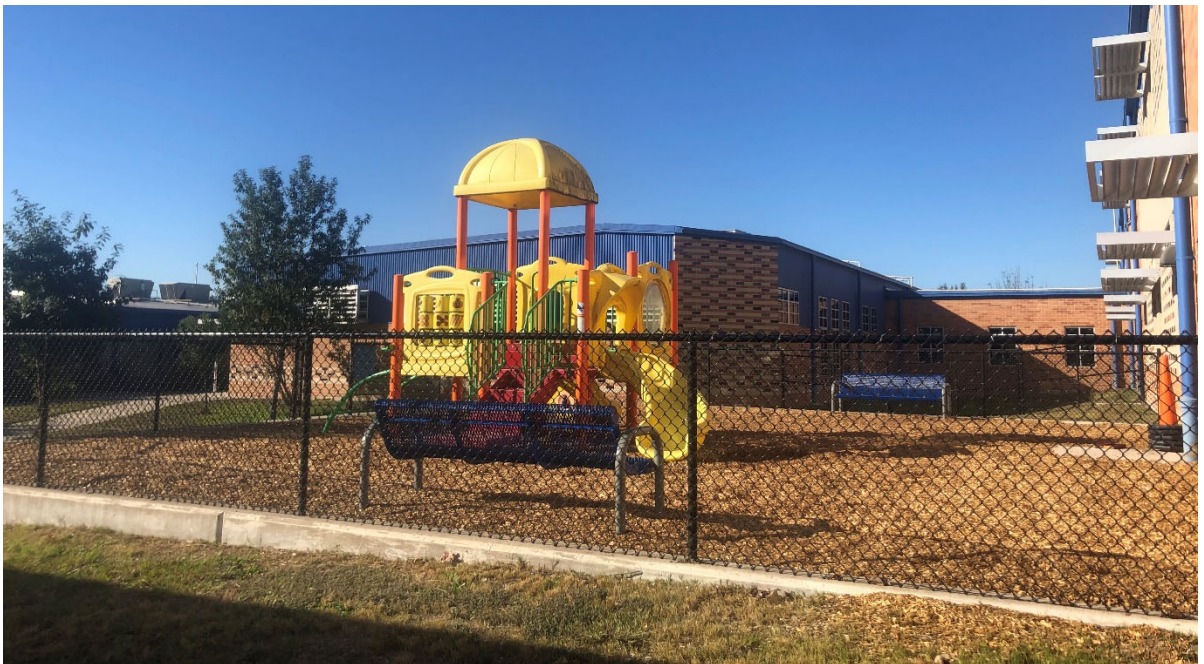
Outdoor Learning and Activity: Both playgrounds on campus do not have shade. This smaller structure is well-connected to the studio wings for lower grade level students.

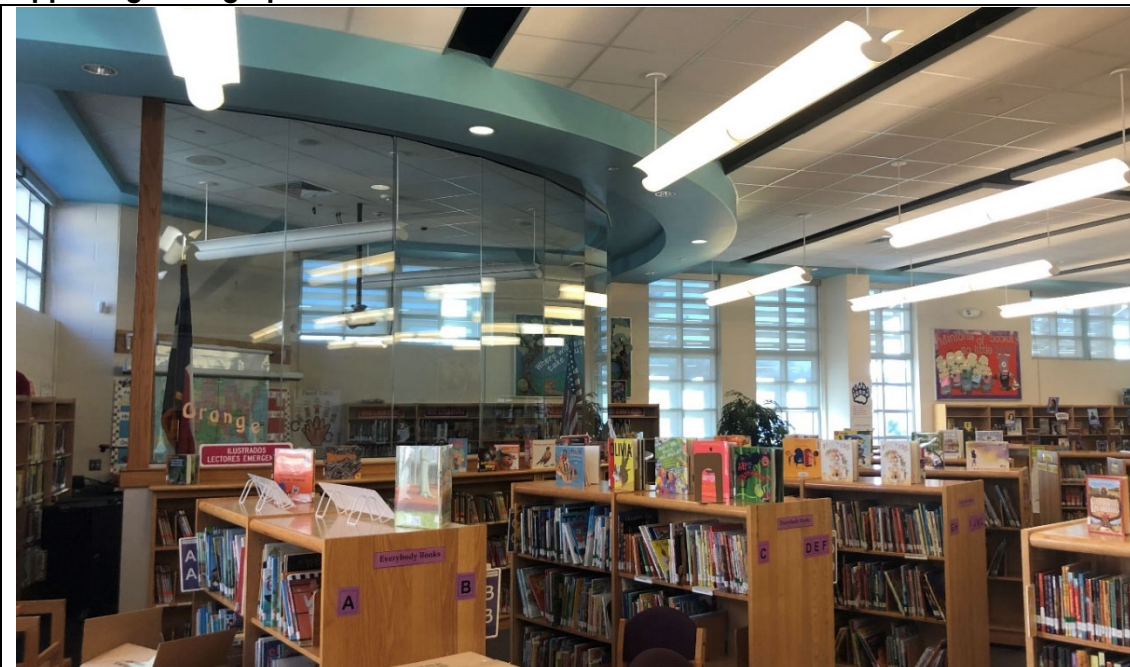
Media Resources: Large windows bring ample natural light into the library and a glass partition at the kiva provides some acoustical control when multiple groups are occupying the space.

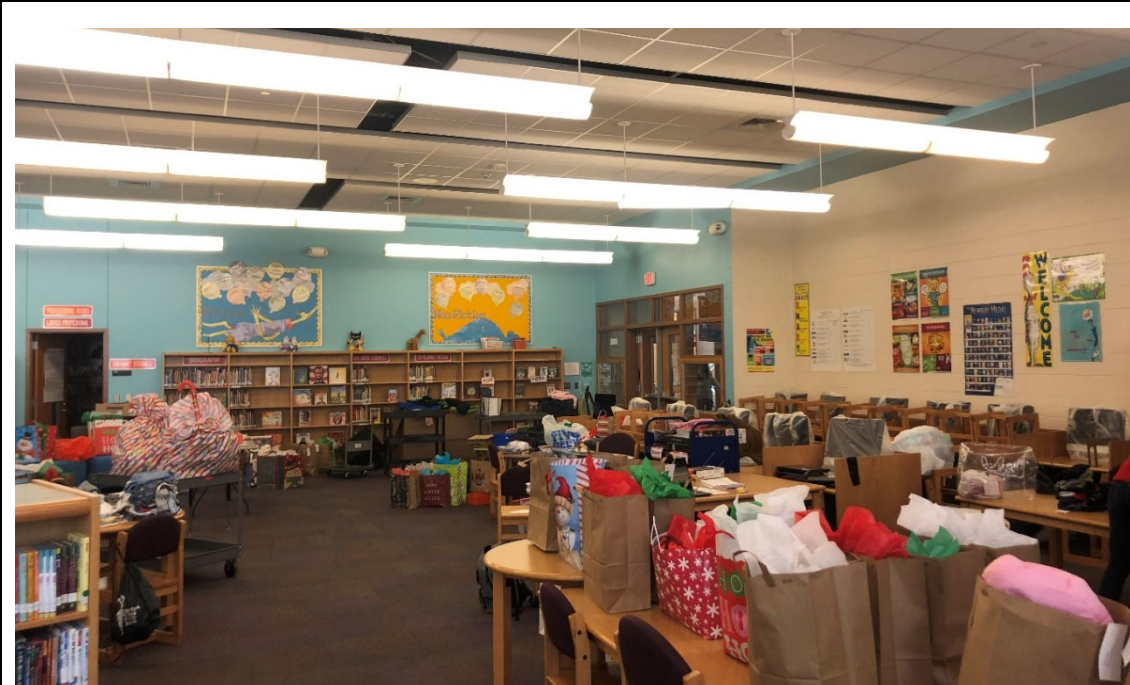
Media Resources: The library is generously sized and centrally located on the campus. Furniture is old and cumbersome to move, but there is plenty of space to accommodate larger groups. Currently the library is not being utilized due to COVID-19 protocols.

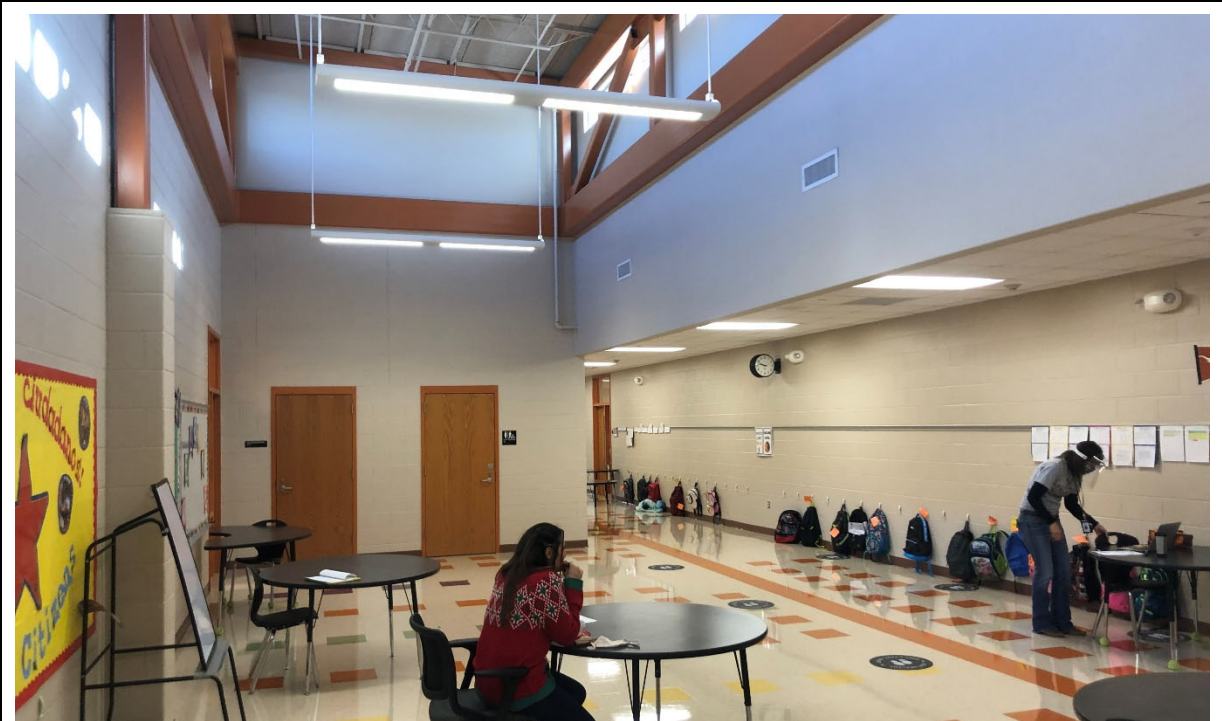
Academics and Learning: Two of the studio wings have a shared flex space in the corridor between studios, providing an area for collaboration for varying group sizes.

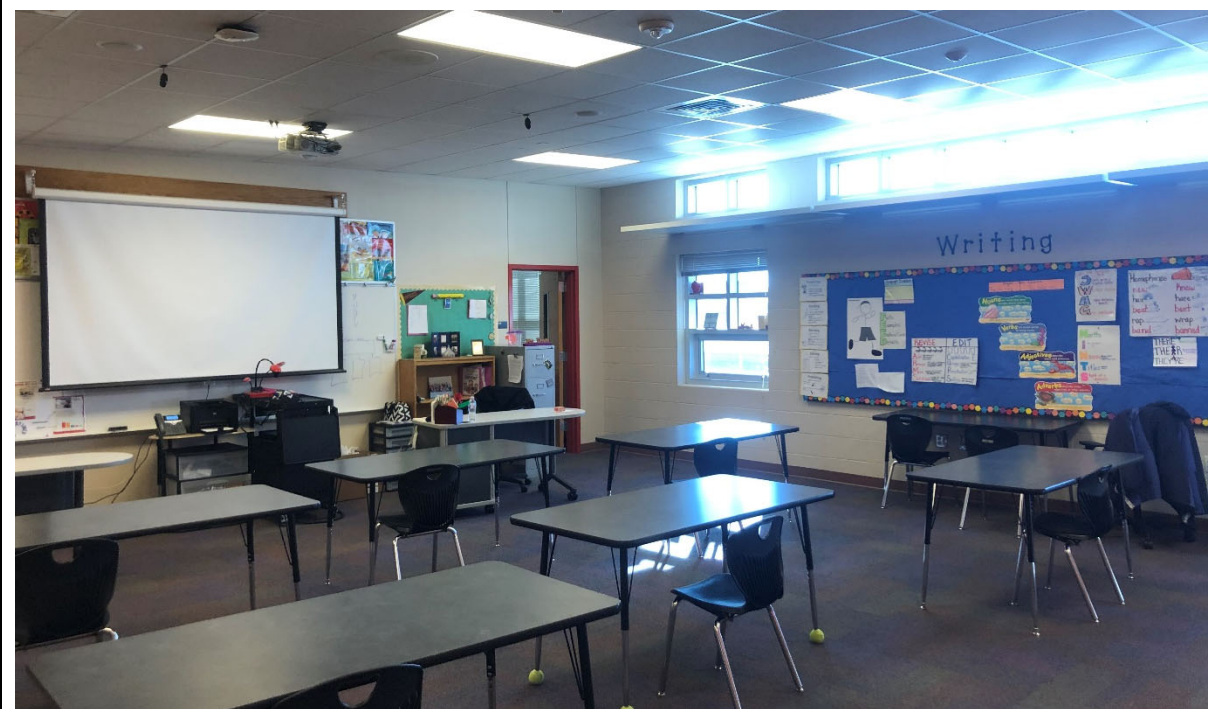
Academics and Learning: All studios have ample access to natural light and views. Furniture is a mix of old and new. More mobile pieces would allow for greater flexibility.

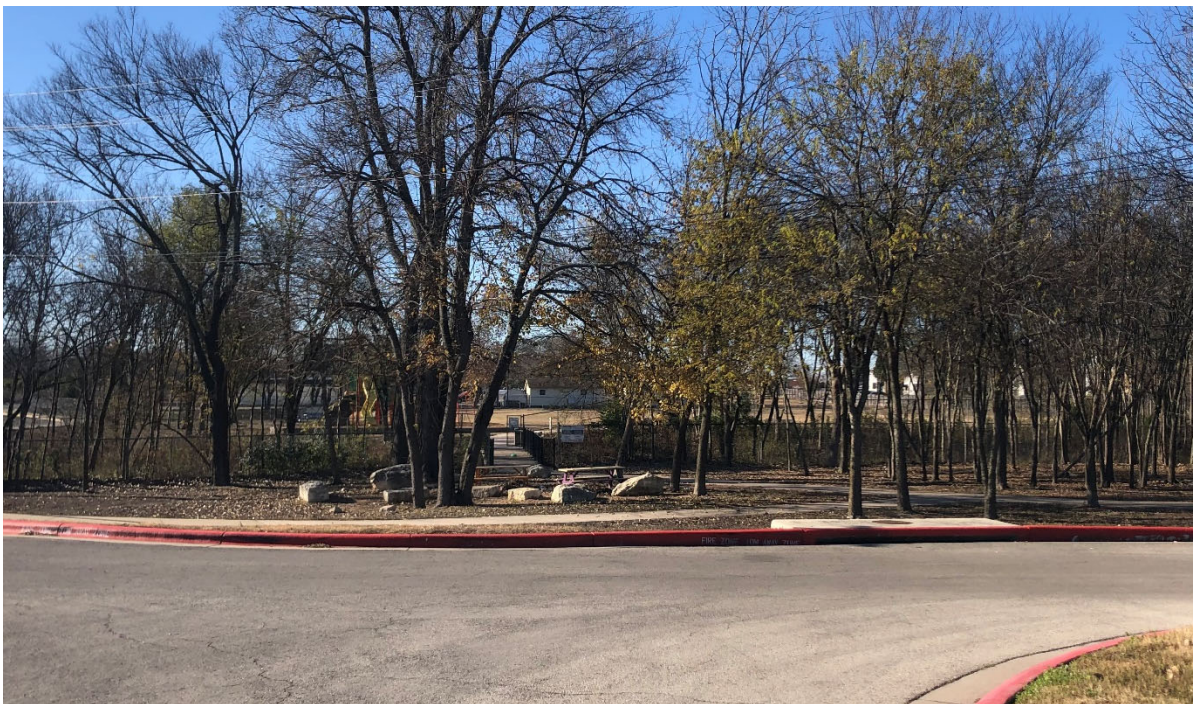
The grass play field, walking loop and larger playground are disconnected from the main campus.

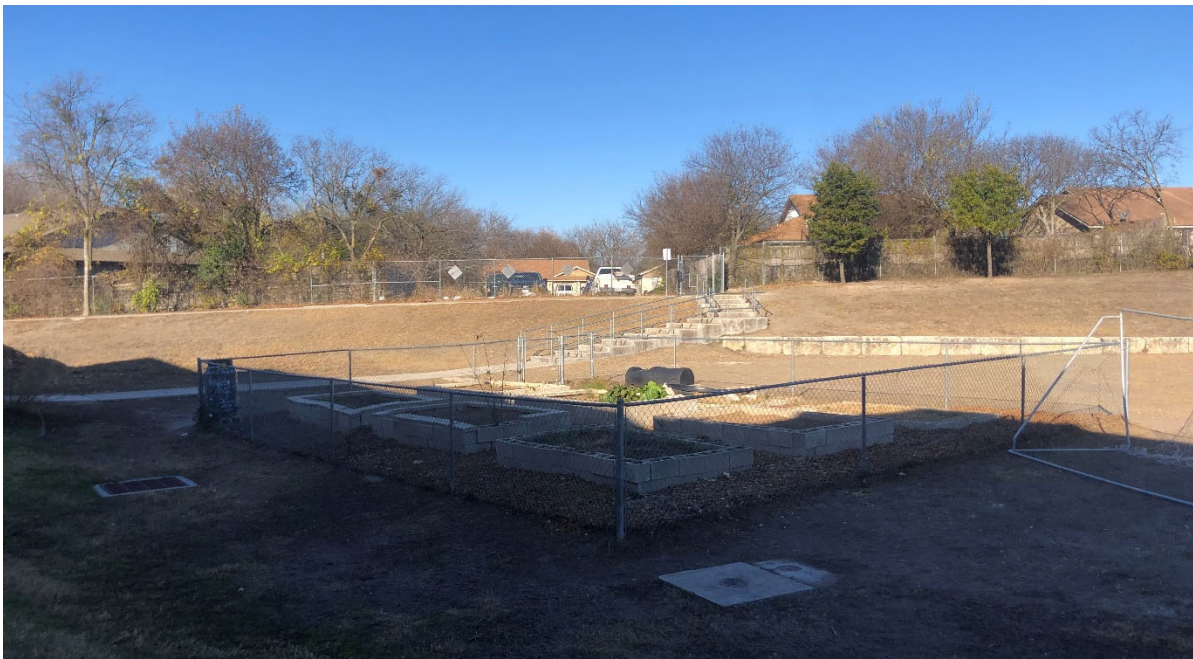
Gardens are undersized for the campus and disconnected from teaching spaces.
