Educational Suitability Summary Report

Highland Park Elementary School

Date: 01/11/2021

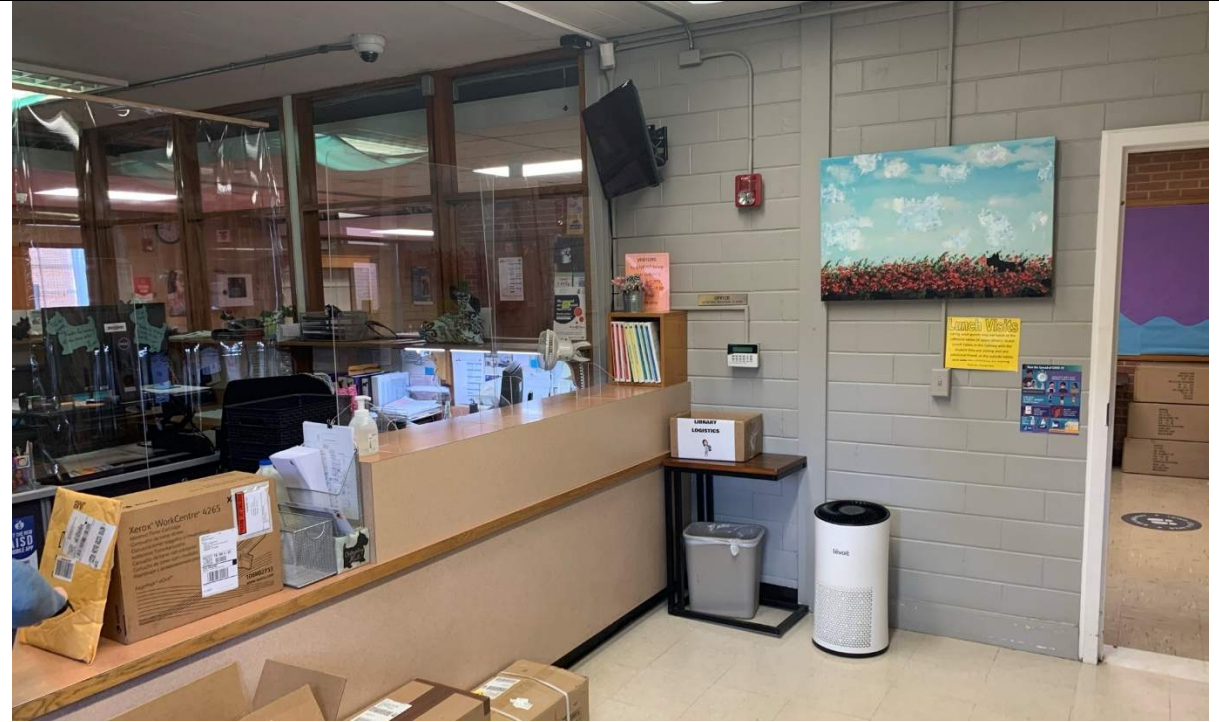
Administration: Reception area acts as a secure vestibule but is small and unwelcoming.

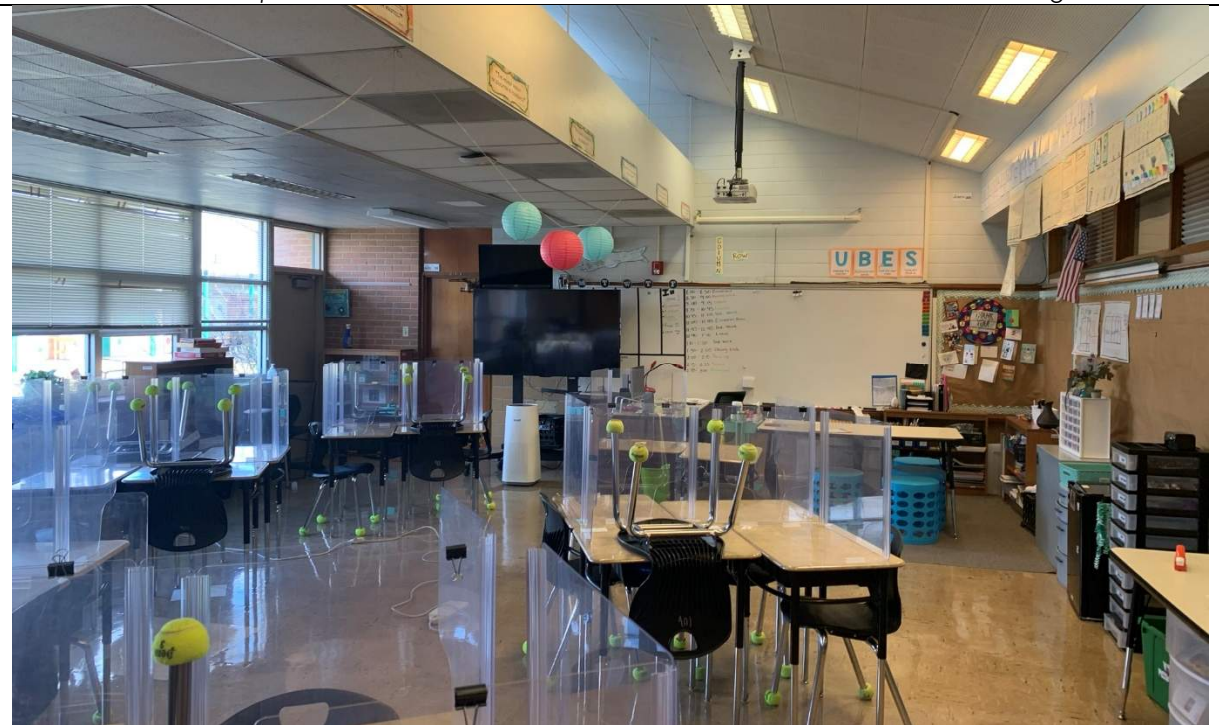
Artificial lighting is aged in the original building. Ample natural light is provided by the large windows.

5.2	Is the studio artificial lighting adequate quality?		2					Comments	1.00 2.00	
1	Very unsatisfactory - Sporadic lights work, glare, less than 20 FC							Very old fixtures with inadequate coverage in original building, newer additions/renos have better coverage/updated lamps.		
2	Unsatisfactory - 10-19 FC or serious glare									
3	Average- 20-29 FC minor glare									
4	Satisfactory - 30-39 FC and no glare									
5	Very satisfactory - 40+ FC and no glare									
N/A	Does not apply

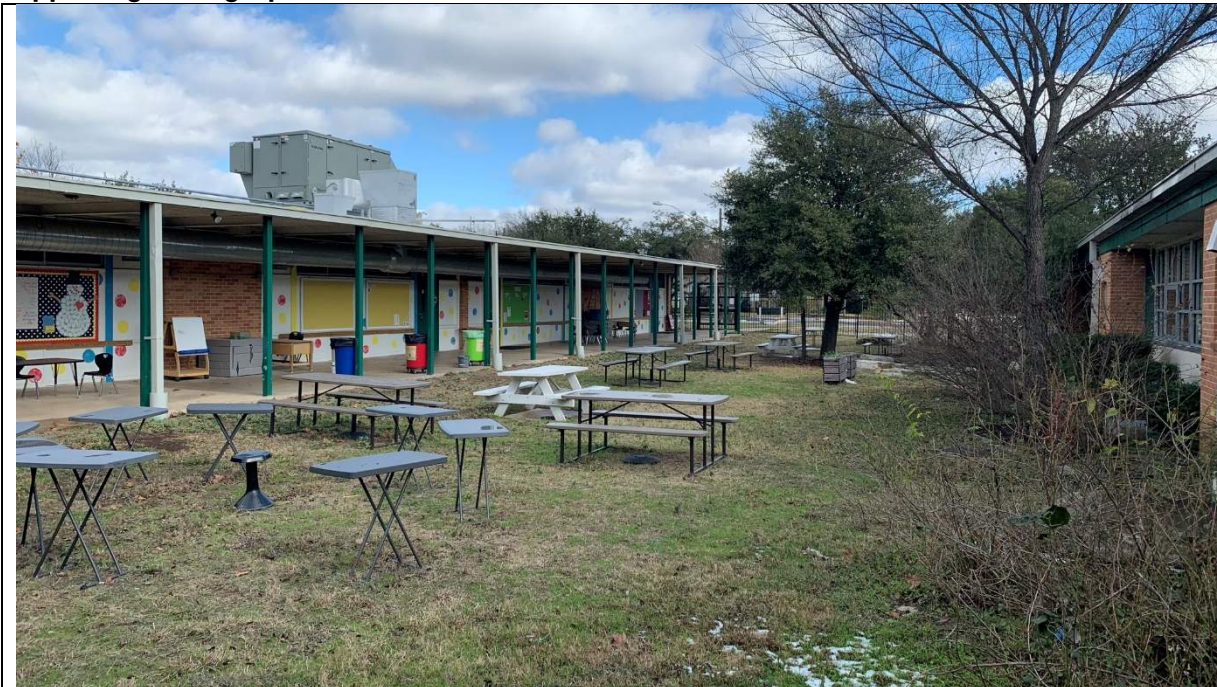
The campus has multiple courtyards for outdoor learning, but they lack shade or protection from weather.

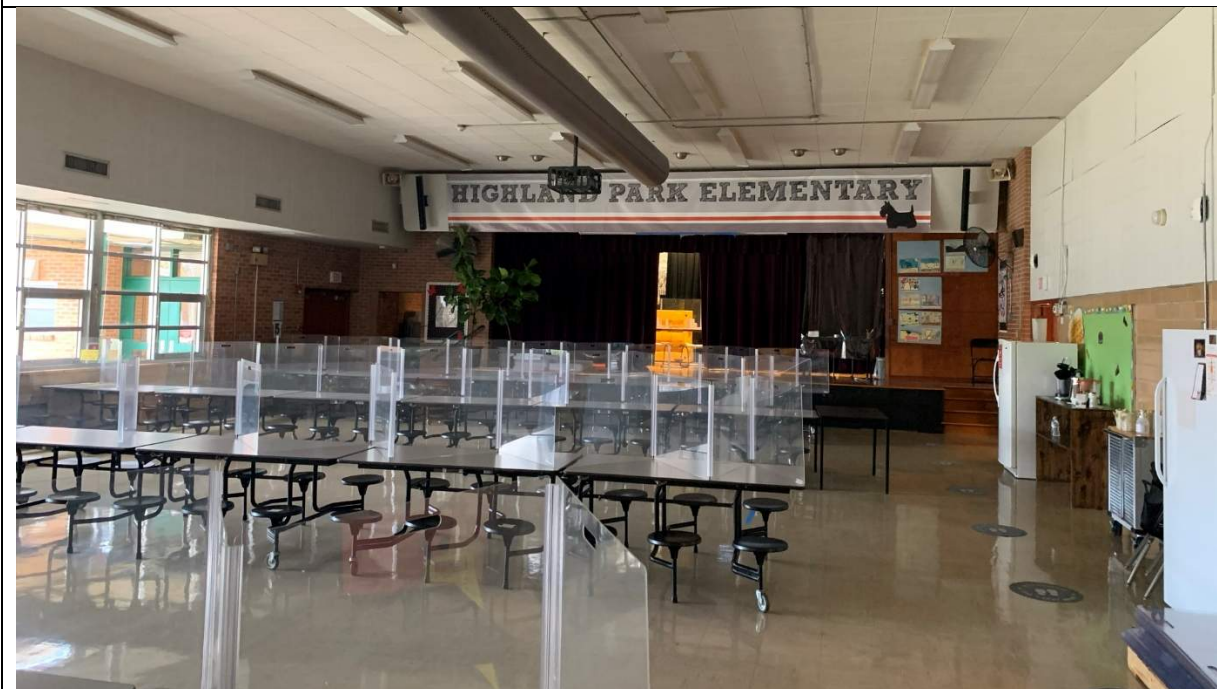
The cafeteria is undersized and unable to accommodate different types of furniture. This space is also used for performances and is unable to house parents and staff during events.

11.1	Is the Dining Commons appropriately configured per the ed spec?		2					Comments	1.00 2.00
	1 Very unsatisfactory - Too small, missing program spaces 2 Unsatisfactory - Too small, poor condition, only one option for eating space provided, inadequate circulation 3 Average - Adequate size and condition, needs updates or renovations to function well 4 Satisfactory - Good size and condition, good circulation, multiple options for eating space (ex: connection to outdoor eating space) 5 Very Satisfactory - Generous size, excellent condition and circulation, multiple options for eating space (ex: connection to outdoor eating space) N/A Does not apply	Current cafeteria is 2400 square feet. By Ed Spec, should be 3400 SF. Principal's note - need additional space for performances.

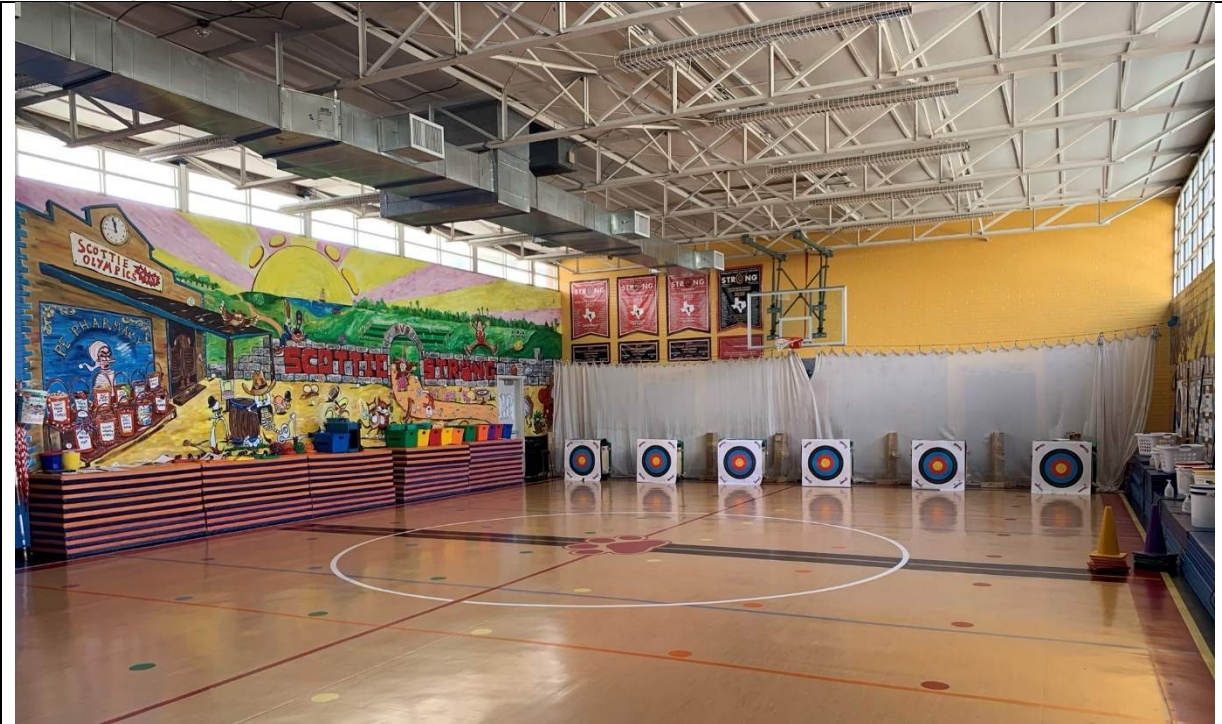
Gym is undersized and lacks storage. Most equipment is stored along the walls.

10 - PE and Wellness		1	2	3	4	5	N/A	10.00	40%
10.1	Does the campus meet the ed spec standard for physical education program spaces?		2					Comments	1.00 2.00
	1 Very unsatisfactory - Too small, missing program spaces 2 Unsatisfactory - Too small, poor condition 3 Average - Adequate size, adequate condition, needs some renovations or updates to function well 4 Satisfactory - Good size, good condition 5 Very Satisfactory - Generous size, excellent condition N/A Does not apply	Gym is undersized at 2400 square feet.

10.2	Are the physical education storage spaces appropriately configured per the ed spec?		2					Comments	1.00 2.00
	1 Very unsatisfactory - None provided 2 Unsatisfactory - Too small, disconnected, poor condition 3 Neutral - Adequate size, average condition, needs updates or renovations to function well 4 Satisfactory - Good size, connected, good condition 5 Very Satisfactory - Generous size, connected, excellent condition N/A Does not apply	Limited to no storage. No office or toilet.							
11 - Food Services		1	2	3	4	5	N/A	10.00	40%

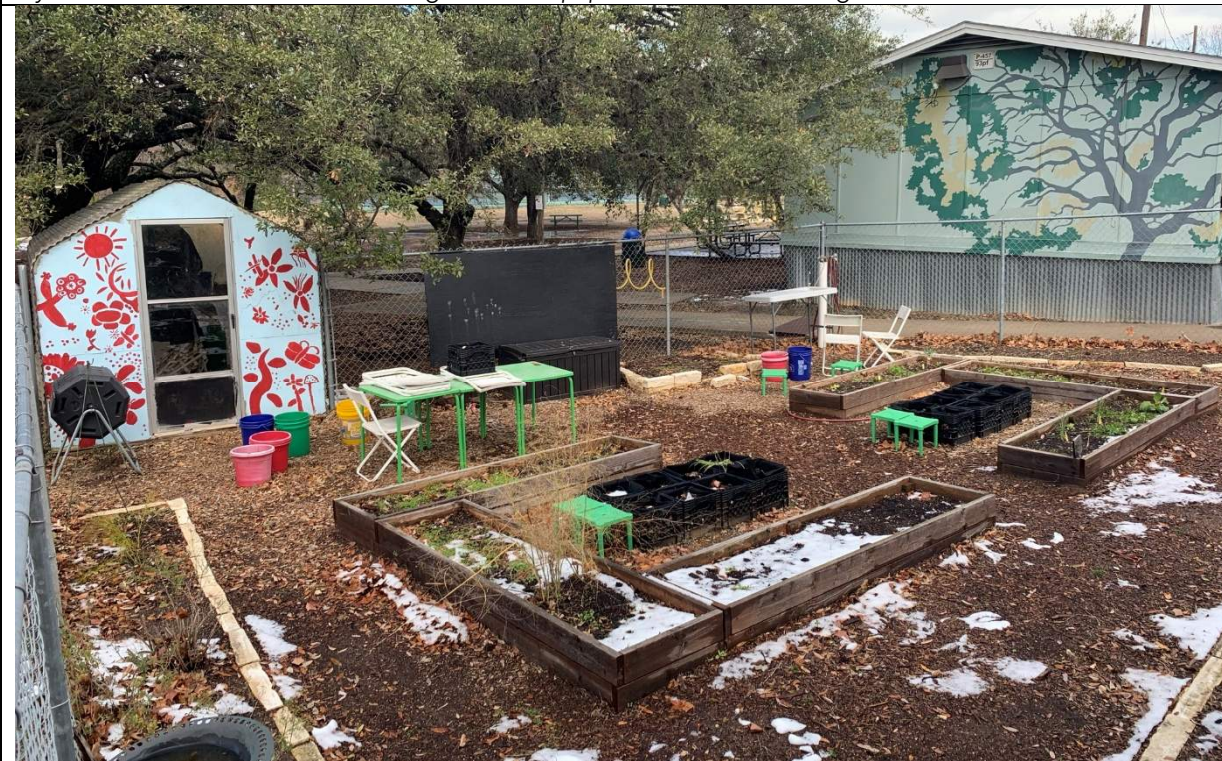
Gardens are located away from other learning courtyards.

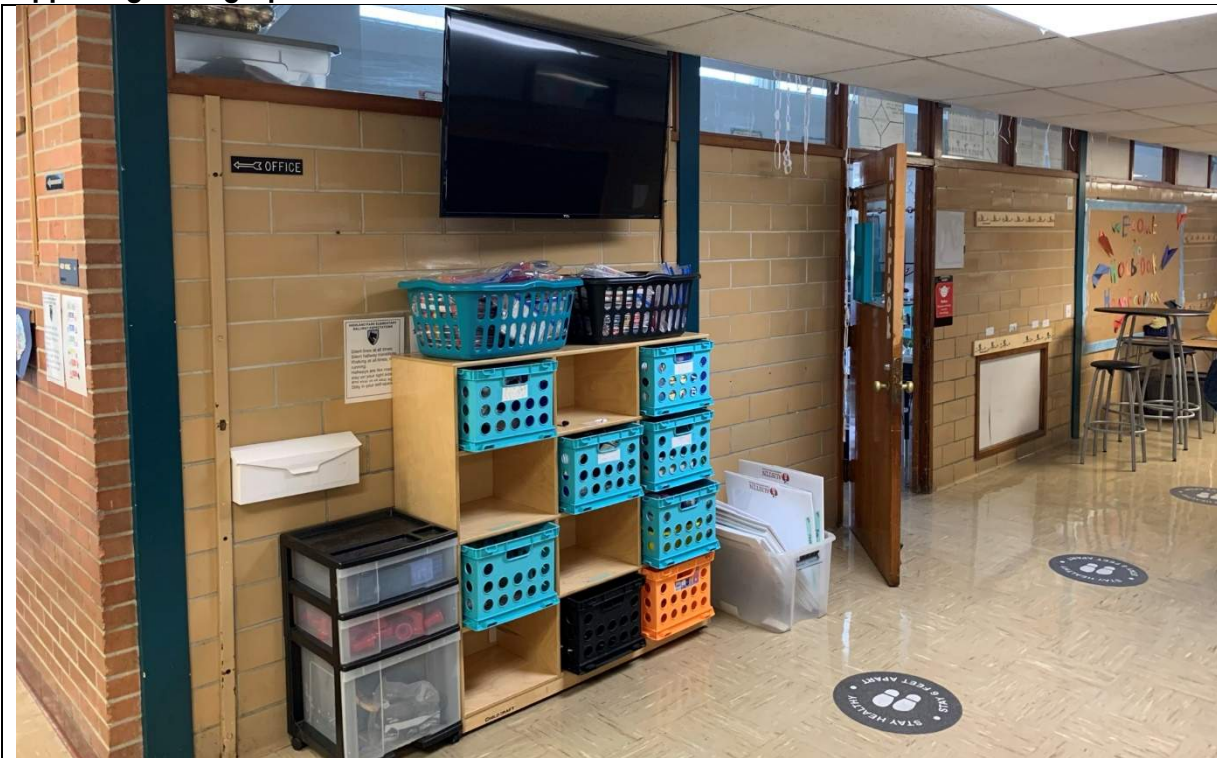
Due to a shortage of storage space, most corridors are lined with cabinets and shelving to accommodate teachers' supplies and equipment.

The interior corridors are a generous width; however, most of them are being used to store a variety of supplies and equipment (possibly due to COVID). The cafeteria, gym and library are not able to be locked off from the rest of the campus for after-hours events, nor do they have direct access from the exterior. There is no community room or dedicated space for parents or visitors on the campus.

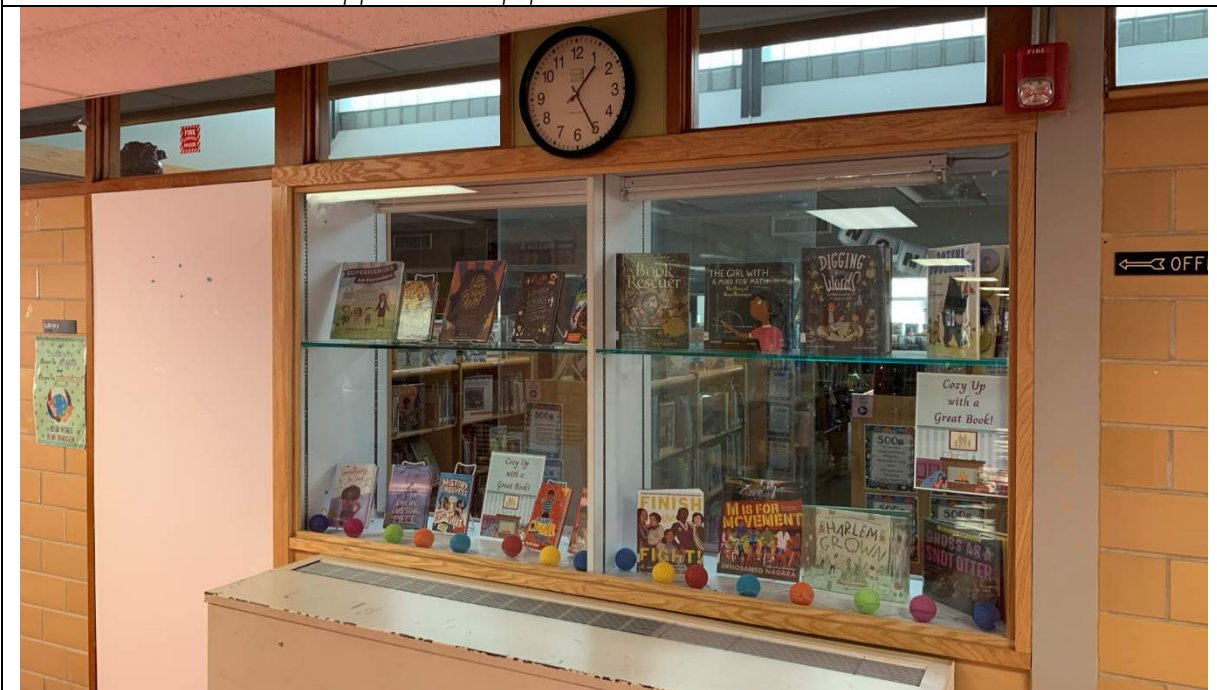
Display of 3D artifacts is very limited. Most corridors have multiple tackboards for 2D display.

8.9	Are there adequate places to display the evidence and artifacts of learning (both 2D and 3D)?		2					Comments	1.00 2.00
1	Very unsatisfactory - No dedicated space							Very few 3D display opportunities but plenty of 2D.	
2	Unsatisfactory - Too small, non-dedicated, poor condition								
3	Average - Adequate size, adequate condition, needs updates or renovations to function well								
4	Satisfactory - Good size, good condition								
5	Very Satisfactory - Generous size, excellent condition								
N/A	Does not apply

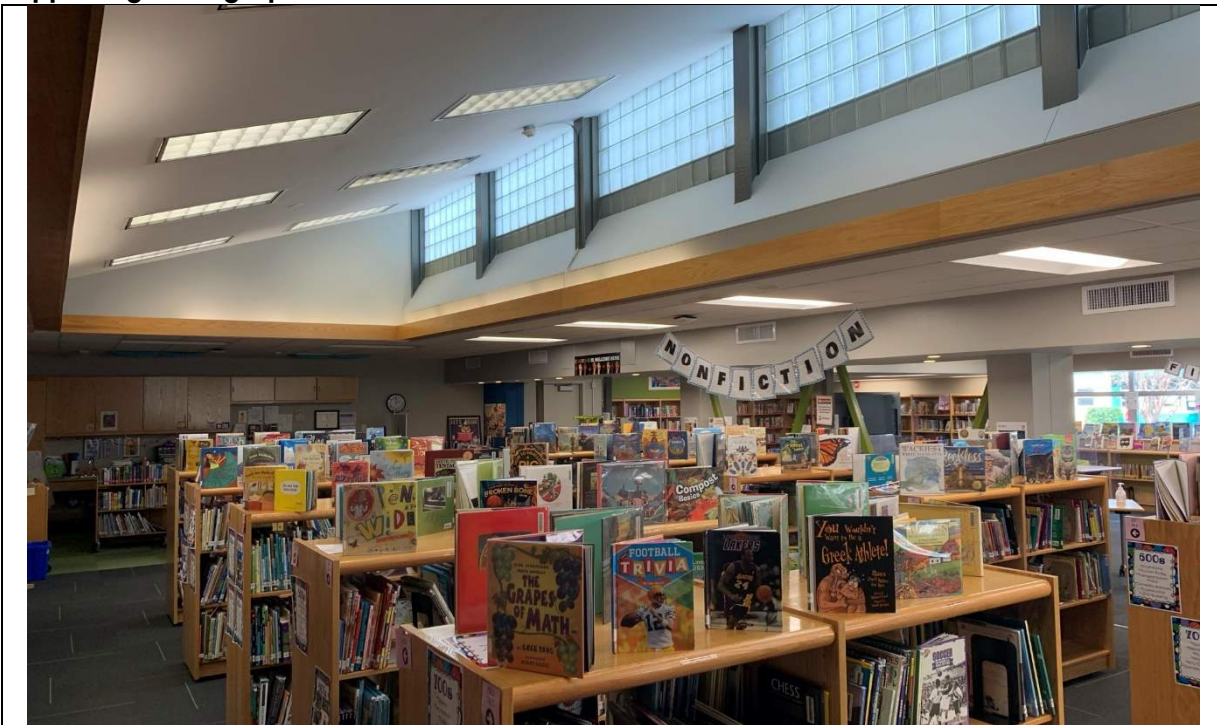
Media Resources: Book stacks occupy much of the library space, limiting the number of students the space can hold at a time.

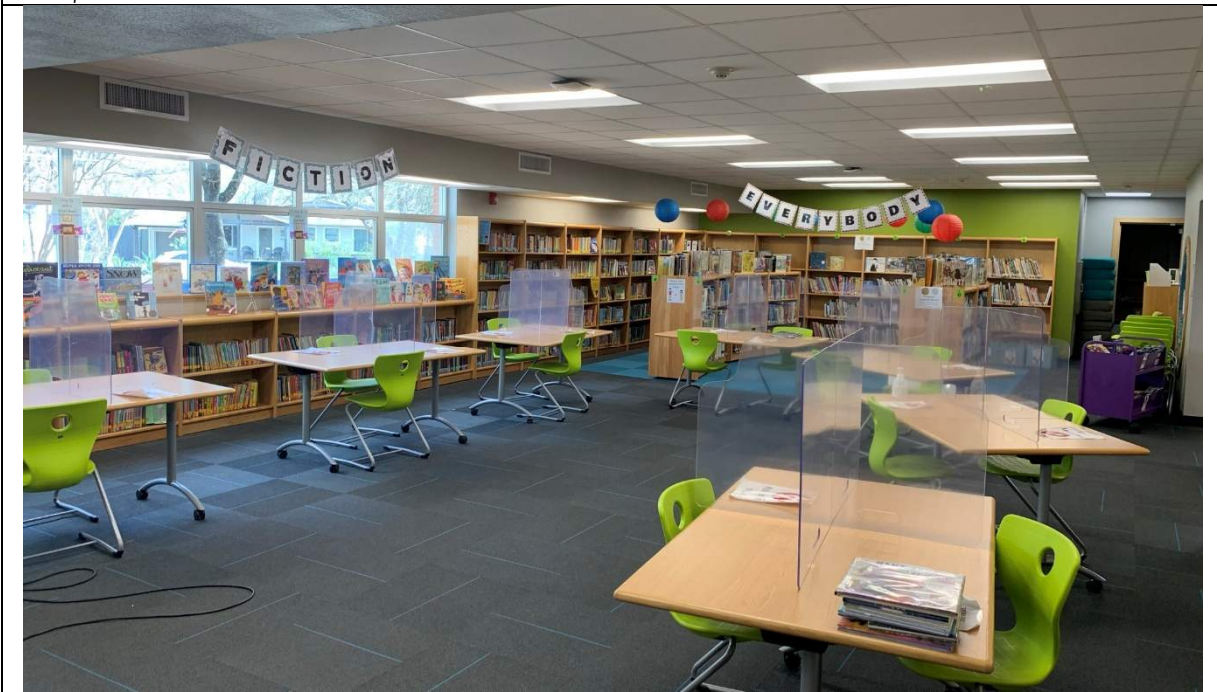
Media Resources: A variety of flexible furniture is provided, but space is limited in terms of separating groups for different zones of activities.

12.4	How well does the Library/Media Center support collaborative work in small groups (4-8 students)?			3				1.00	3.00
	1 Very unsatisfactory - No breakout rooms, no flexible furniture, no support 2 Unsatisfactory - Too small, one area, poor condition 3 Average - Adequate size, multiple areas provided, needing updates or renovations to function well 4 Satisfactory - Clusters or small rooms adjacent to media center, flexible furniture, good condition 5 Very Satisfactory - Multiple clusters or small rooms adjacent to media center, flexible furniture, excellent condition N/A Does not apply	Different layout of furniture/stack could provide more opportunities to support this.
