Educational Suitability Summary Report

Joslin Elementary School

Date: 01/27/2021

Score 54% Average

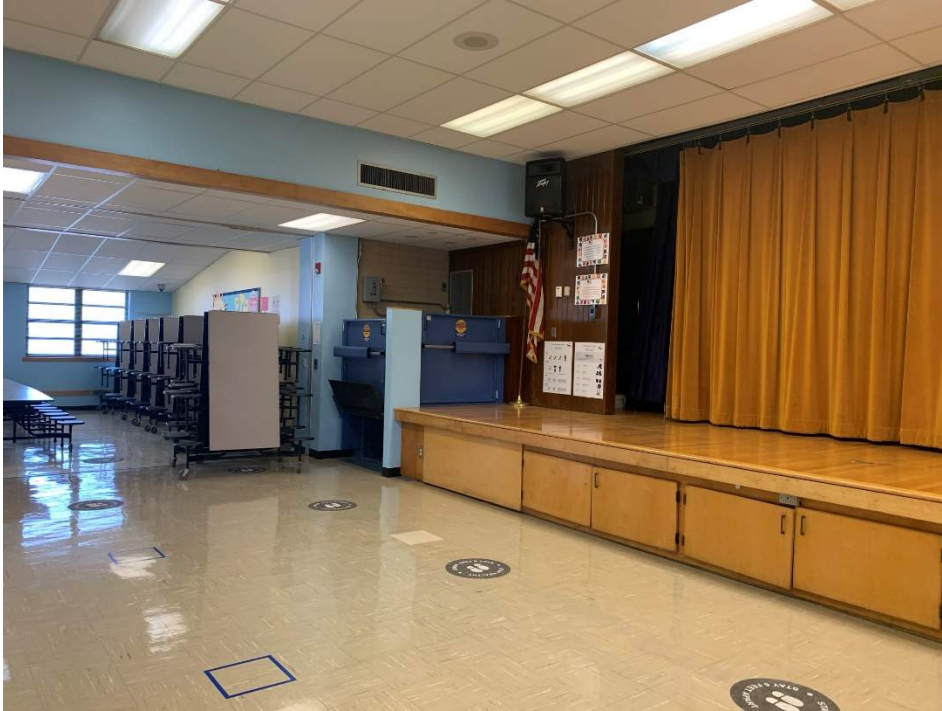
Cafeteria stage is too small and located off to one side of the cafeteria. The current lift works sporadically. After the assessment site visit, there were a series of water leaks from storms that damaged the stage, teacher's lounge, and nurse's office.

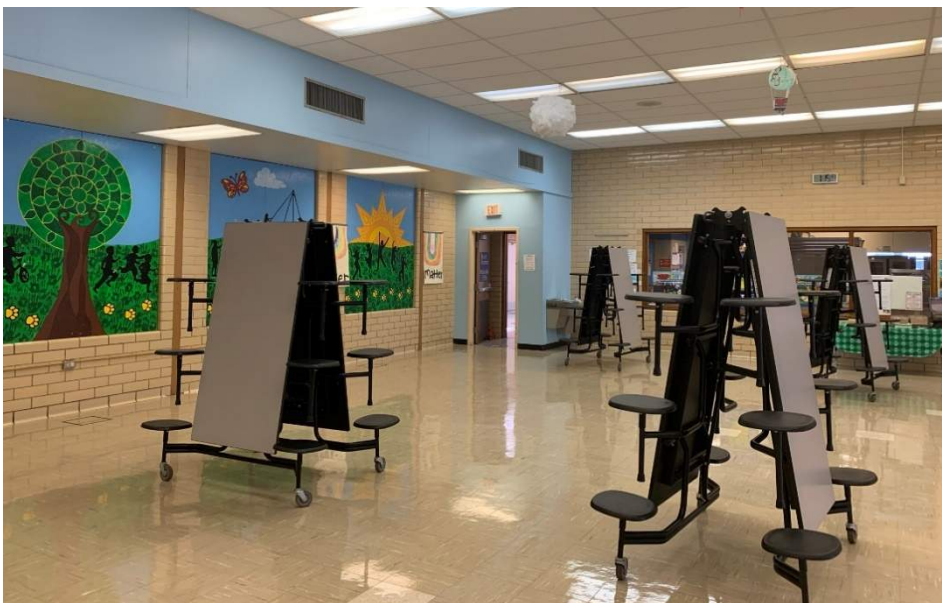
Cafeteria is sized appropriately for student enrollment. Kitchen is very undersized and has only one serving line. Murals throughout the school show school pride.

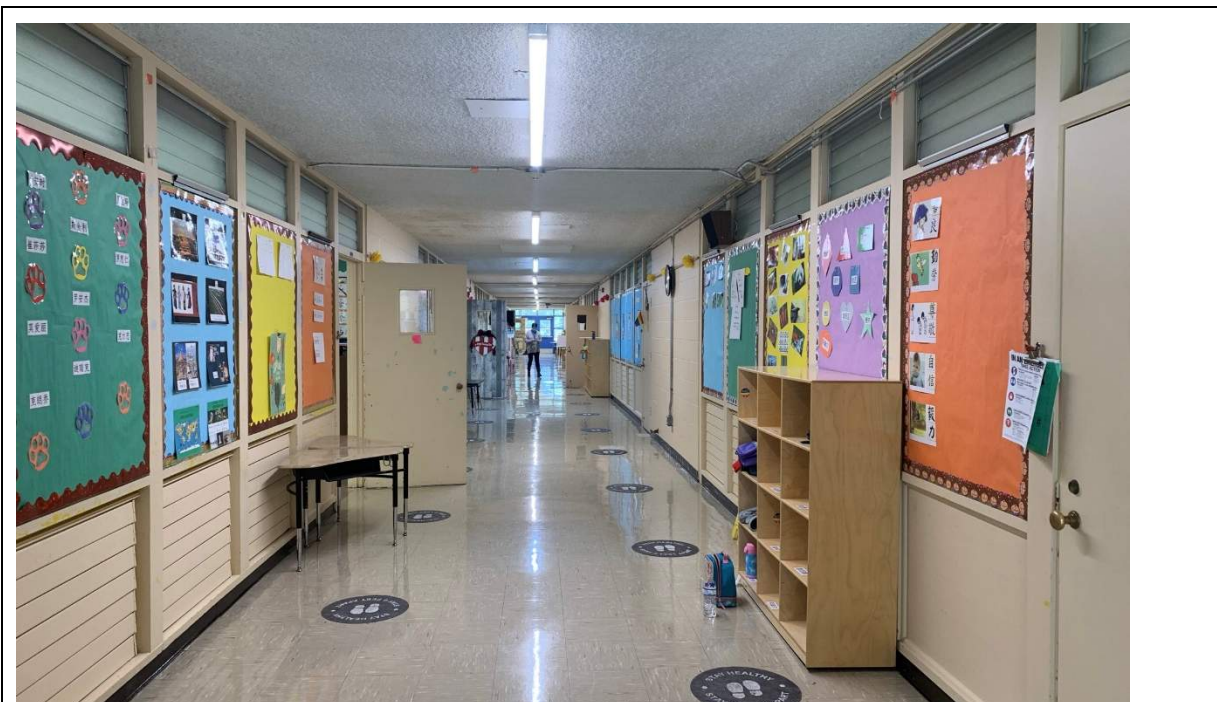
Studios have poor acoustics. Walls between hallway and studios have louvers/vents, creating a high level of sound transmission.

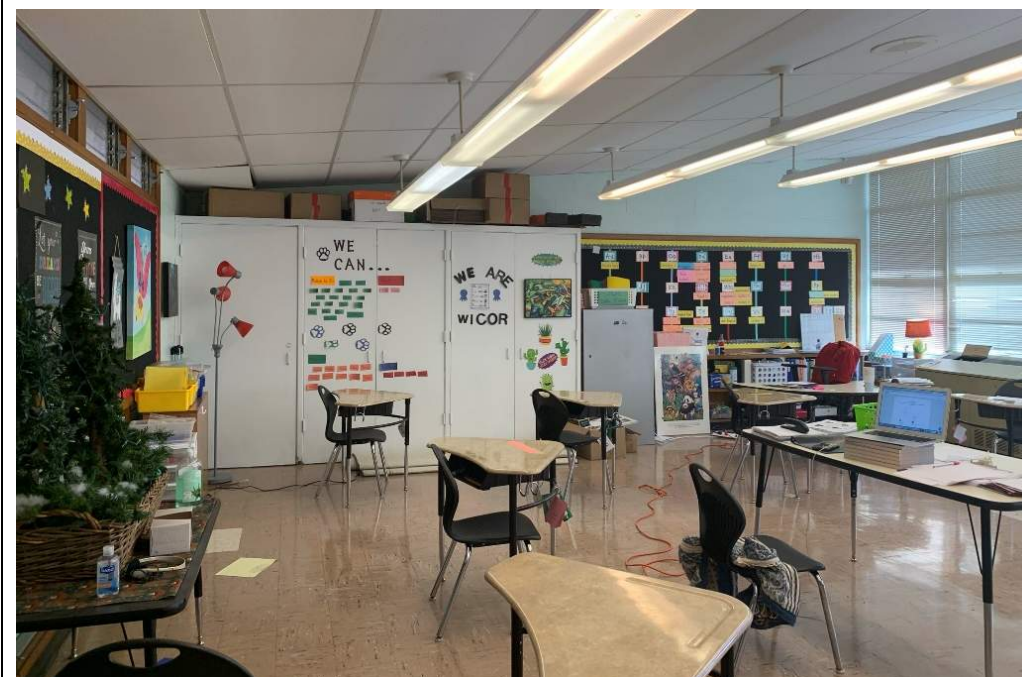
Typical studio has abundant daylight. Storage is not uniform throughout the studios. There is not adequate power in the studios.

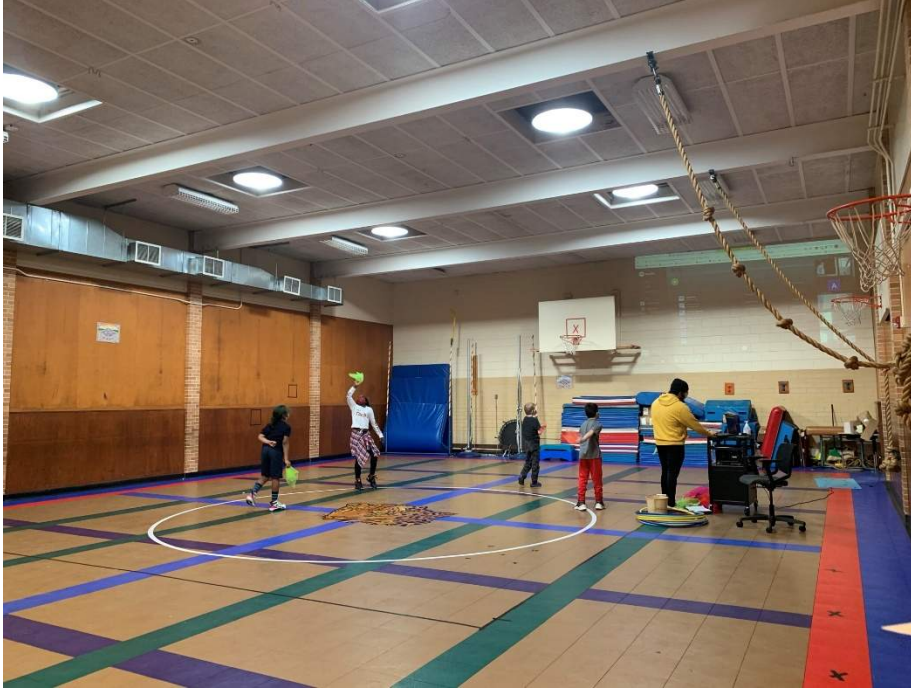
Gym is undersized and finishes need upgrades.

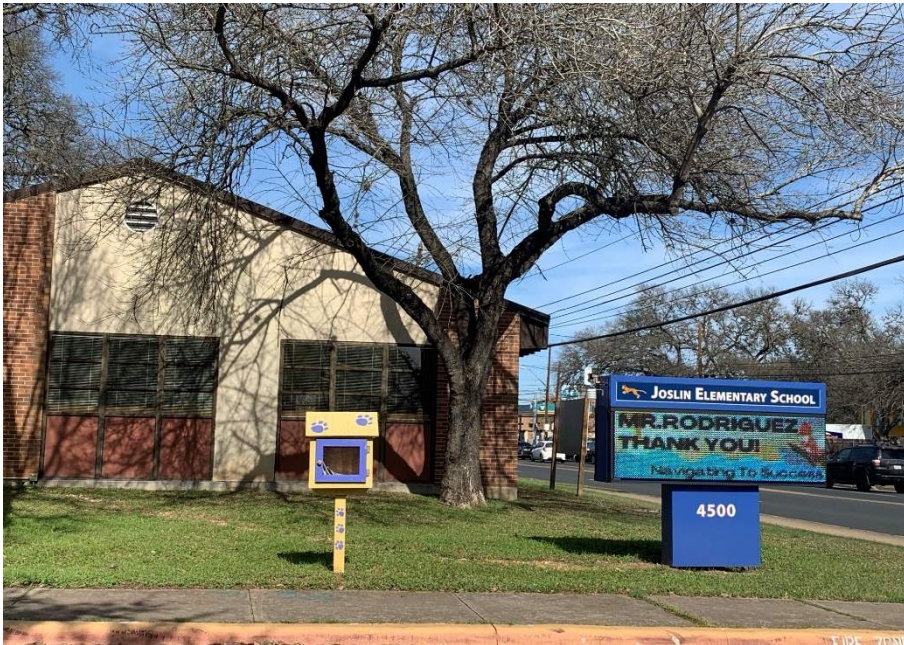
Small digital marquee sign in front of school. Location of staff/visitor parking is not apparent and difficult to access off Menchaca Road. Admin office is located far from main entry gate.

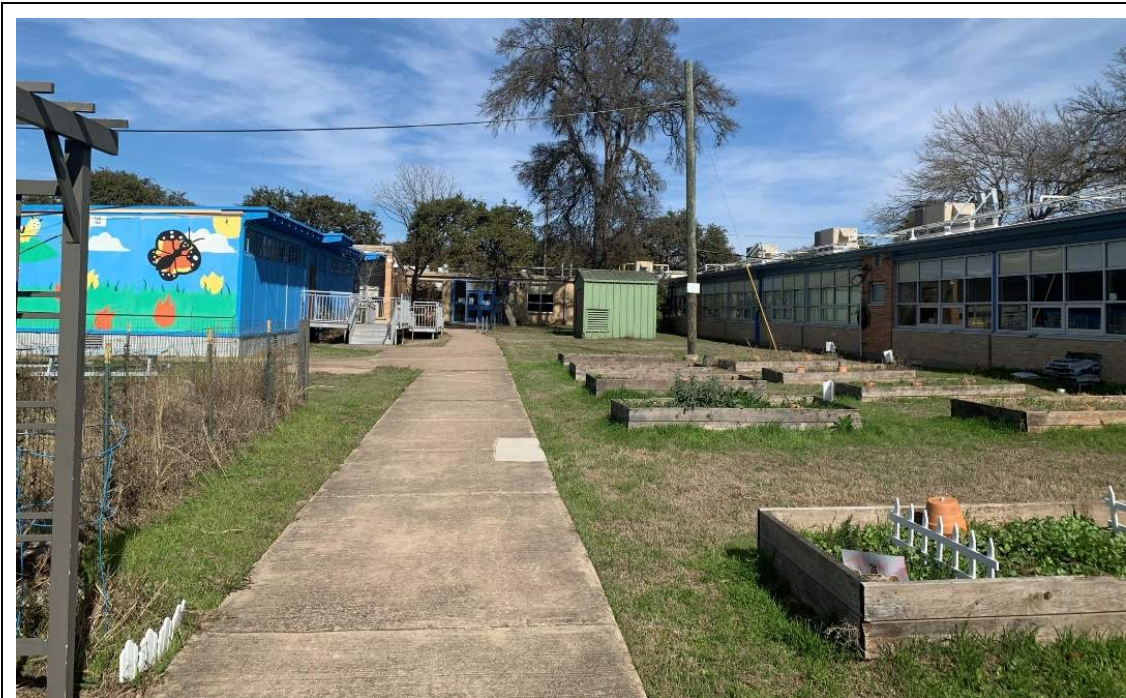
Garden space is provided for outdoor learning, but lack of shading and limited furniture prevents it from being utilized as an outdoor studio.

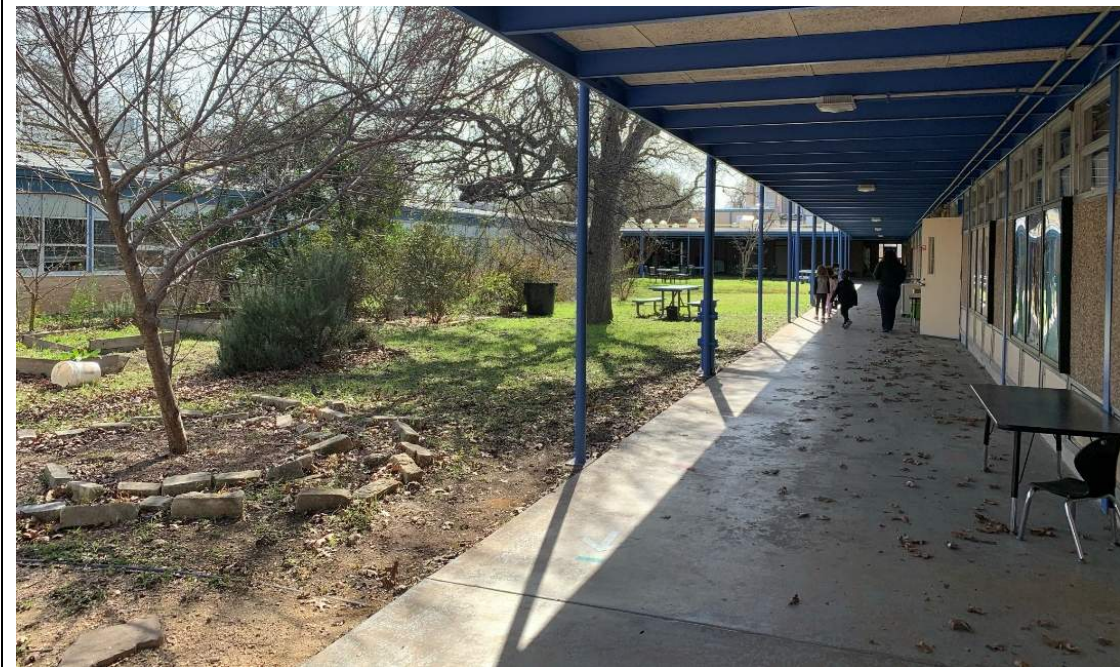
Courtyard is secured within school perimeter but requires upgrades to furniture and landscape to function as an outdoor studio. The plants and landscaping sustained damage from the winter storm (after site visit).

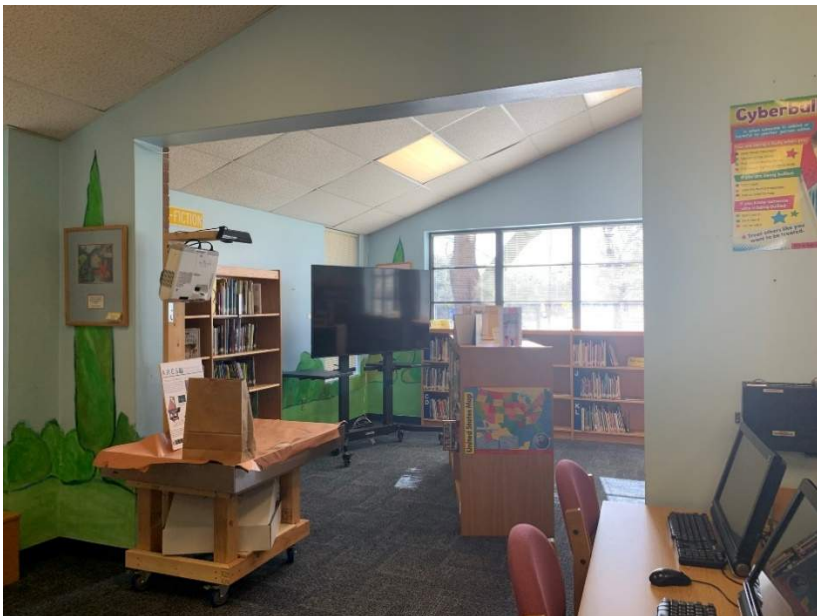
Library can be separately opened for after-hours activities. Library does not support group or individualized study/reading. Most furniture is not easily movable. Technology is adequate.

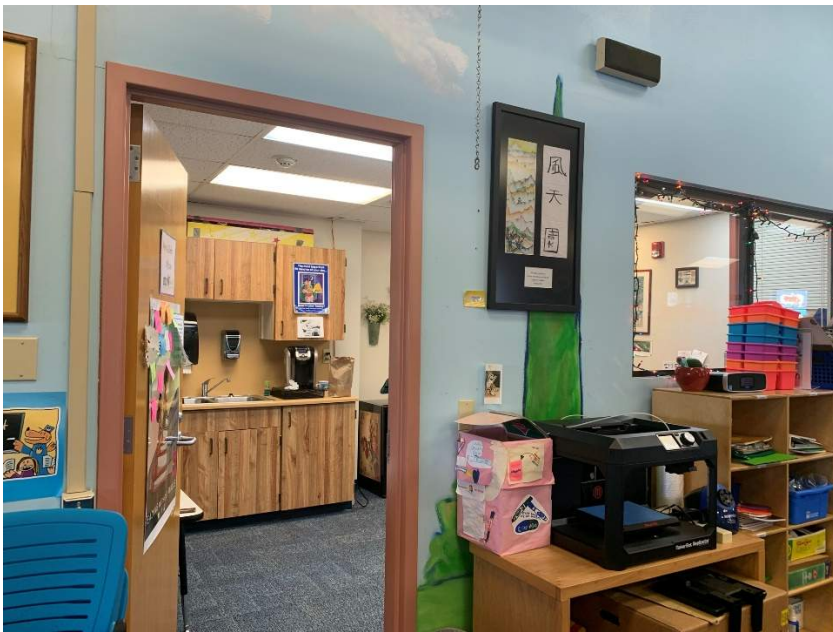
Library has adequate storage and workroom is provided.
