Educational Suitability Summary Report

Kiker Elementary School

Date: 12/14/2020

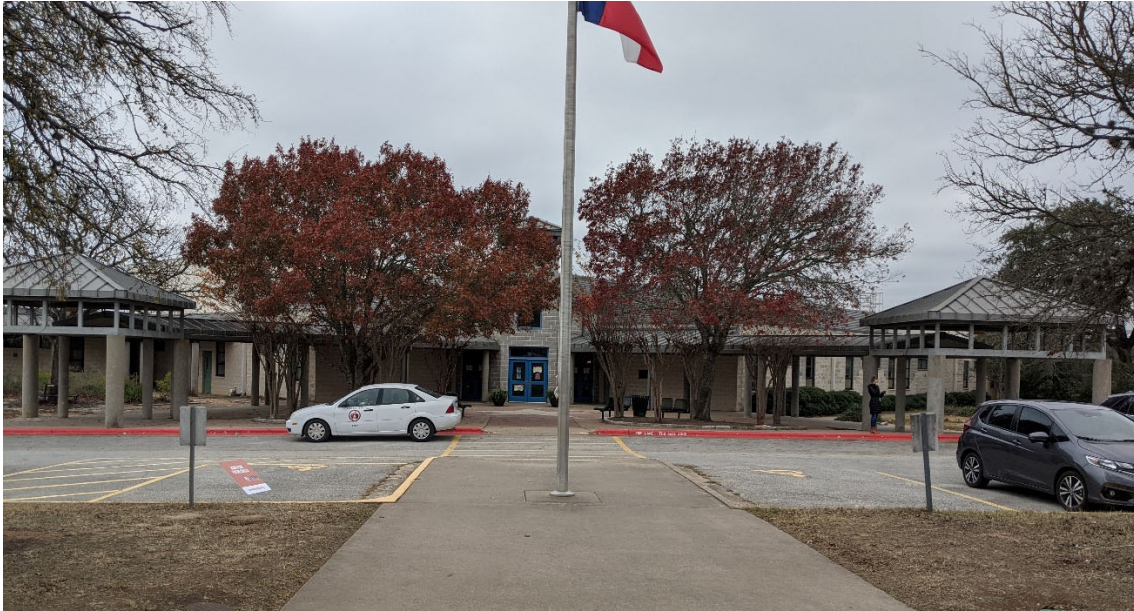
Main Entry: A large, covered canopy covers circulation from the front parking lot.

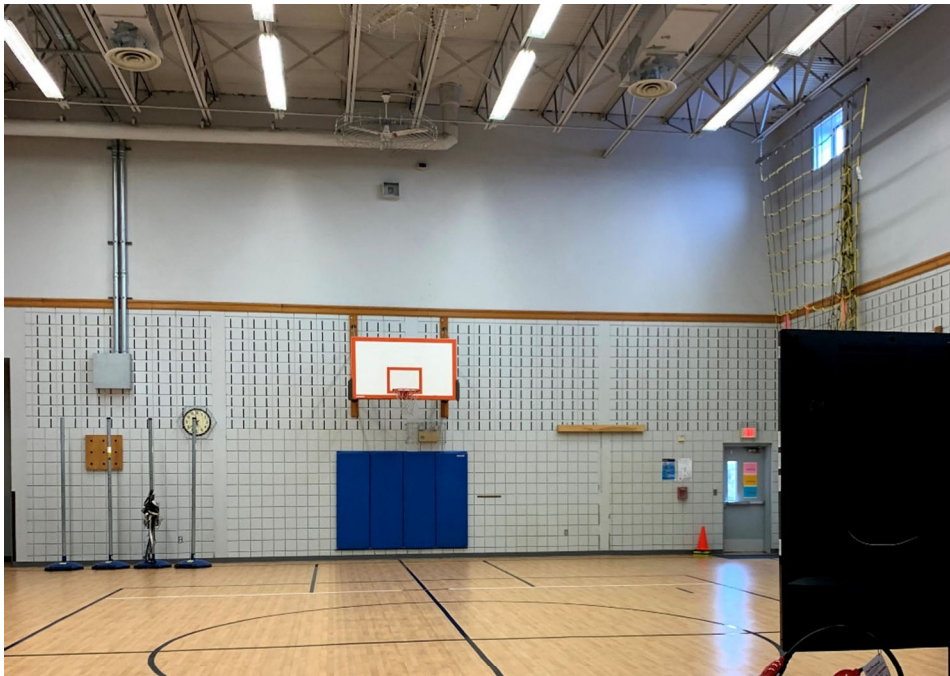
Gym is appropriately sized per Ed Spec but does not meet the current needs of the school. The gym and cafeteria open to one large space with an operable partition.

The main gym is adequately sized per Ed Spec, but some PE classes take place in a portable. The gym has appropriate support space – gym office, restroom and storage room, which opens both to the gym and to the exterior.

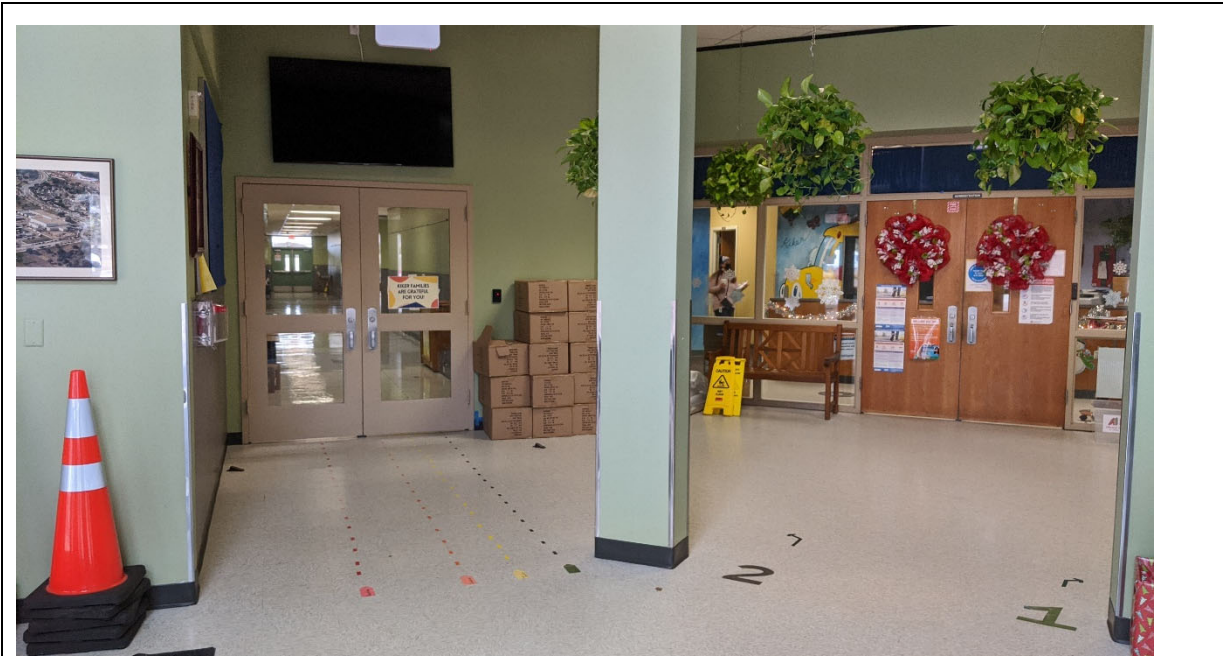
Entry vestibule directs traffic directly to the front office.

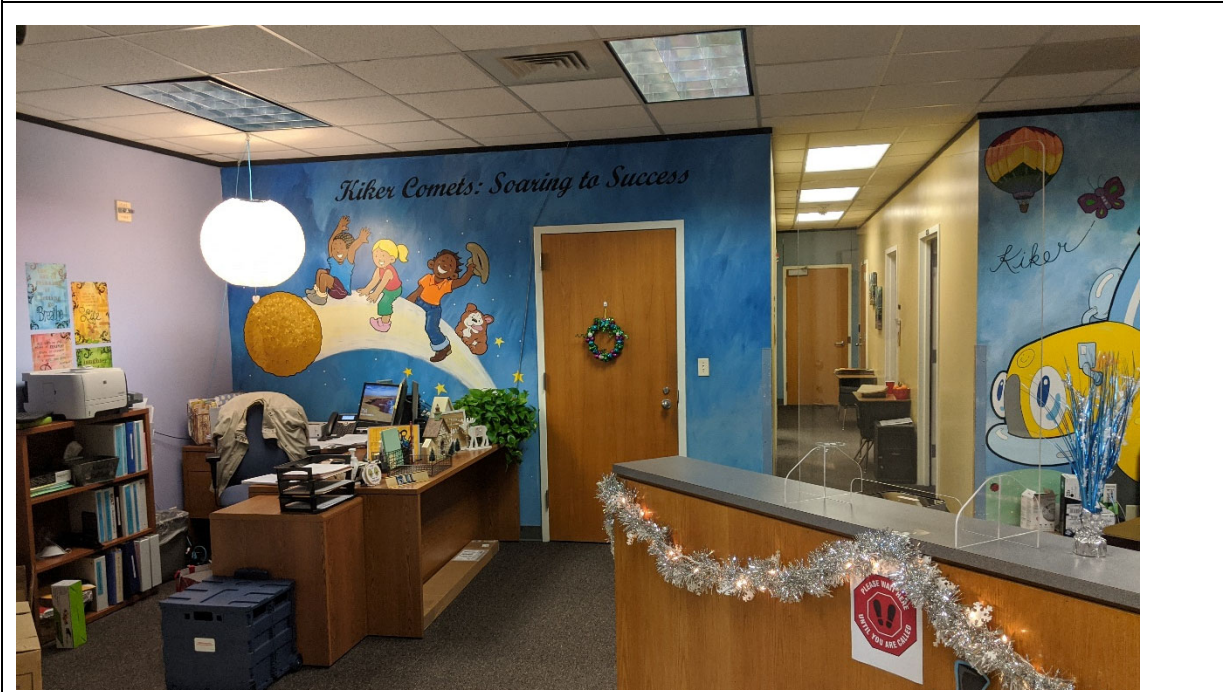
Administration: Reception area is welcoming and colorful.

The administration space is nicely laid out and welcoming. It has good transparency and views to the main entry vestibule. Acoustics are good, providing privacy when speaking at normal voice levels.

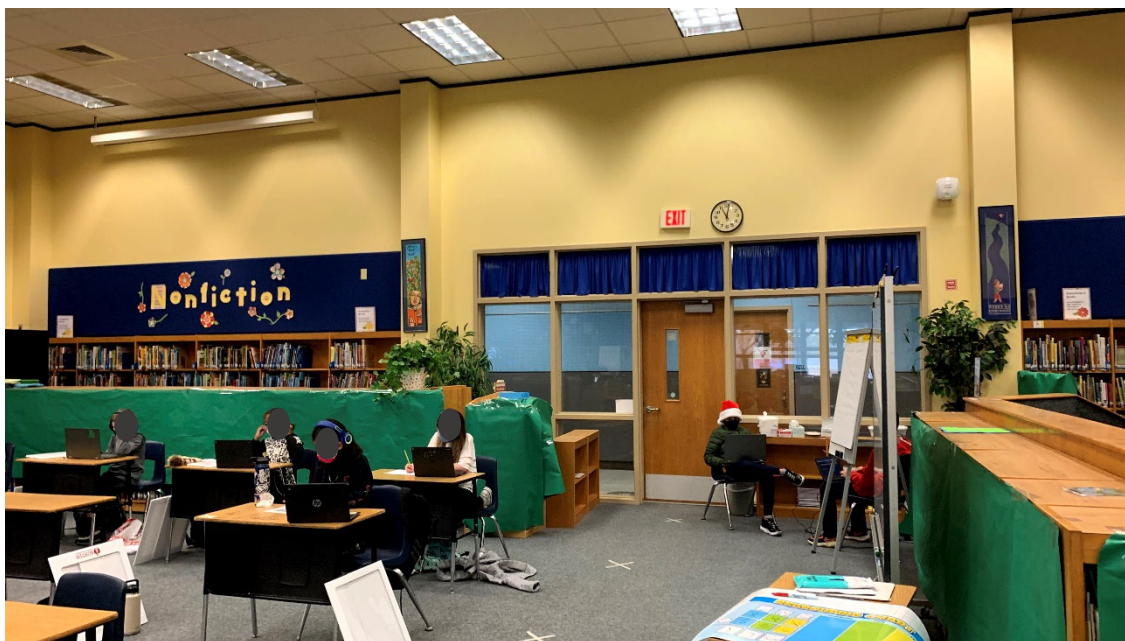
Media Center: Library is in good condition, but furniture ergonomics could be improved.

The library is easily accessed by a short corridor from the main entry vestibule. The interior is a large, open space with high ceilings and adequate daylight. Two breakout rooms are being used for other functions but could support small groups or quiet study.

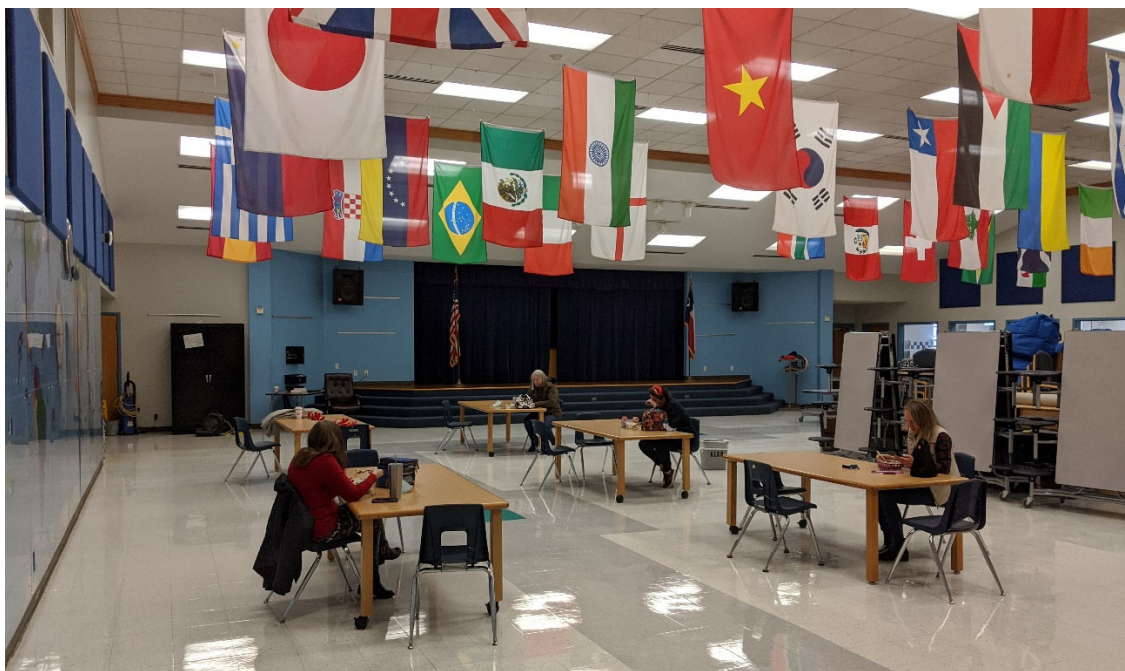
Food Services: Cafeteria is in good condition, but size does not meet Ed Spec based on current enrollment.

Cafeteria is not large enough for student enrollment, with no variety of seating and limited opportunity for outdoor dining. Parents often eat lunch with students on a covered deck between the school buildings, but upgrades would help this space function better. There is no natural light or views from within the cafeteria.

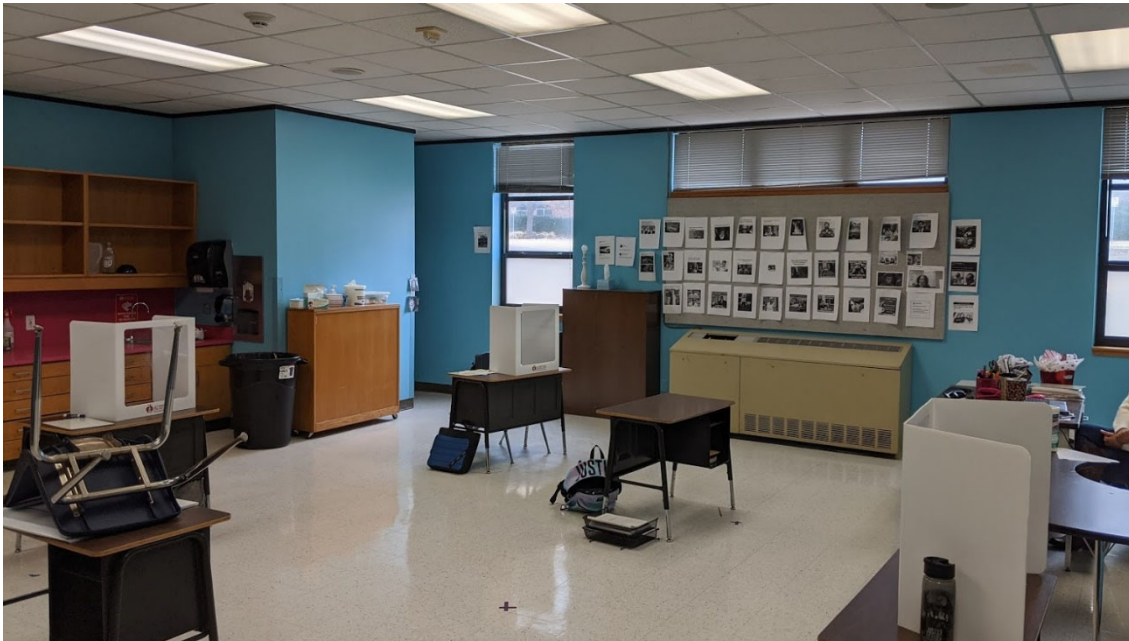
Most studios have ample daylight. Furniture is dated and in average condition.

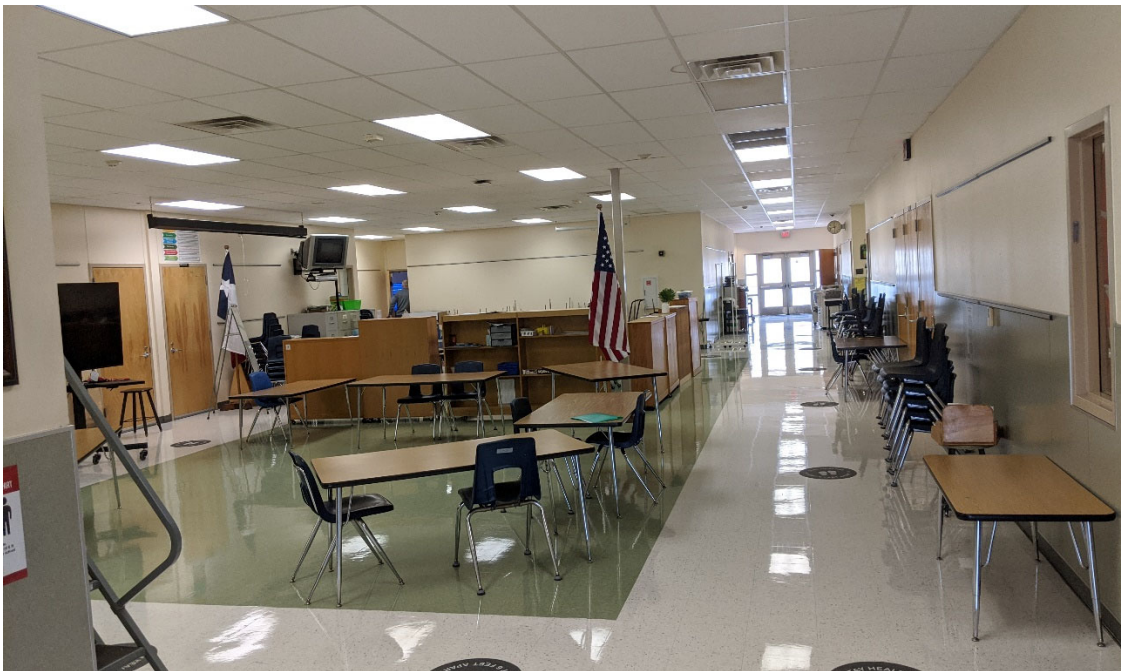
Annex Building: A central, open breakout space flanks studios in the annex building. Storage of chairs/tables is an outcome of Covid-19 protocols, but in general furniture is not flexible to allow for quick reconfiguration of space. This space is used daily. Built-in technology (i.e., large TVs on wall) is dated and not used.

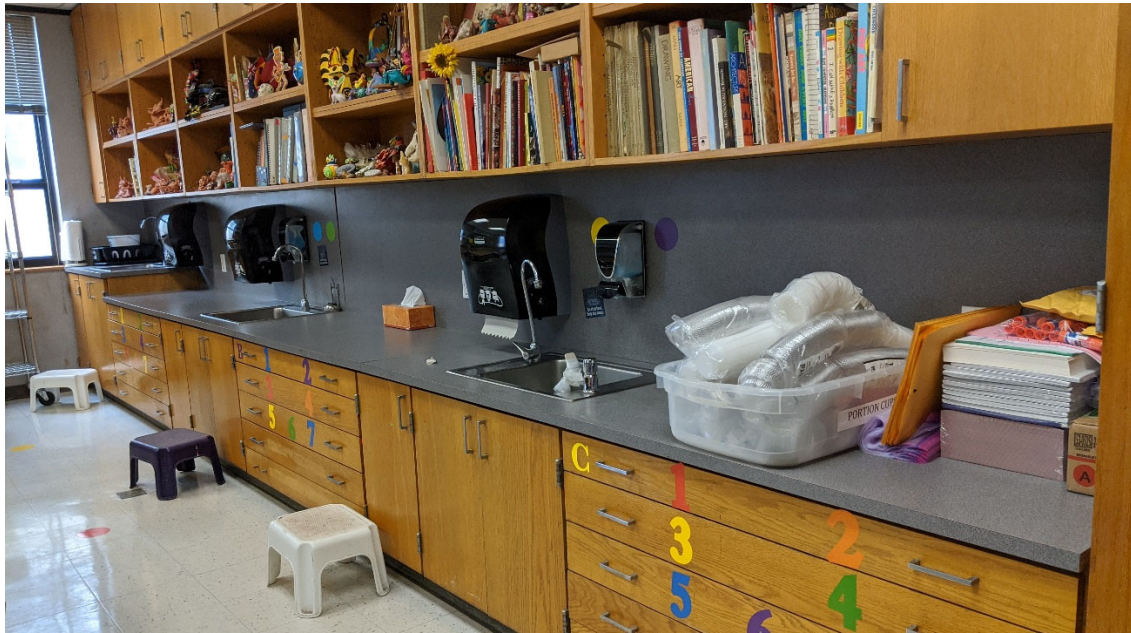
Visual and Performing Arts: Art room is well-organized and has ample storage.

The main art room and music room are equipped with a restroom and storage. Music has good proximity to the performance space in cafeteria. The cafeteria stage does not have accessible access and lacks adequate storage.

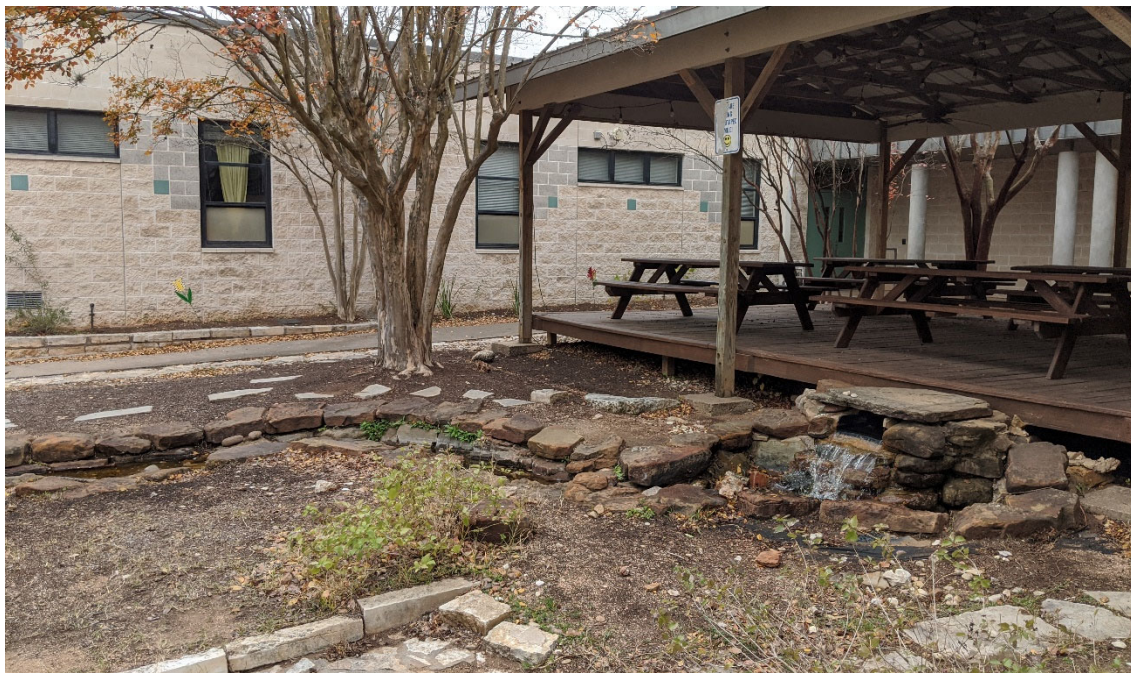
Outdoor Dining and Stream: A covered patio serves as a touchdown lunch area for students and parents.

The outdoor play spaces are in good condition. The school has two playscapes. One has shade, and the other does not. The learning garden needs updates and is in poor condition. There is an outdoor patio (covered with picnic tables) for outdoor dining. It is not currently used as an outdoor studio.
