Educational Suitability Summary Report

McBee Elementary School

Date: 12/15/2020

Score 72% Satisfactory

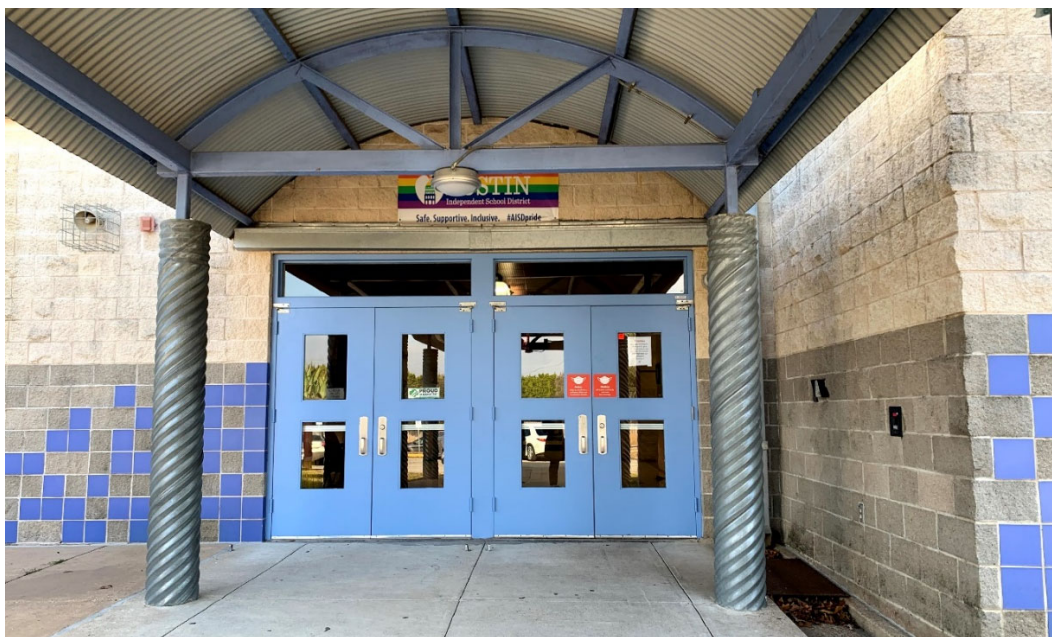
Main entrance covered by canopy from driveway.

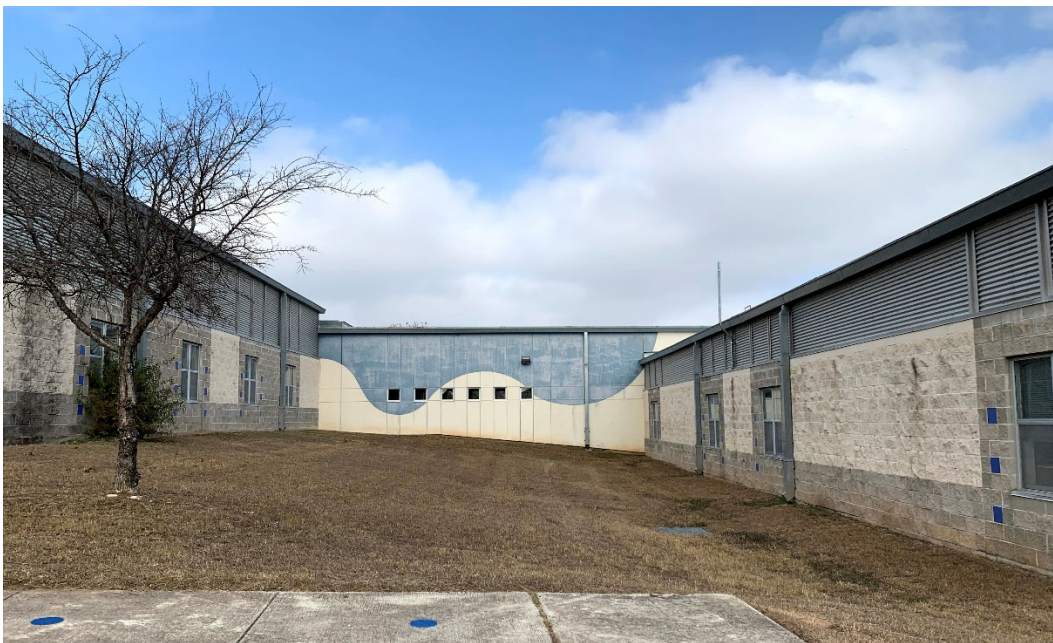
Exterior – South Façade: The studio wings create an exterior area that is not utilized currently for outdoor learning.

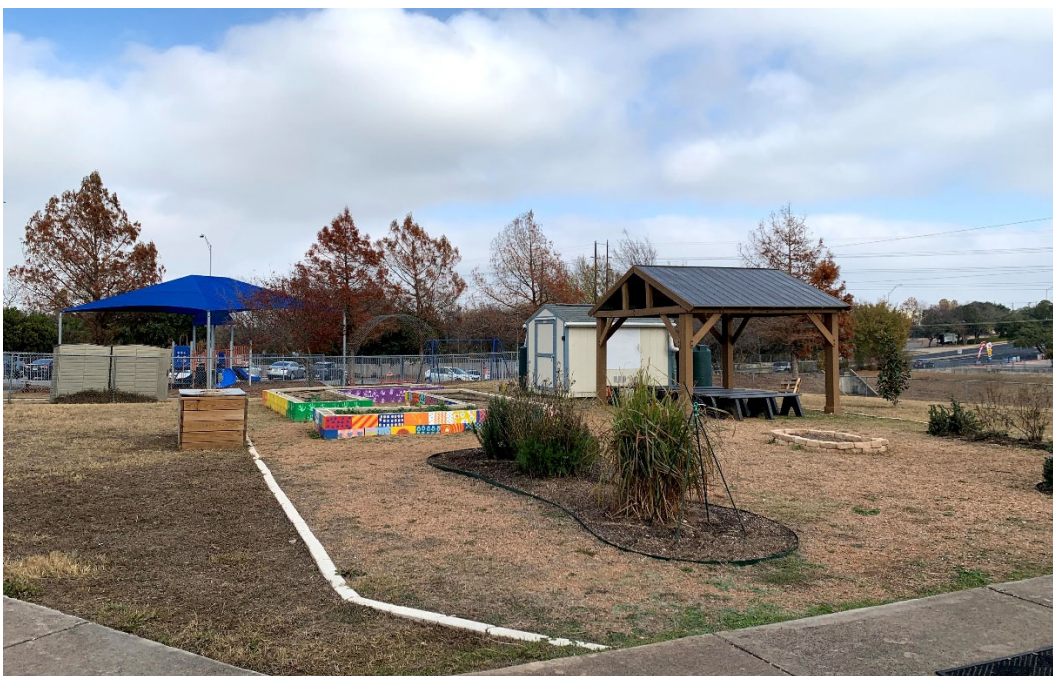
The school built its own outdoor learning space/shelter and maintains the gardens. They take great pride in this area.

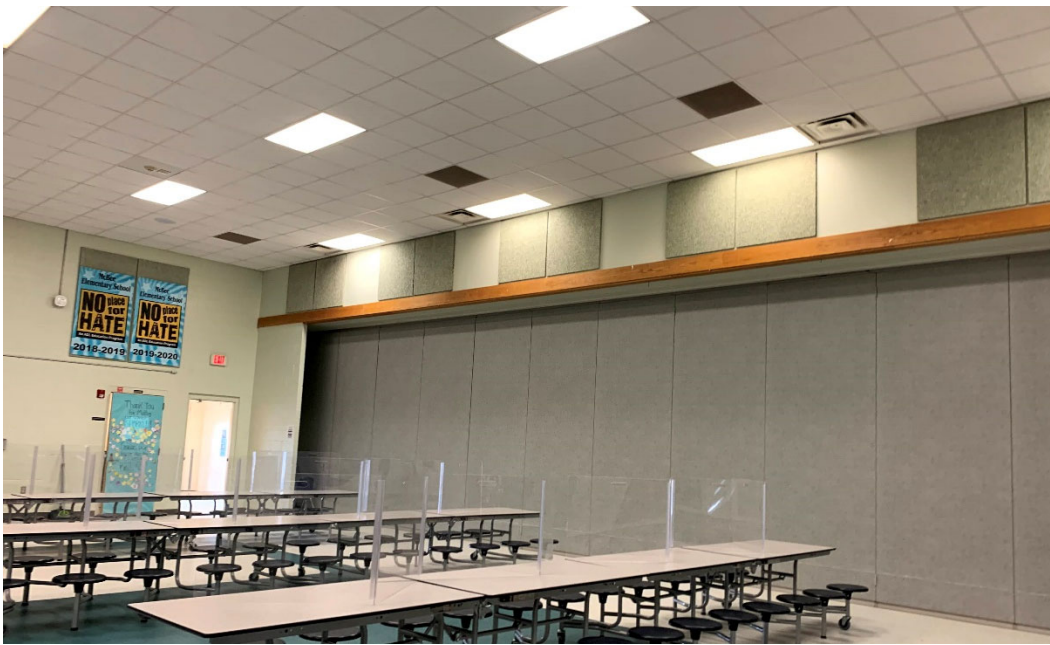
The cafeteria is adequately sized and has a movable partition separating it from the gymnasium. This provides for flexibility but compromises acoustics.

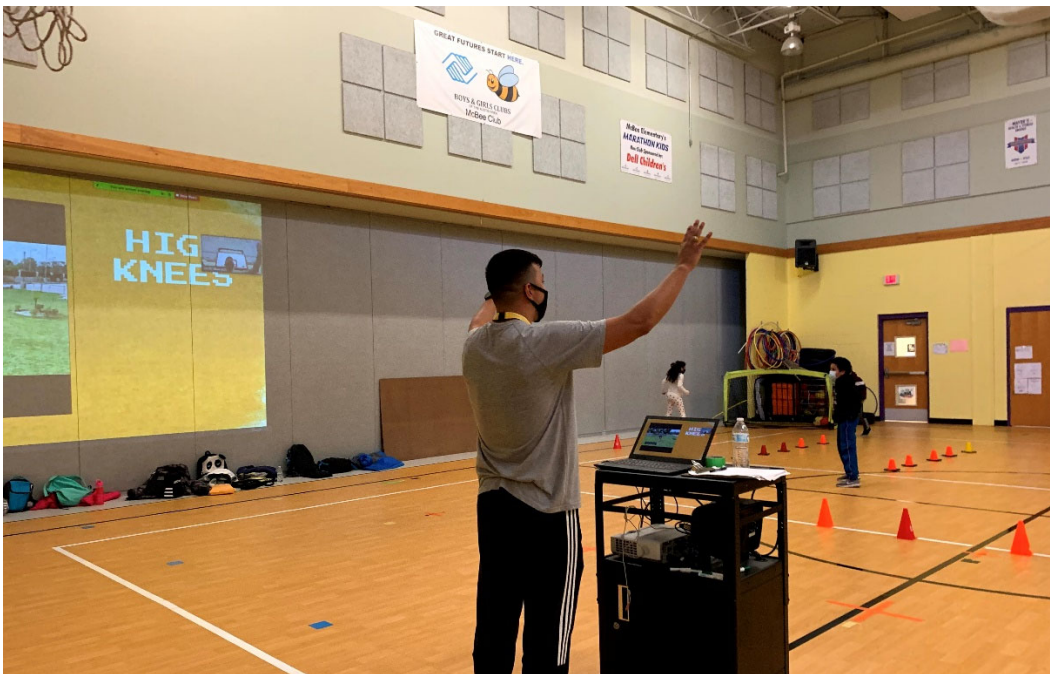
The gym is in great condition and serves its purpose well. It cannot be accessed independently from the exterior for school-related or other events.

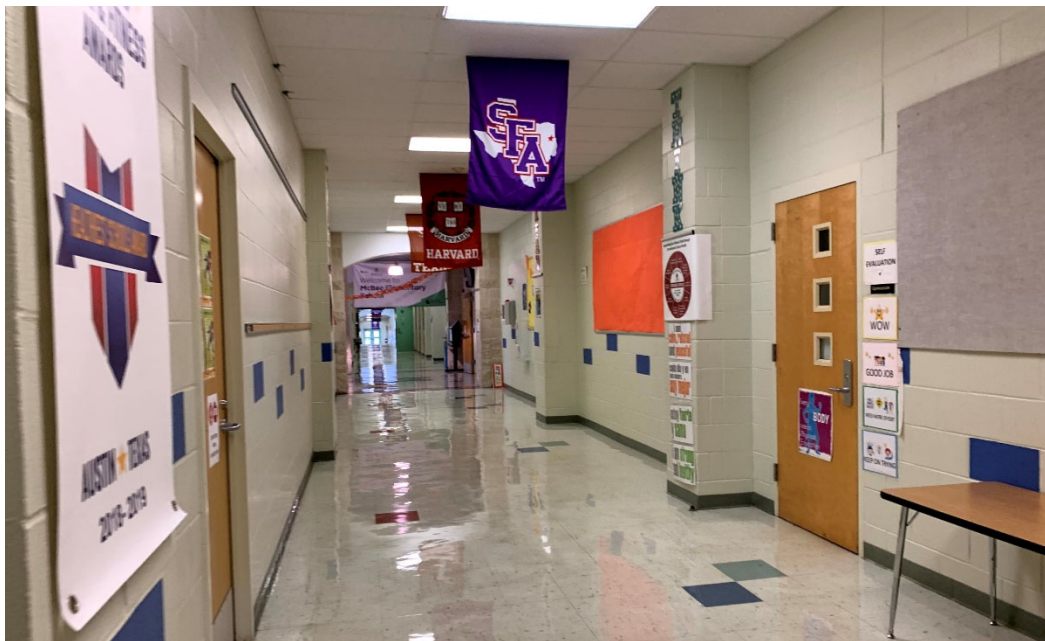
Typical Hallway: The display of art, aspirational college flags and school pride is abundant, although signage and wayfinding could be improved. There is limited visibility from the studios.

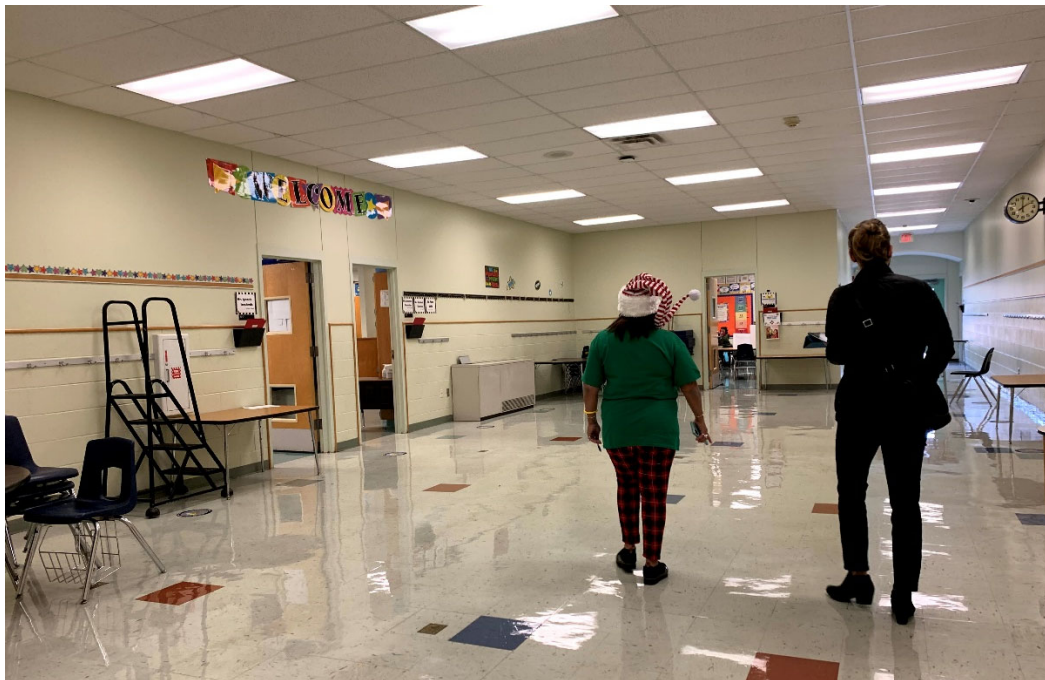
Collaboration Space: One of two in the school, this space is used every day by students and extracurricular groups. The school could use more spaces like this.

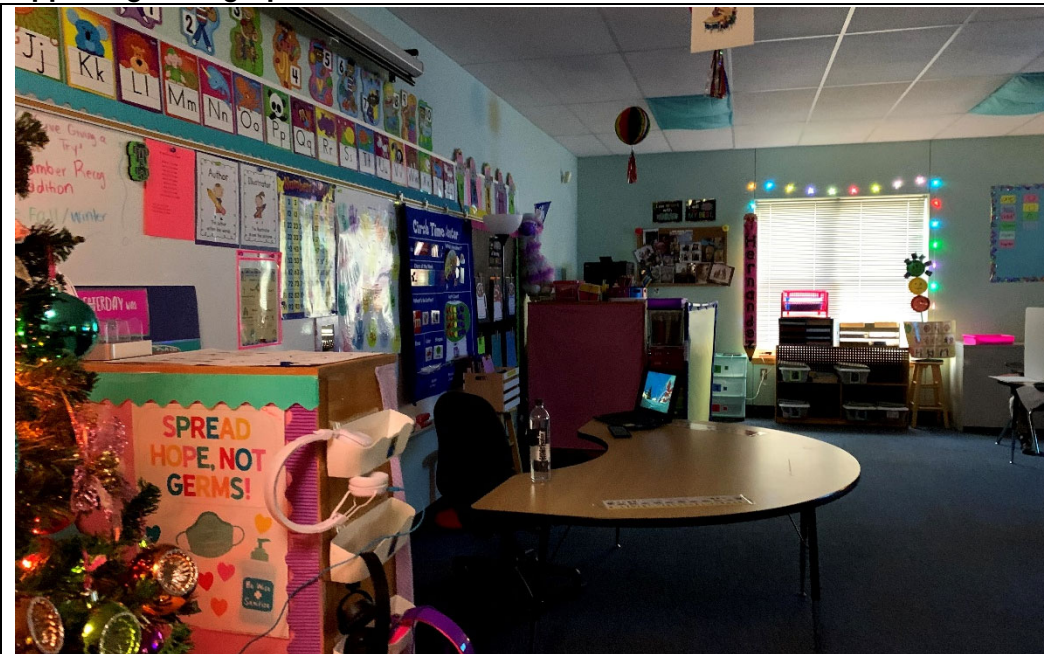
Typical Studio: Due to the shape of the building, all studios have access to daylight and views. The studios are adequately sized; however, the school could benefit from smaller breakout spaces.

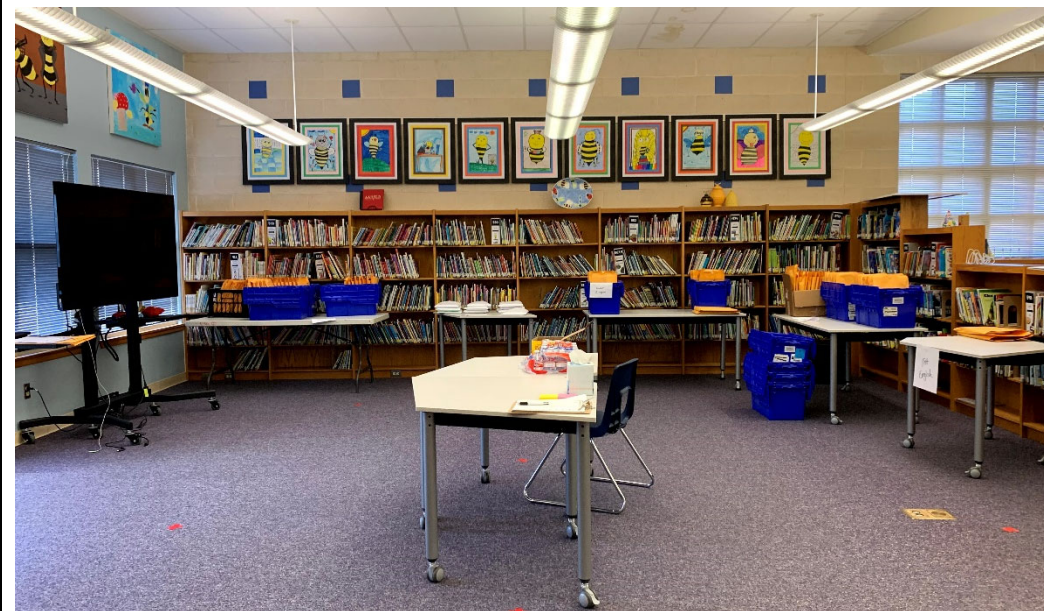
Media Center: There is a good mix of furniture types; however, the chairs are all one size. There could be additional space for accessible seating in the reading area.

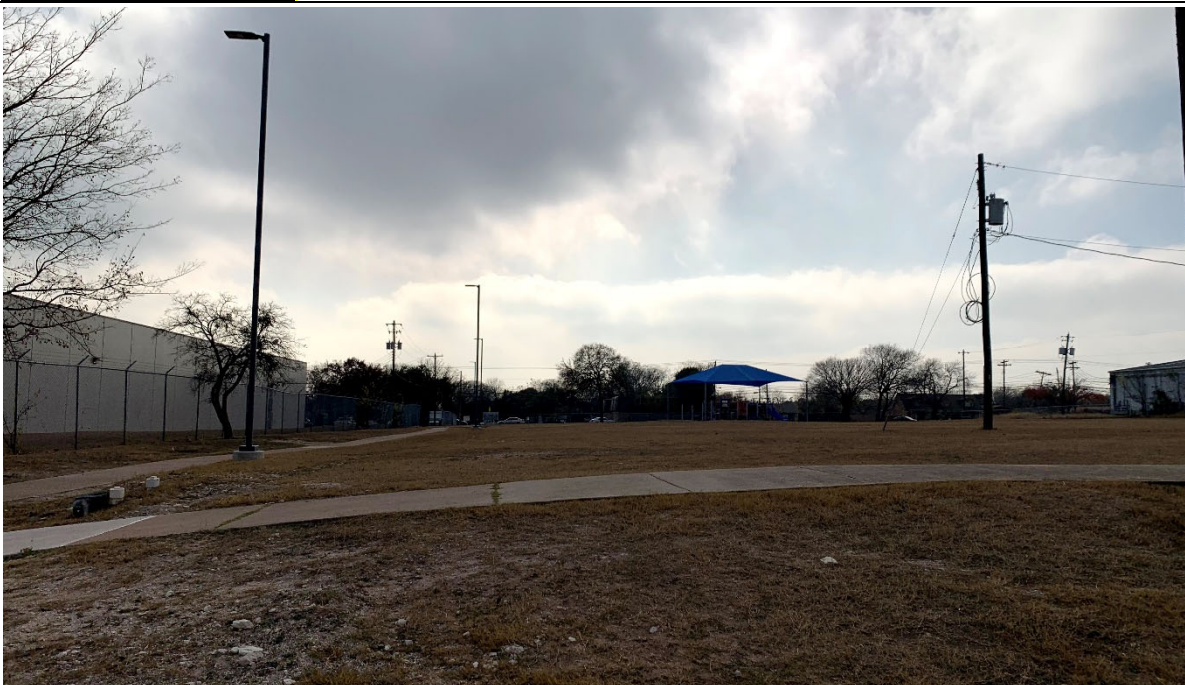
The detached field across the back drive serves as a recreation space.

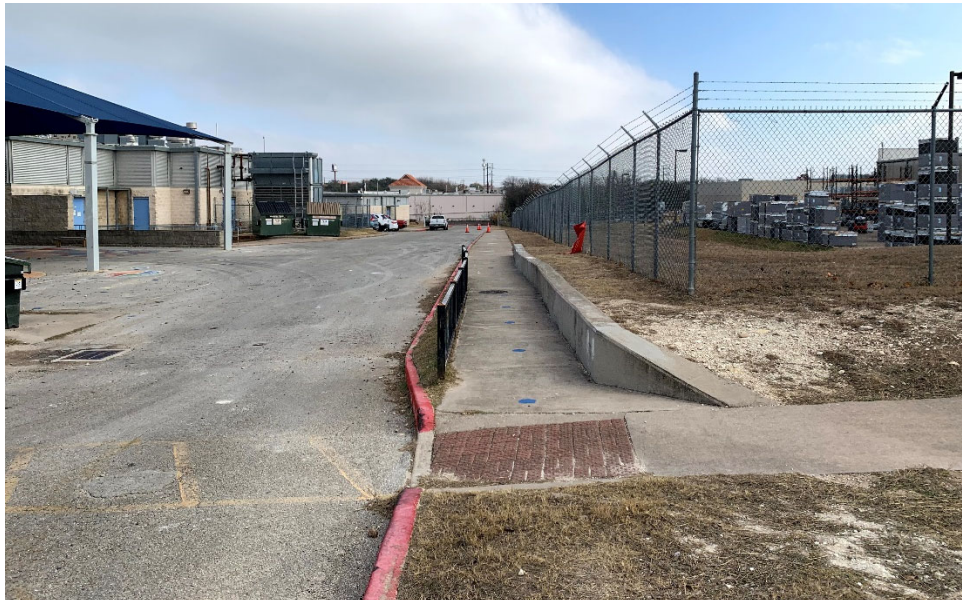
South Driveway: The school must use the south driveway for drop-off and pickup since the main drive is located off Braker Lane. It works, but it is not ideal.

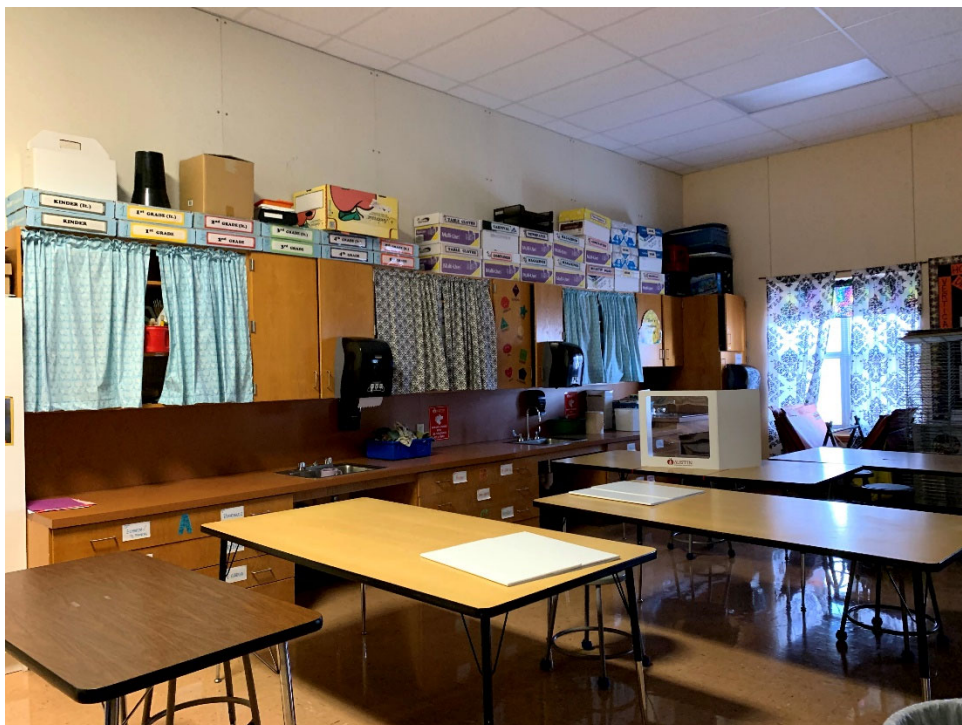
Art Studio: Storage is dated but adequate. Sinks are provided.
