Educational Suitability Summary Report

Metz-Sanchez Elementary School @ Sanchez Campus

Date: 2/1/2021

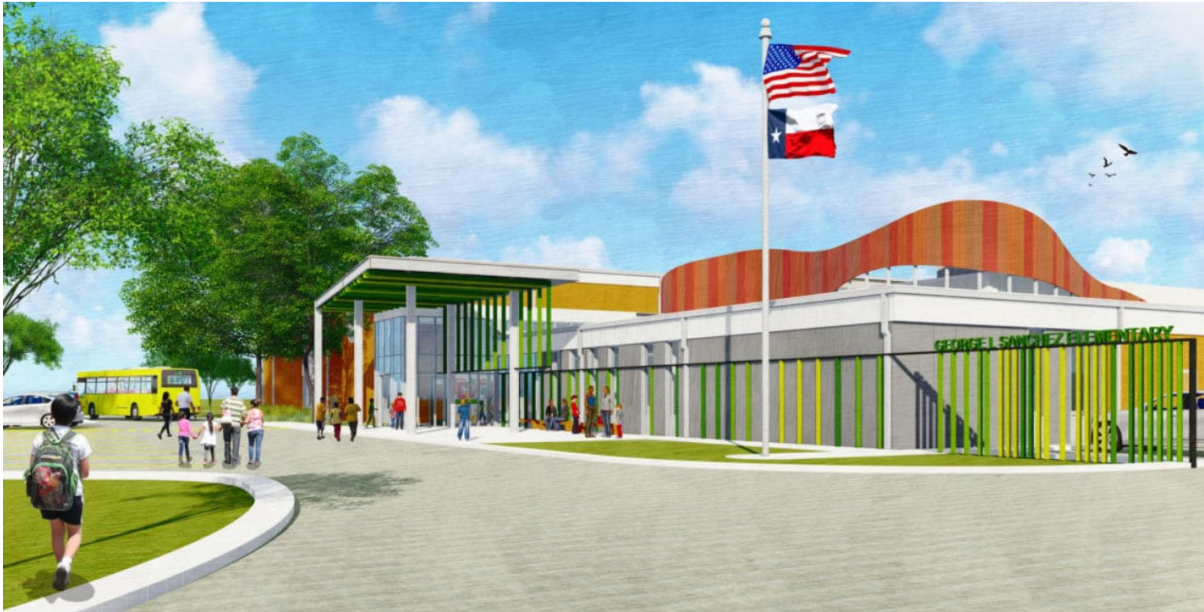
New entry with additional glass and openness provided on the exterior walls. A canopy is provided at both east and west entries.

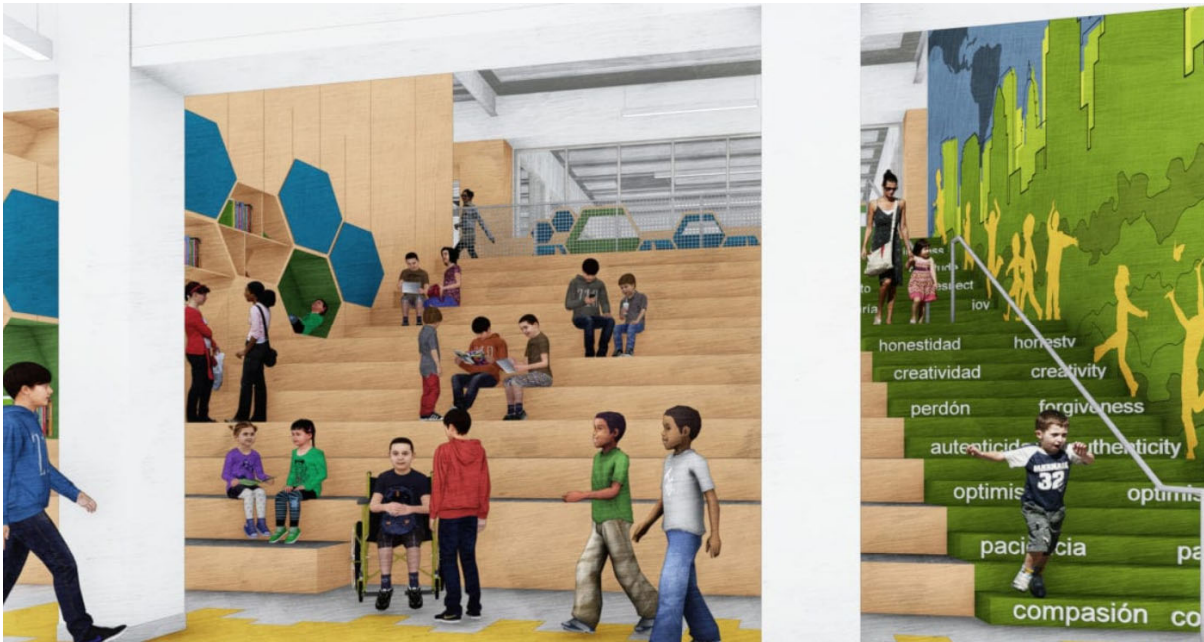
Learning stairs for large group learning. The cafeteria has a retractable partition that can open to this staircase. At the top of the stairs is the library.

The dining commons will have a retractable partition that opens to a large learning staircase connecting the ground floor to the second level. At the top of the learning stairs is the library, which will include a reading room and small group breakout rooms.

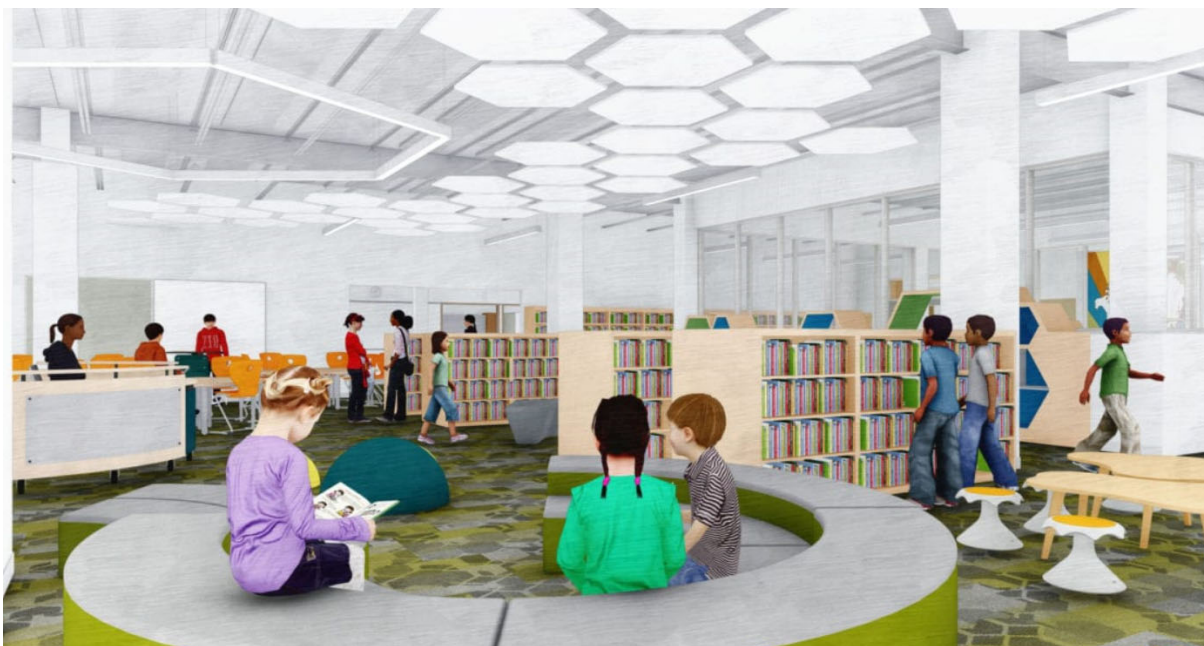
Media Center will have a variety of seating options.

The library is adequately sized with one large open area, and moveable partitions are provided on the east and west of Reading Room to allow for the space to open to collaborative areas. There are small group rooms adjacent to the library that can accommodate smaller groups or individuals for quiet study.

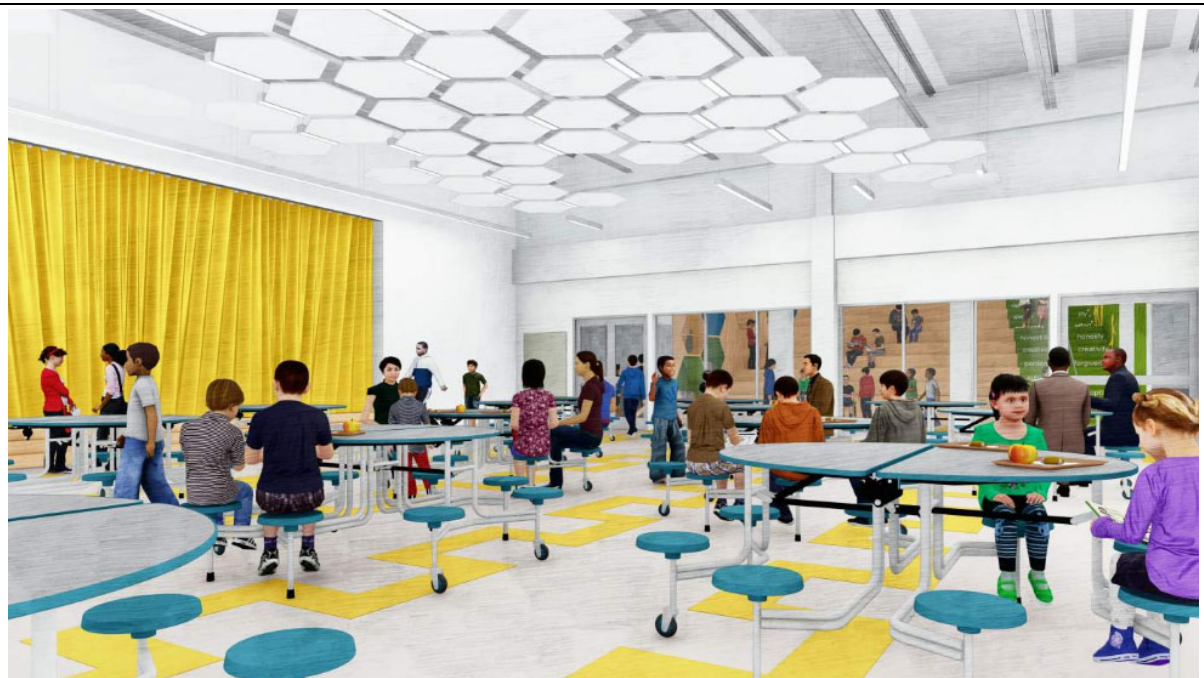
Dining Commons: Flexible furniture and transparency to learning stairs beyond.

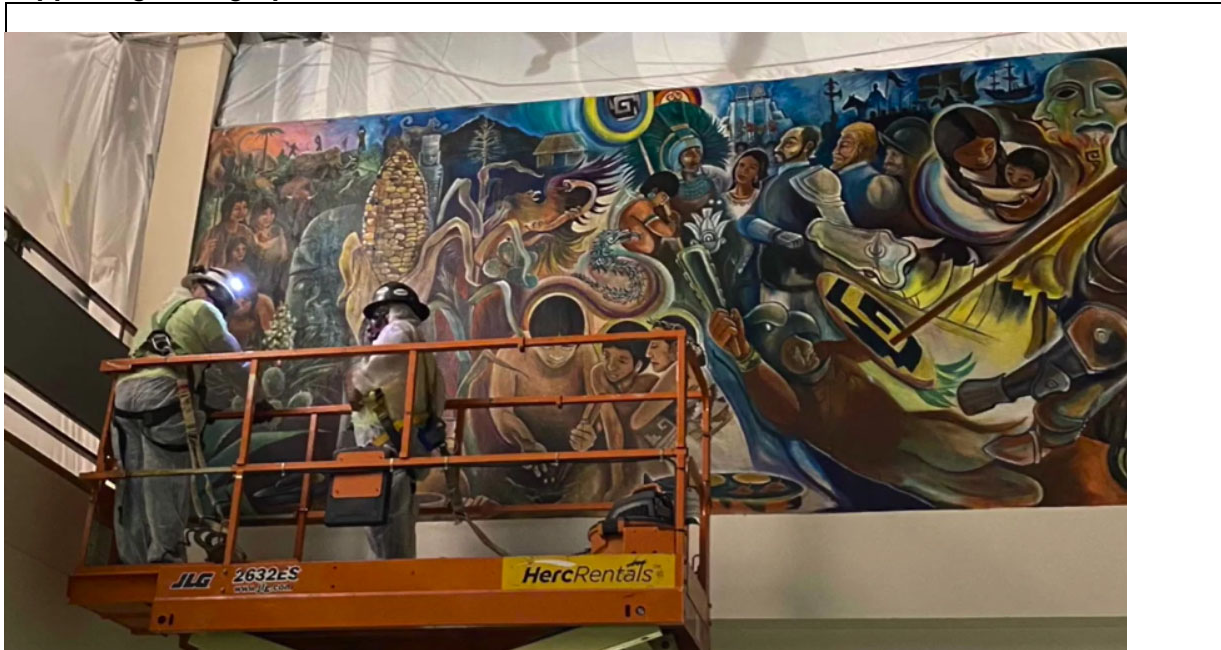
Existing murals by Raul Valdez depicting the school's Hispanic history and heritage being removed for installation at the new Sanchez campus.
