Educational Suitability Summary Report

Palm Elementary School

Date: 01/26/2021

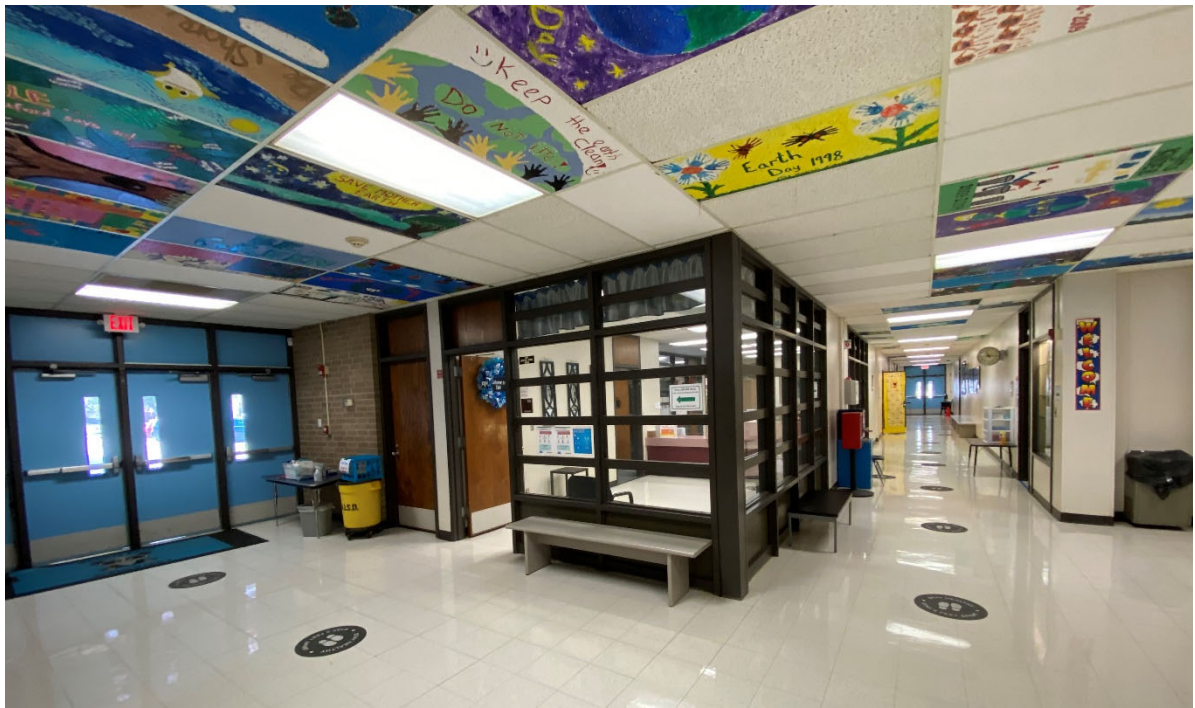
The main entry is bright and colorful with painted ceiling tiles.

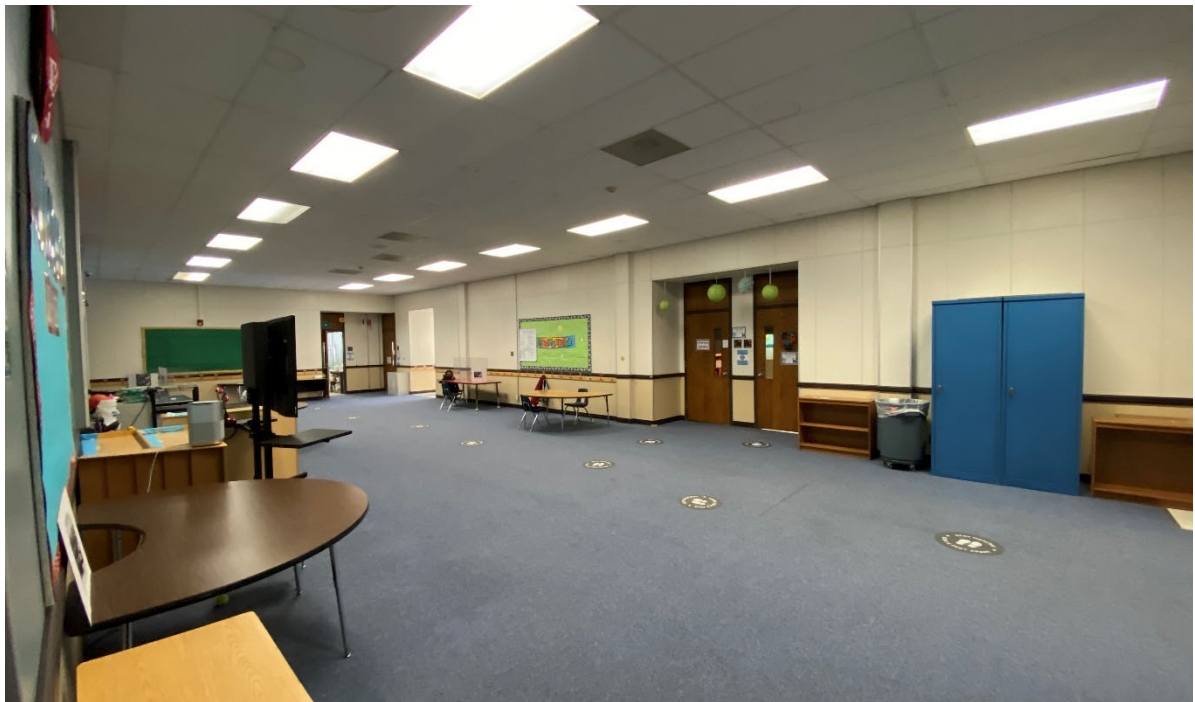
The studio wings of the original building have a large, shared flex space in the corridor for each grade level to gather.

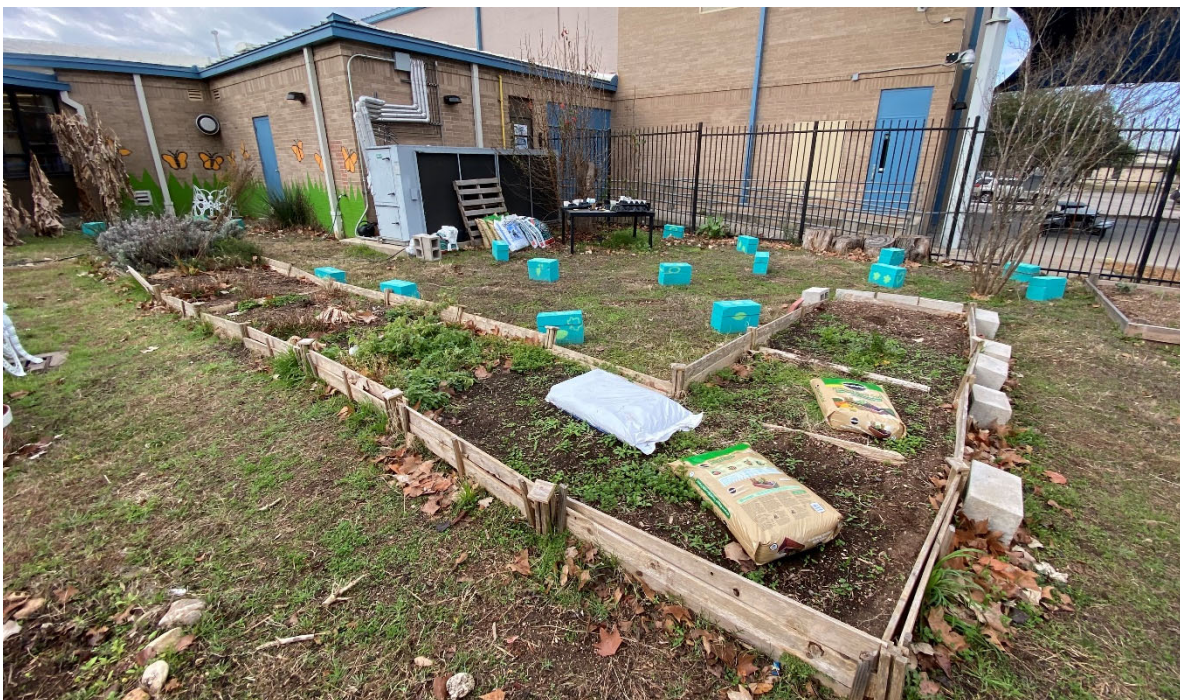
Outdoor Learning and Activity: A large, fenced garden area has stools for outdoor learning and close access to water.

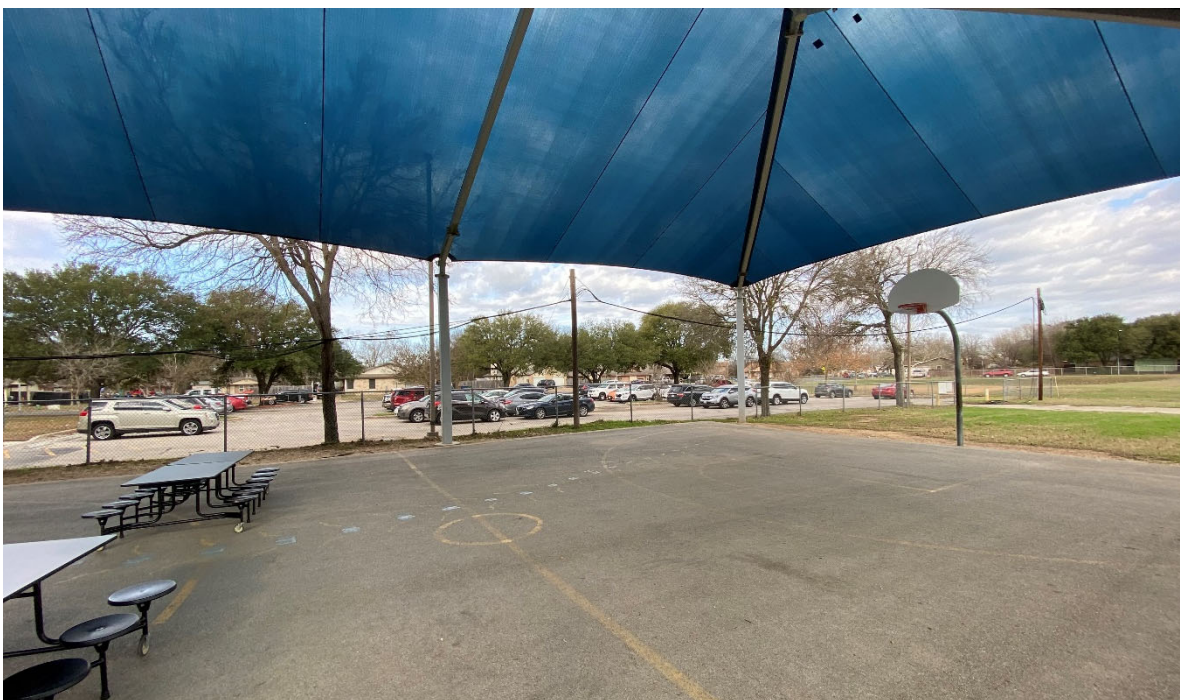
Outdoor Learning and Activity: Large outdoor courts with a canopy cover are located directly off the gym with easy access to other outdoor activity areas.

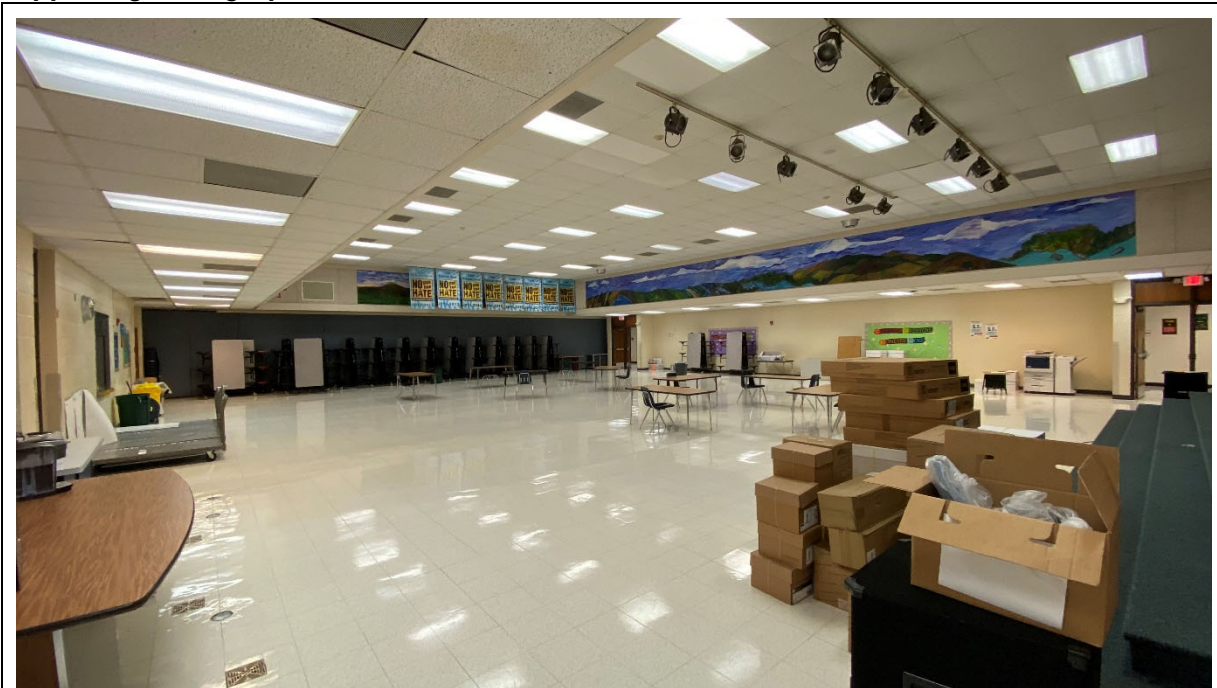
The cafeteria is appropriately sized but has no access to natural light or outdoor dining opportunities. It is connected to the gym with an operable wall.

The cafeteria is appropriately sized and connects to the gym with an operable wall. There is only one seating type available and no access to natural light.

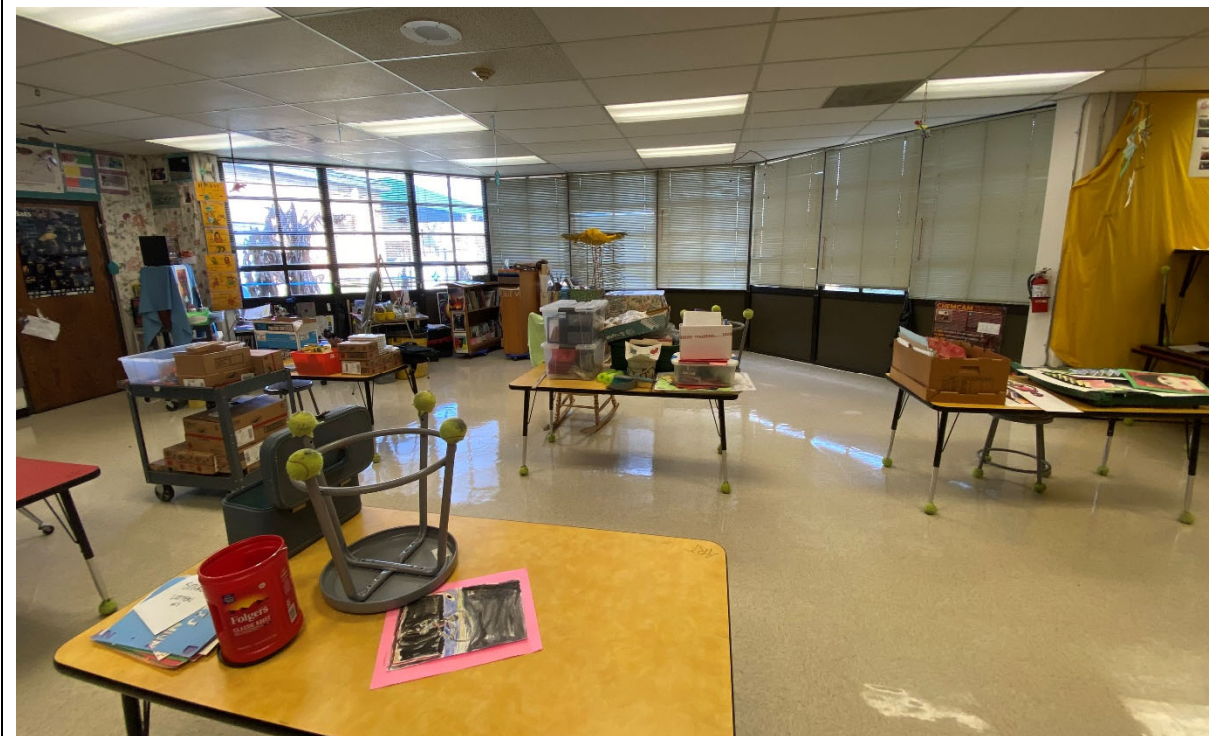
Large art studio has adequate storage closet space as well as a kiln and three sinks.

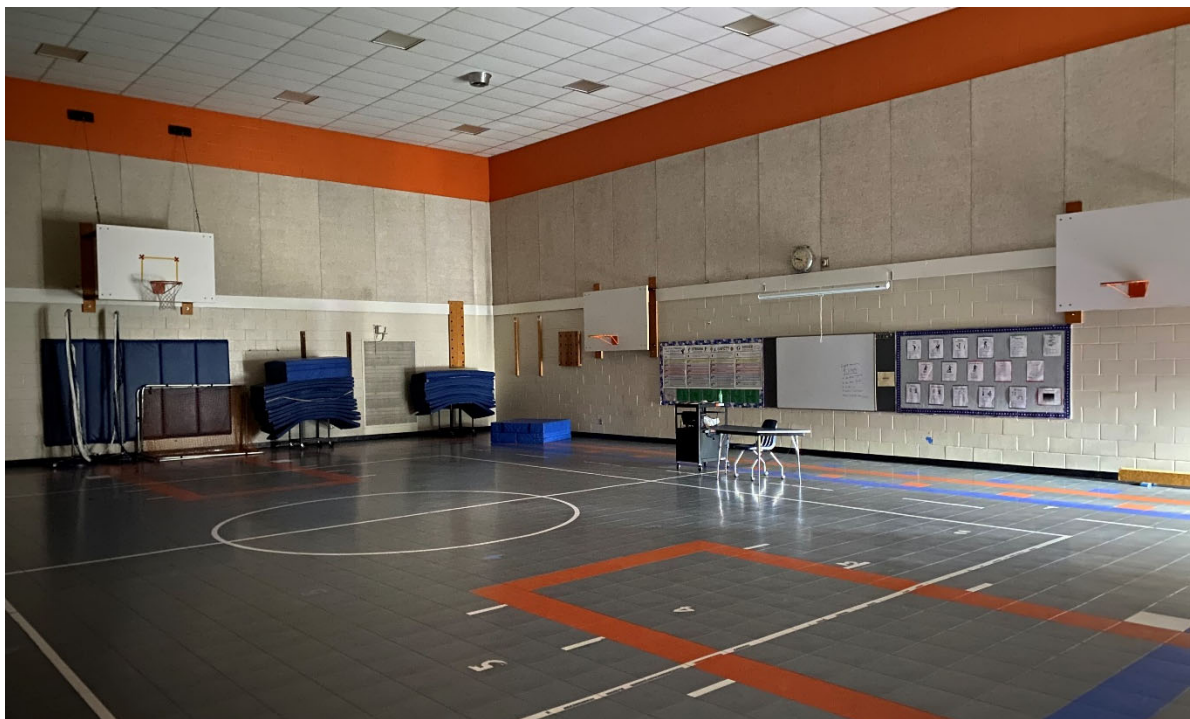
The gym is appropriately sized, but flooring is aged. Coaches' office and storage are small and disconnected as they are located across the hall. A projection screen and mobile projector as well as markerboards and tackboards are present for teaching.

The gym is appropriately sized and equipped with a projection screen, as well as other teaching instruments such as markerboards and tackboards.

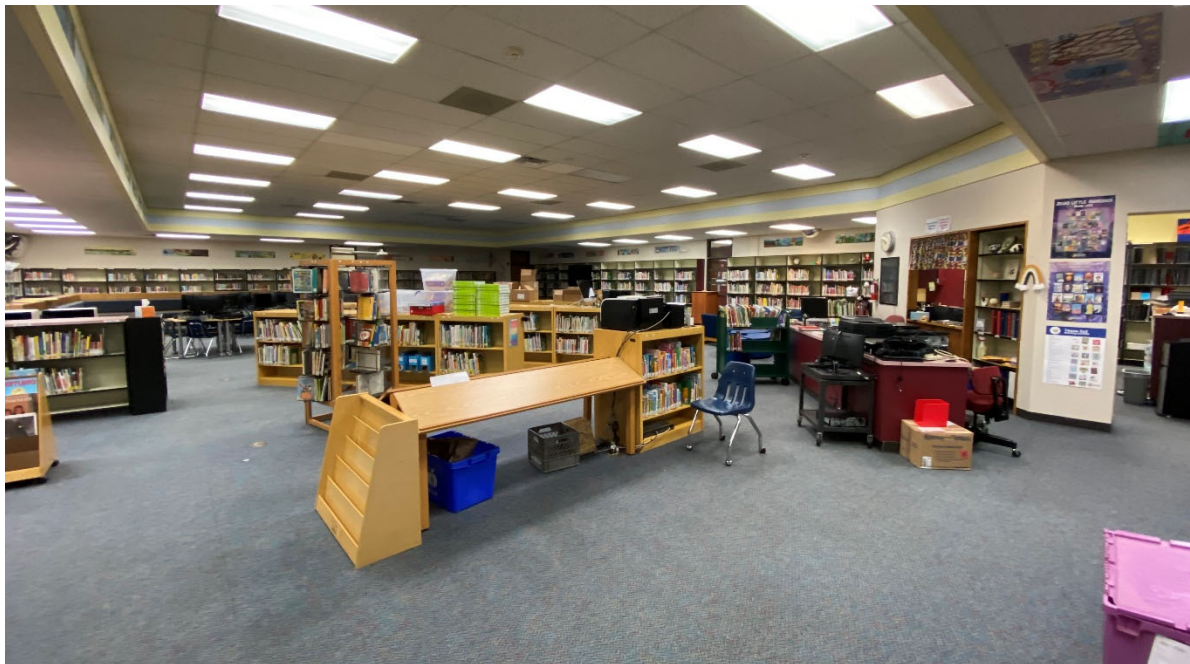
Media Resources: The library is generously sized but lacks flexible furniture and book stacks for easy reconfiguration.

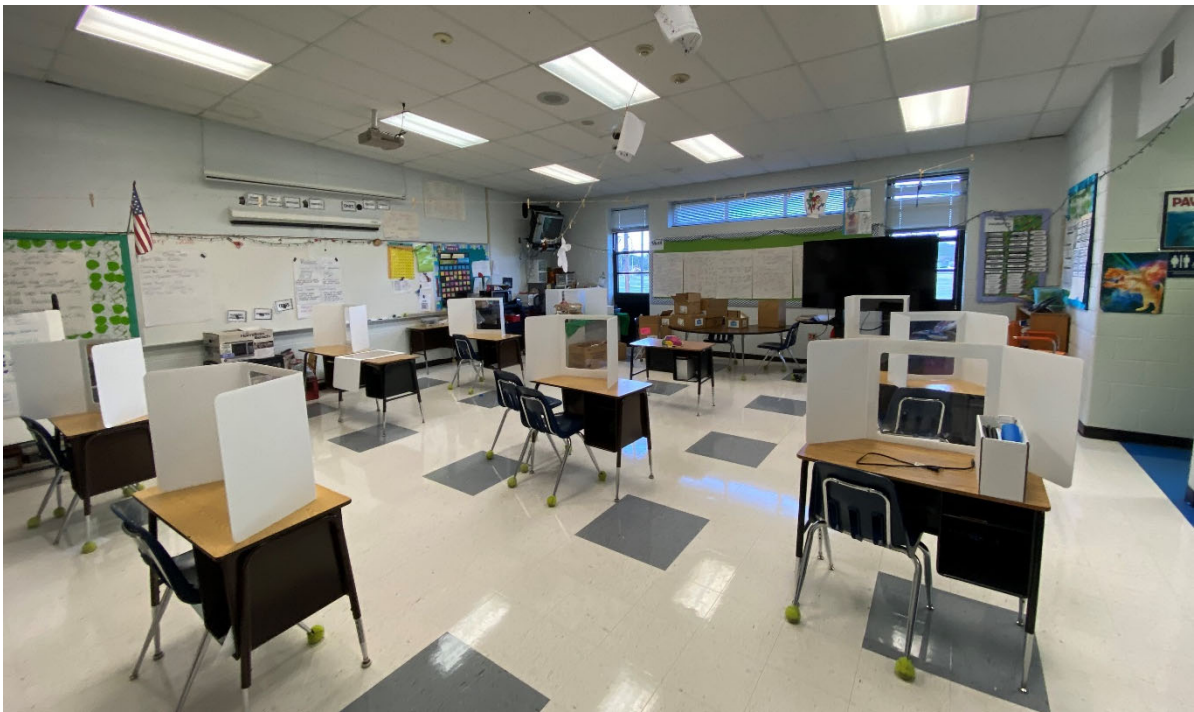
All studios have windows with access to natural light and views of nature and are equipped with projection and mobile TV displays.

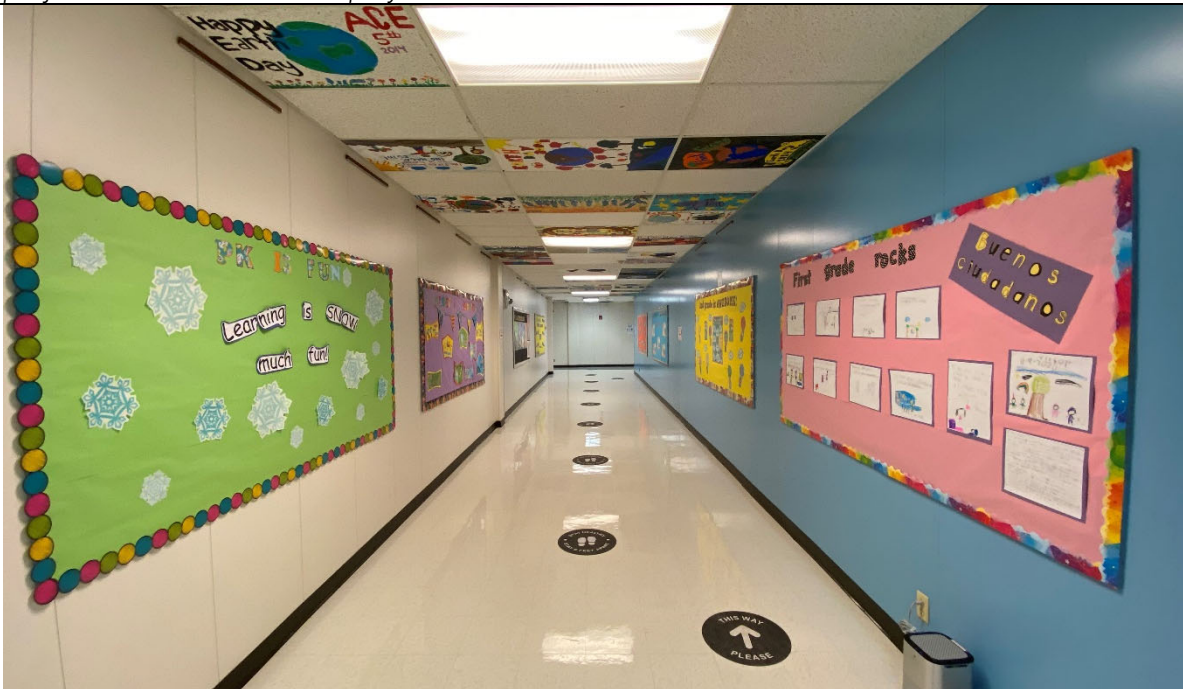
Corridors are an adequate width, and there are many opportunities to display student work on walls throughout the campus.
