Educational Suitability Summary Report

Patton Elementary School

Date: 12/07/2020

Score 63% Average

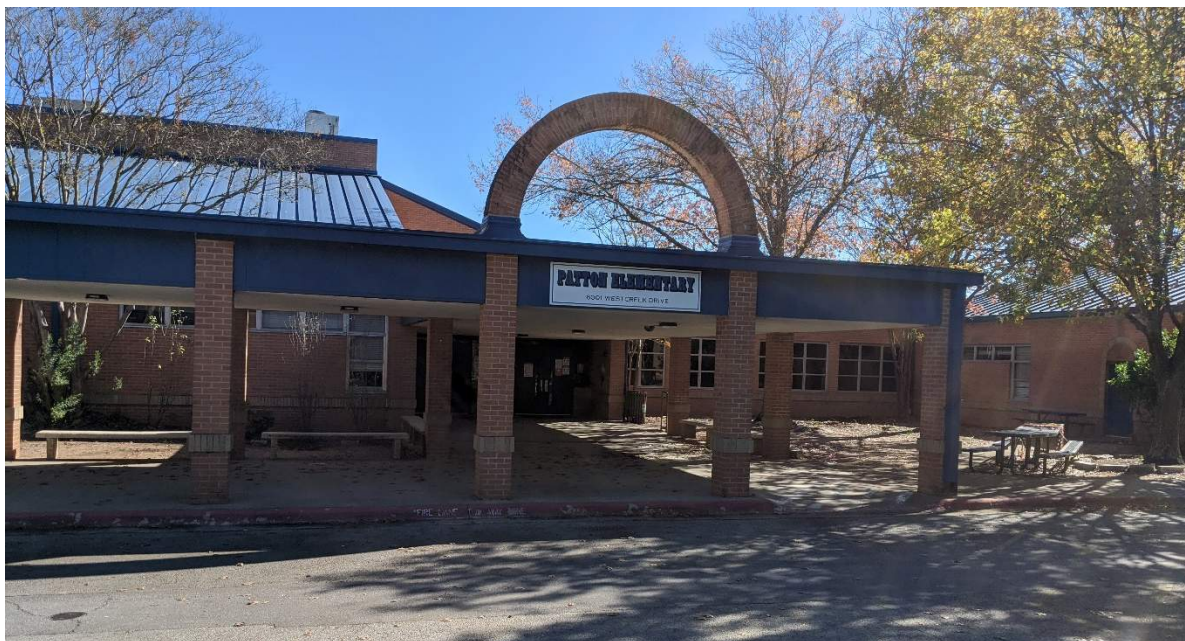
Main entry has good building identification.

| 1 - Exterior | | 1 | 2 | 3 | 4 | 5 | N/A | 8.75 | 43% | |
|---|---|---|---|---|---|---|---|--|---|---|
| | 1 Very unsatisfactory - Campus has no signage / wayfinding | | | | | | | Good building identification but no wayfinding signage for traffic. | | |

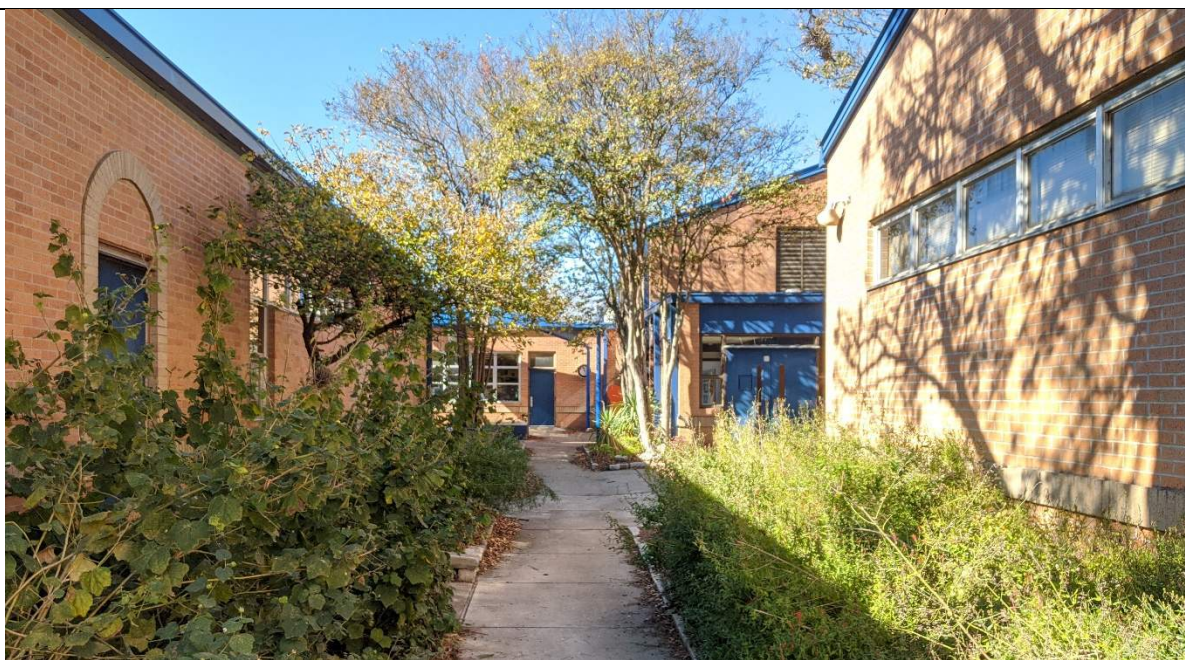
Butterfly garden.

Outdoor butterfly garden and “keyhole” gardens provide unique outdoor learning opportunities but there are no covered exterior spaces dedicated to teaching in an outdoor studio.

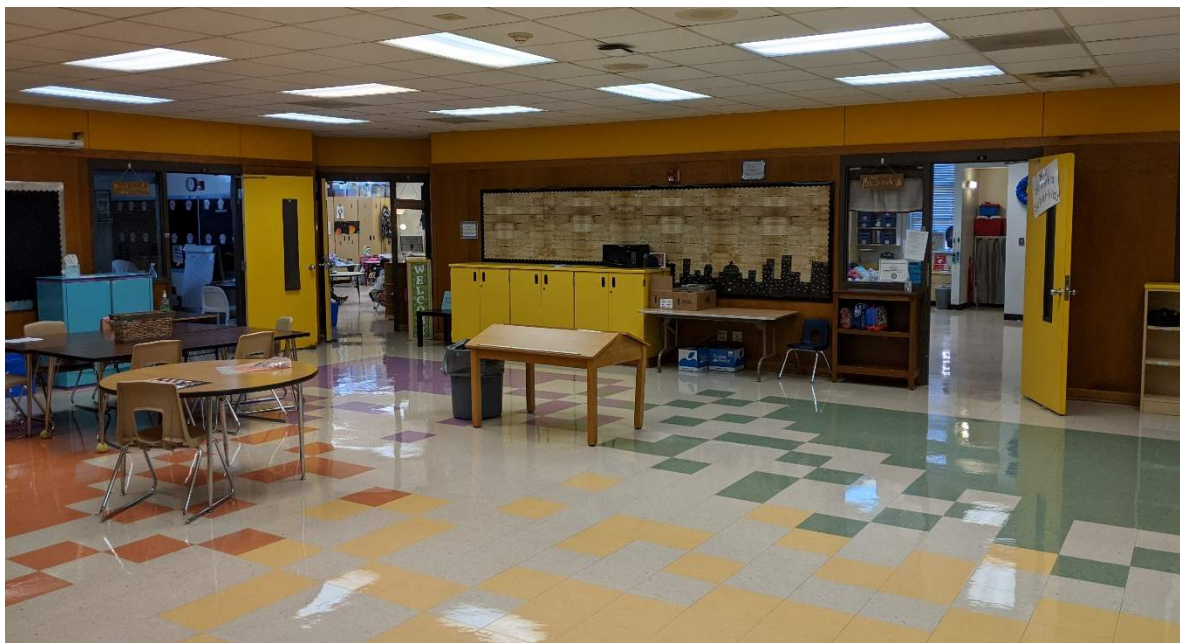
Shared commons area between cluster of studios.

The majority of interior educational spaces are studio clusters wrapped around central open flex spaces referred to as "commons" areas. All studios have large interior windows that allow high visibility from studios into the commons areas.

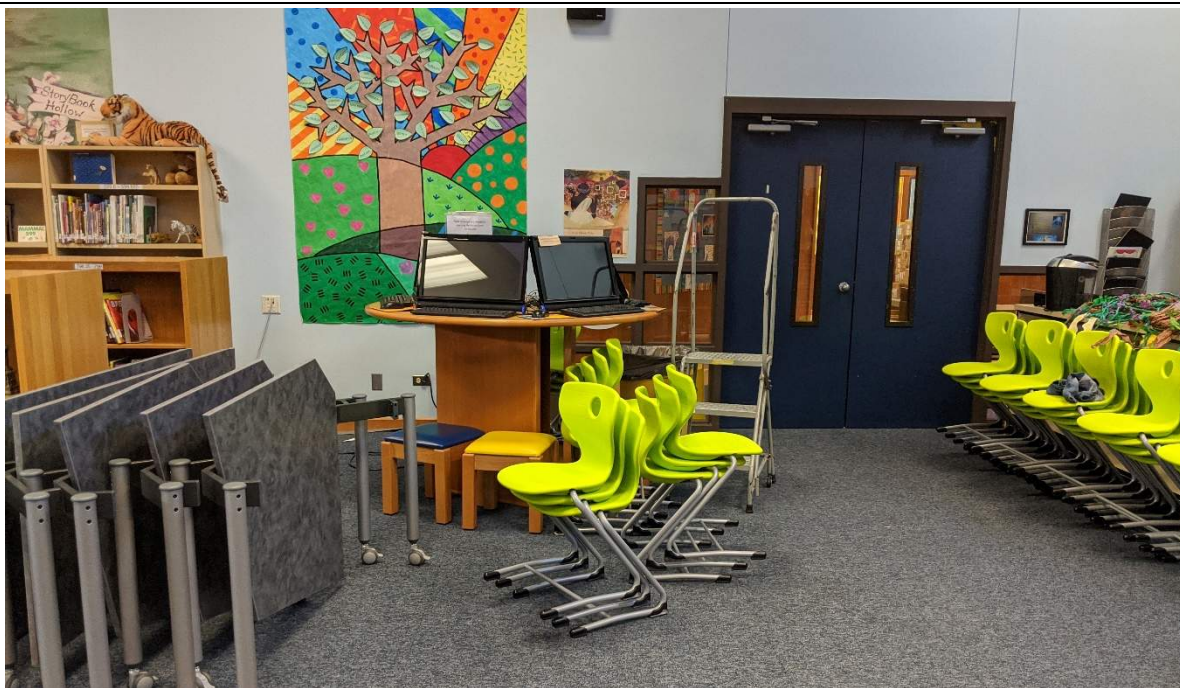
Media Resources: Flexible furniture in library.

Large, open space but bookshelves are not mobile; there is no flexibility. No enclosed small group or medium group breakout spaces. Kiva allows for tiered seating.

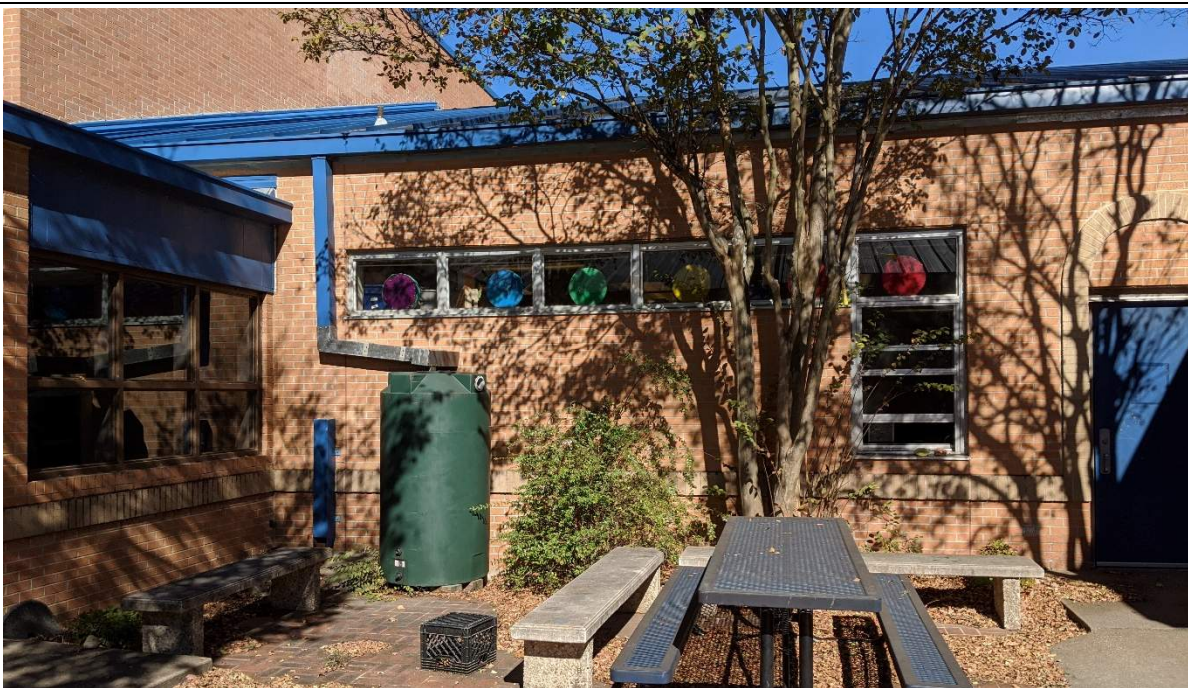
Outdoor courtyard with rain collection cistern.

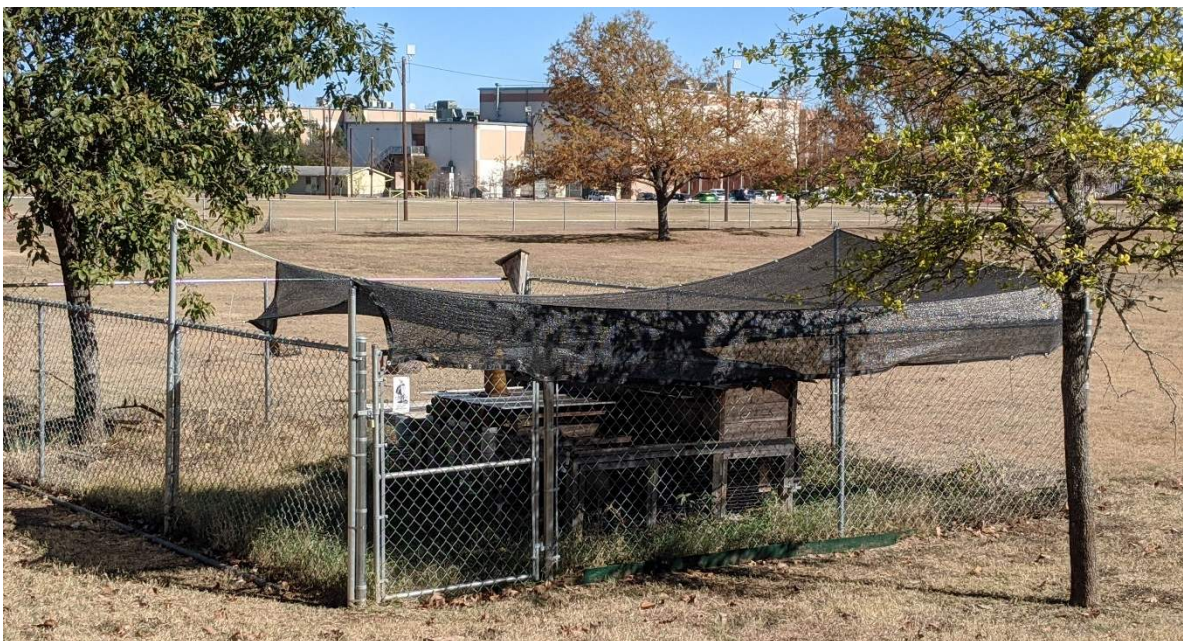
Chicken coop on campus.

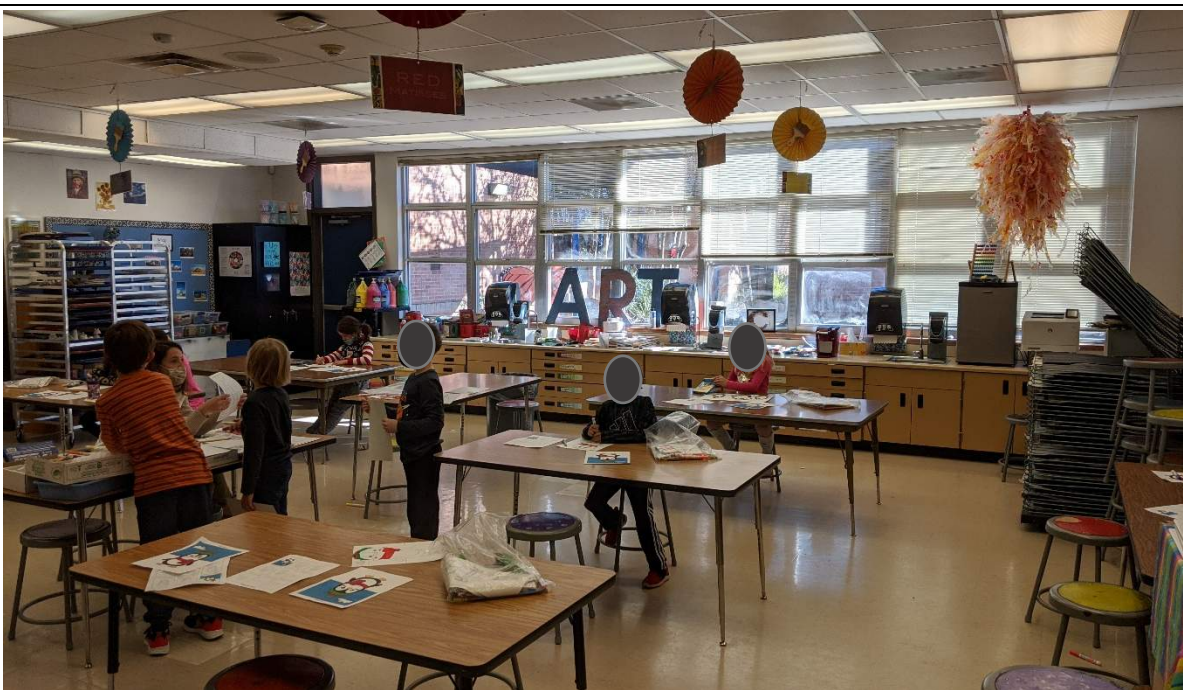
Environmental Quality: Art studio has ample windows and natural light.

All studios have windows to provide natural light and views. Artificial light is evenly distributed. No noticeable pest or odor problems.

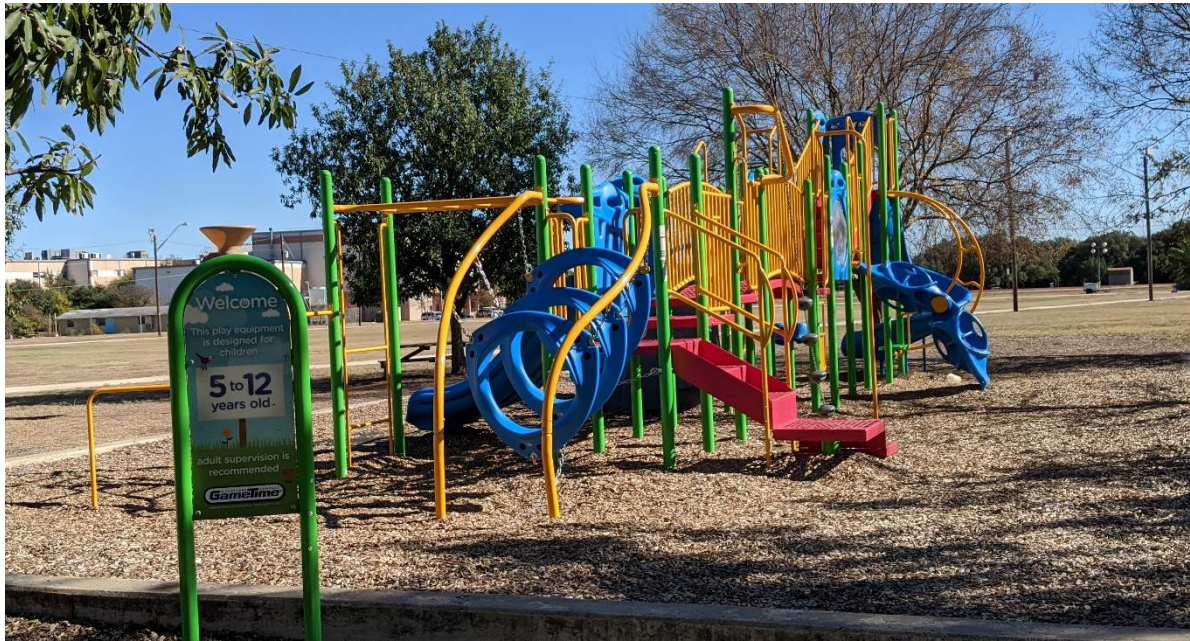
Playground in good condition but uncovered.

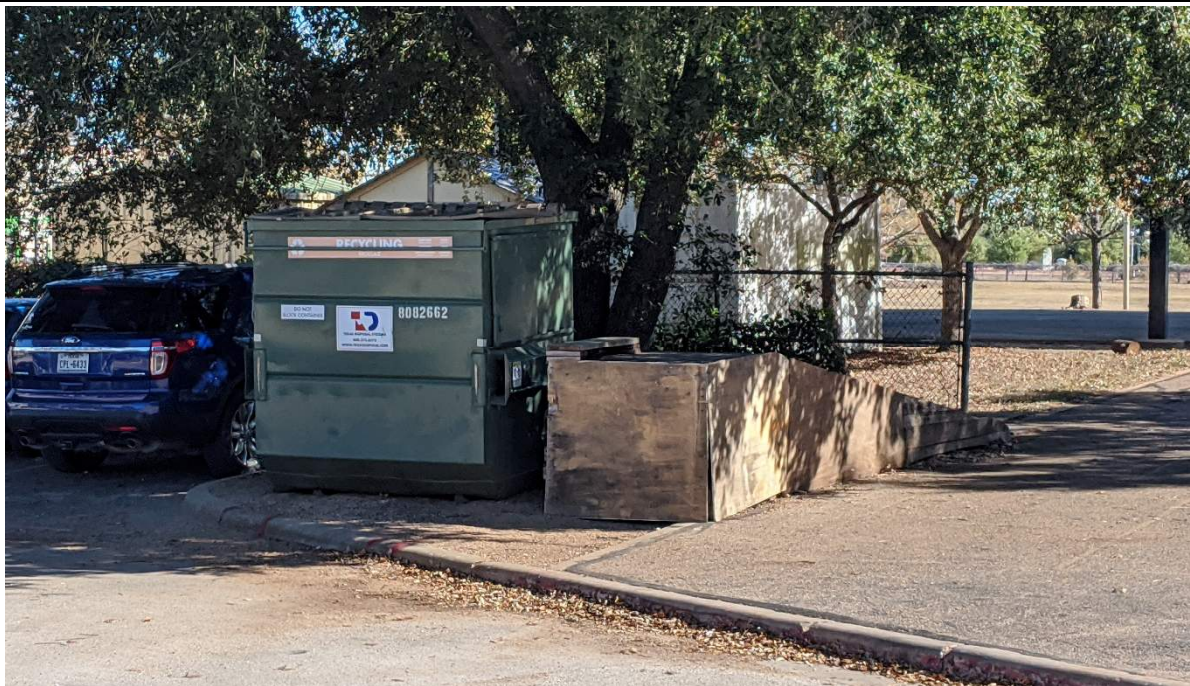
Waste bins are not accessible and makeshift ramp is required.

No queue space for parent pickup and drop-off. Lack of queue spaces causes conflict with bus and car traffic. Good building signage but no exterior wayfinding signage. Dumpsters for composting, recycling and landfill are difficult to access.

| 1 - Exterior (cont.) | | 1 | 2 | 3 | 4 | 5 | N/A | | | |
|---|--|---|---|---|---|---|---|---|---|--|
| 1 | Very unsatisfactory - No compost present, route has obstacles (stairs, curbs, barriers) to dumpster | | | | | | | All dumpsters provided but not easy access. | | |
