The Educational Suitability Assessment of Rodriguez Elementary School earned a 56% overall score and places the campus in a category of Average. The assessment consists of seven General Building categories and seven Academic categories to determine areas that need more attention.

Educational Suitability Summary Report
Rodriguez Elementary School

Austin ISD Educational Suitability Assessment Criteria

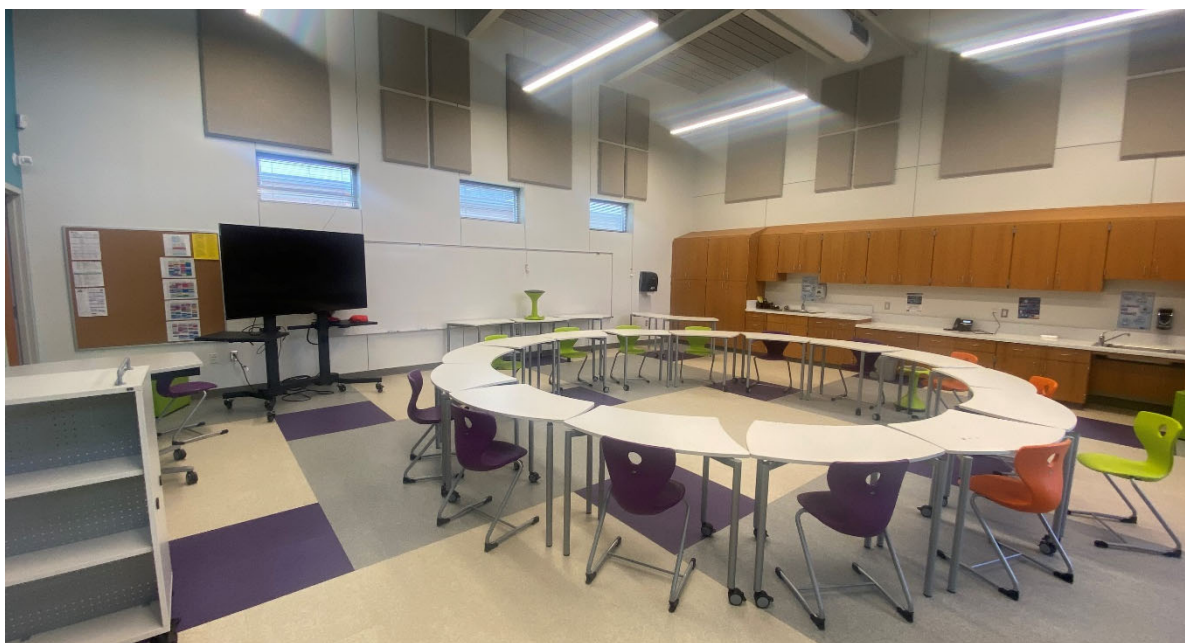
Multipurpose room is well equipped with sufficient room, flexible furniture and storage.

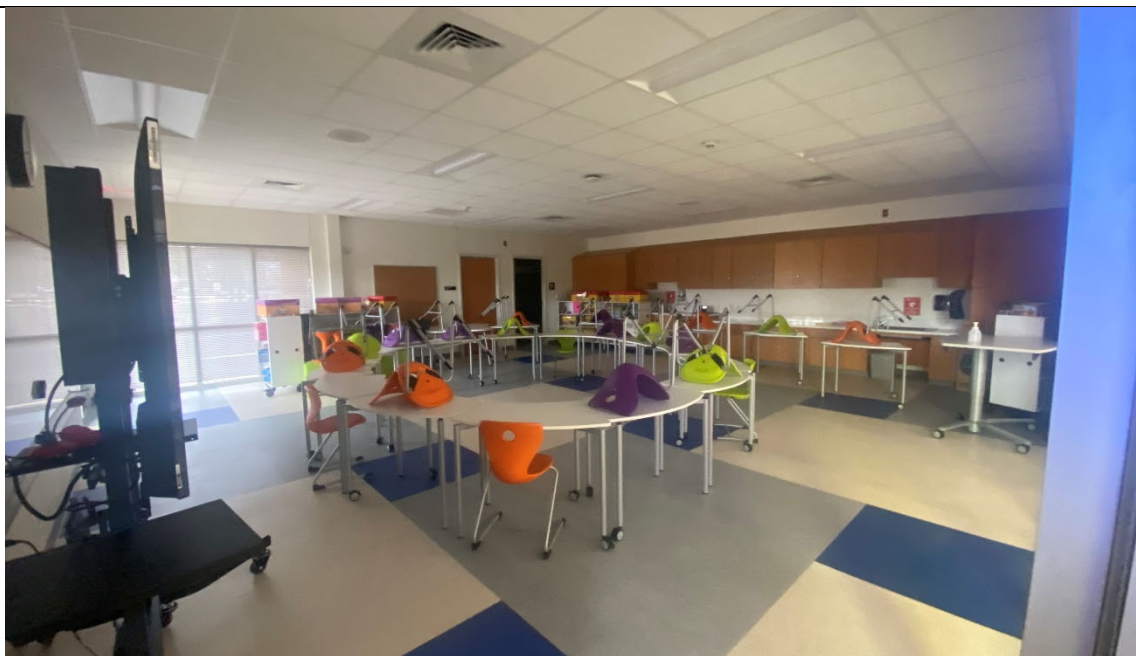
Multipurpose room has sufficient storage and space and direct access to exterior learning space.

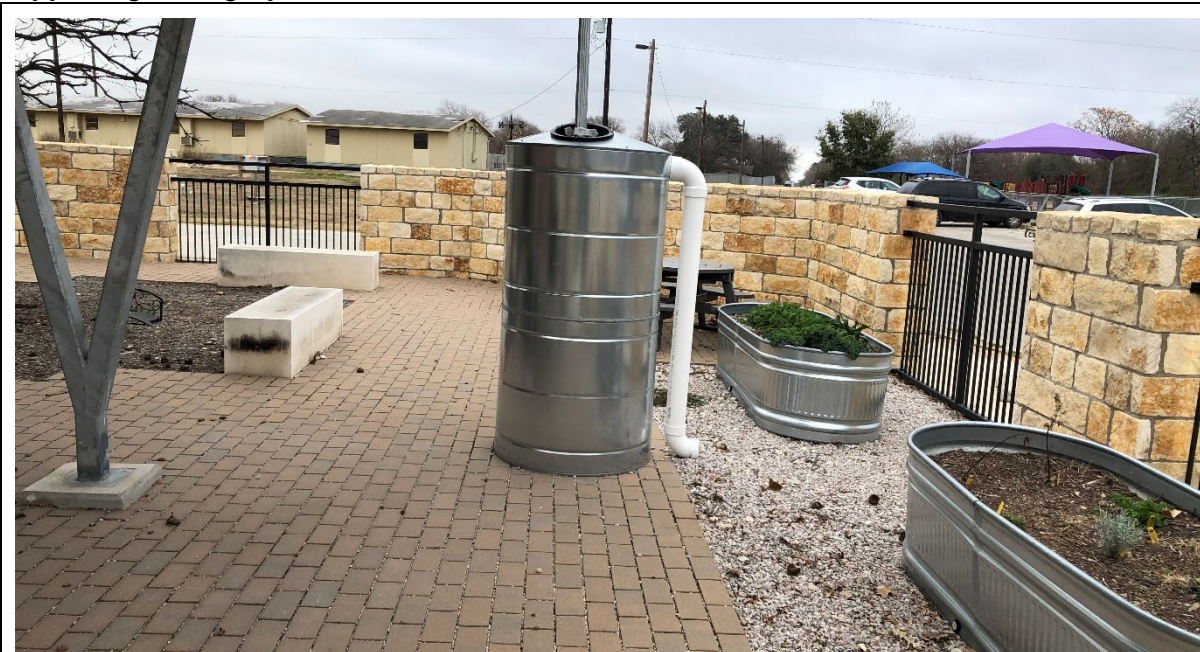
Exterior learning space is well configured with shade and seating with direct connection to multipurpose room.

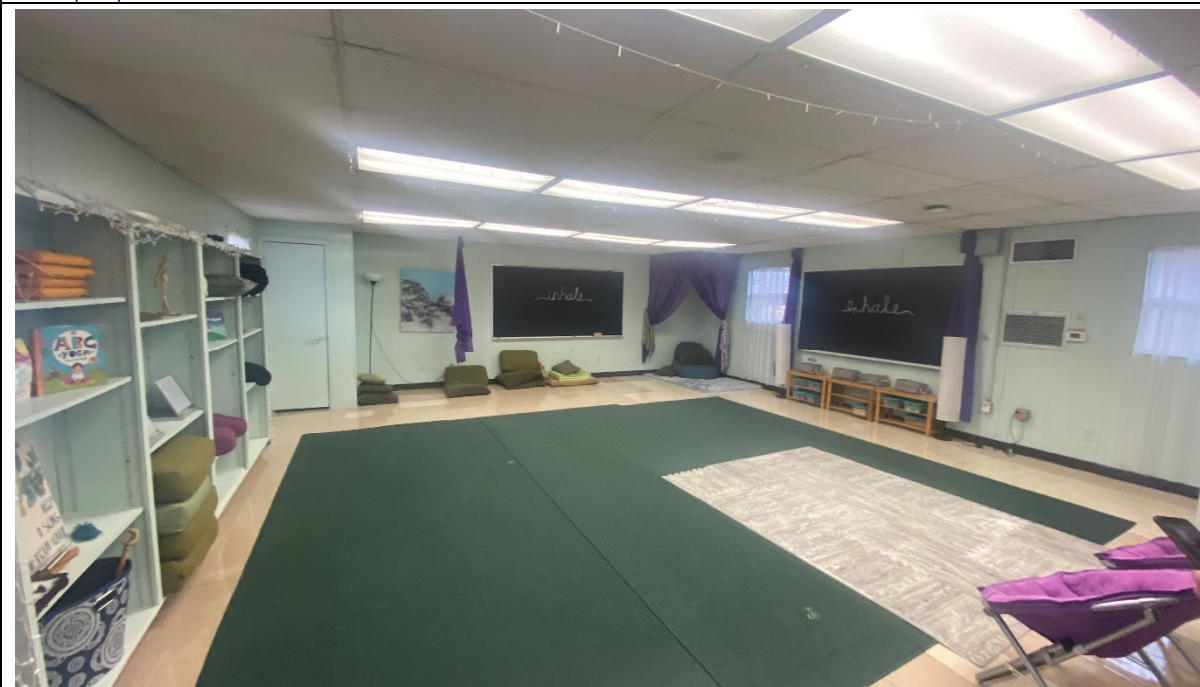
Mindfulness space for students is in a portable.

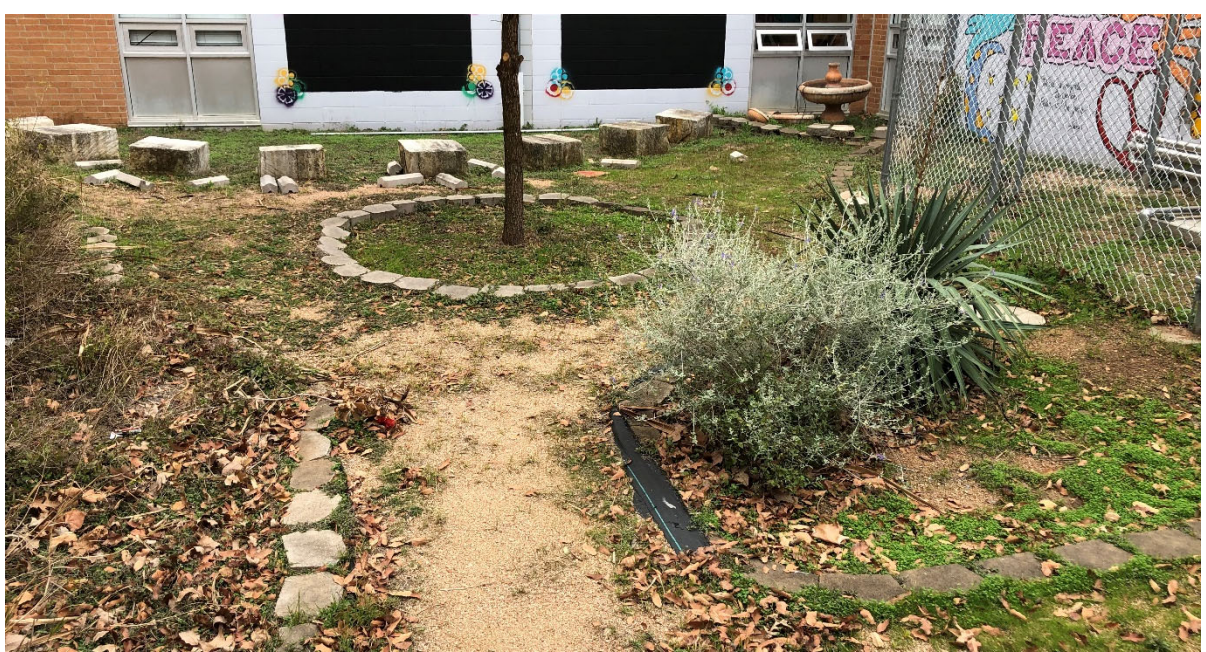
Small courtyard space between studio wings is used as an outdoor learning area but does not have direct access to the building. Space is fenced in and lacks a developed walkway for access, and therefore is not ADA accessible.

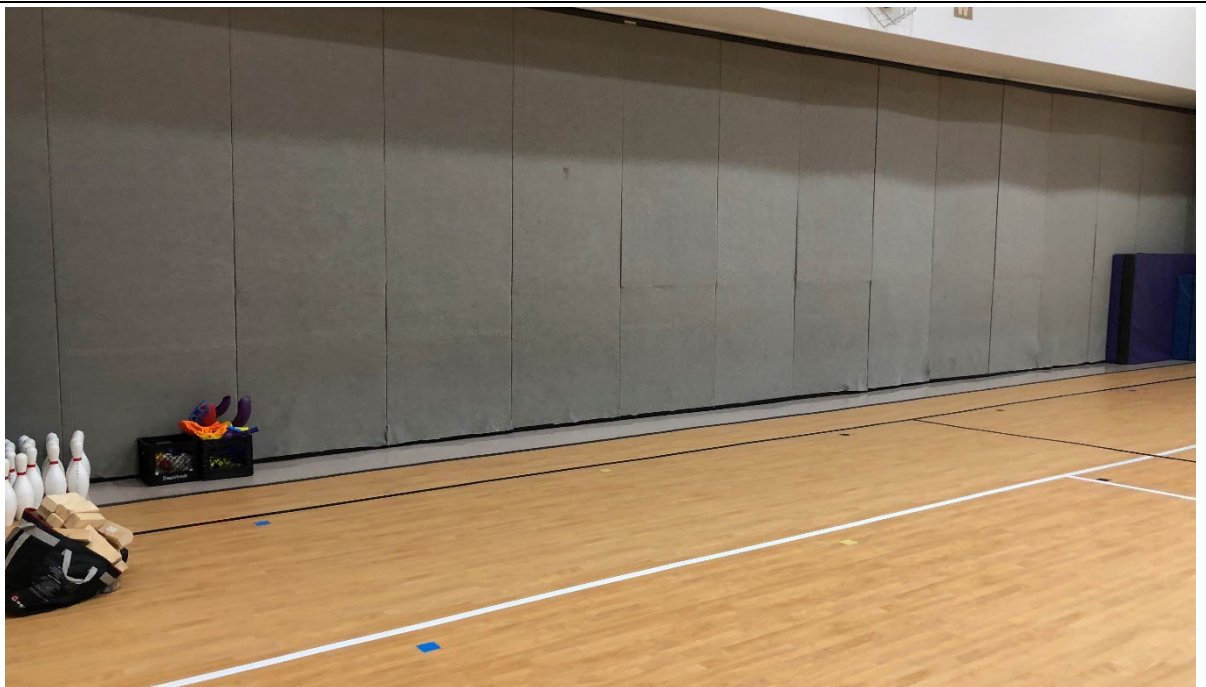
General appearance of school is aged. Community room is a good size and layout but must be accessed using key card or by going through interior corridors. Operable partition between cafeteria and gym is difficult to operate and typically stays closed for this reason.

Operable partition between gym and cafeteria is deteriorating and not functioning properly. Difficult to open and campus typically keeps spaces separated.

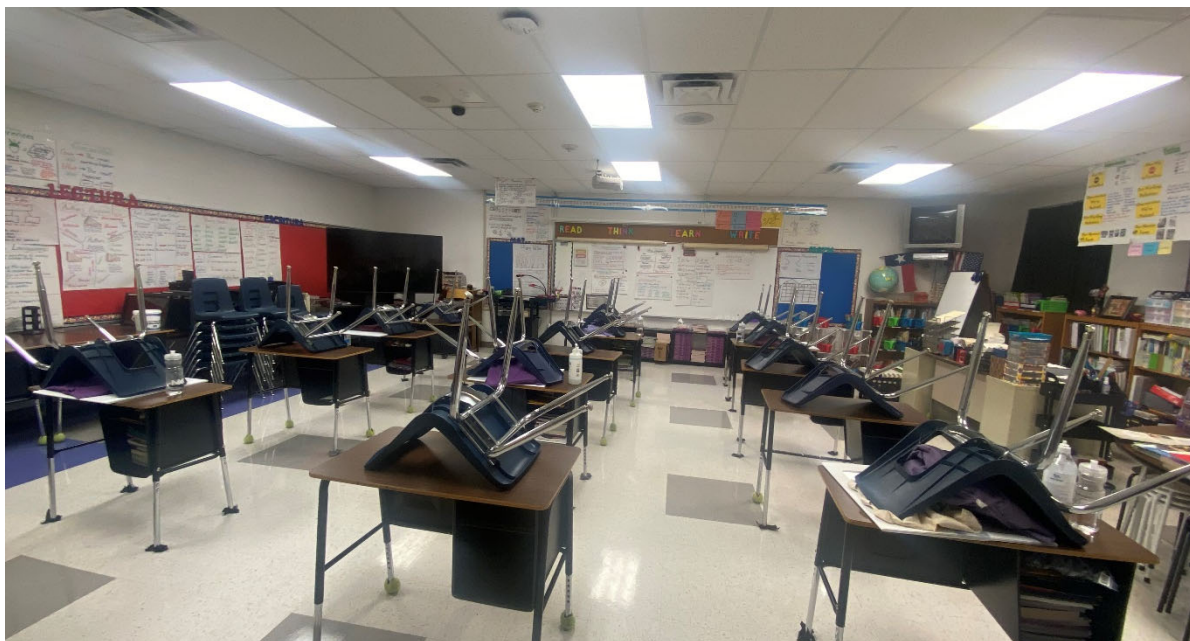
Furniture is not new, but in good condition. Flexible furniture provided in library and in multipurpose room. Older desks in studios are difficult to reconfigure.

Typical studio with furniture that is not very flexible.

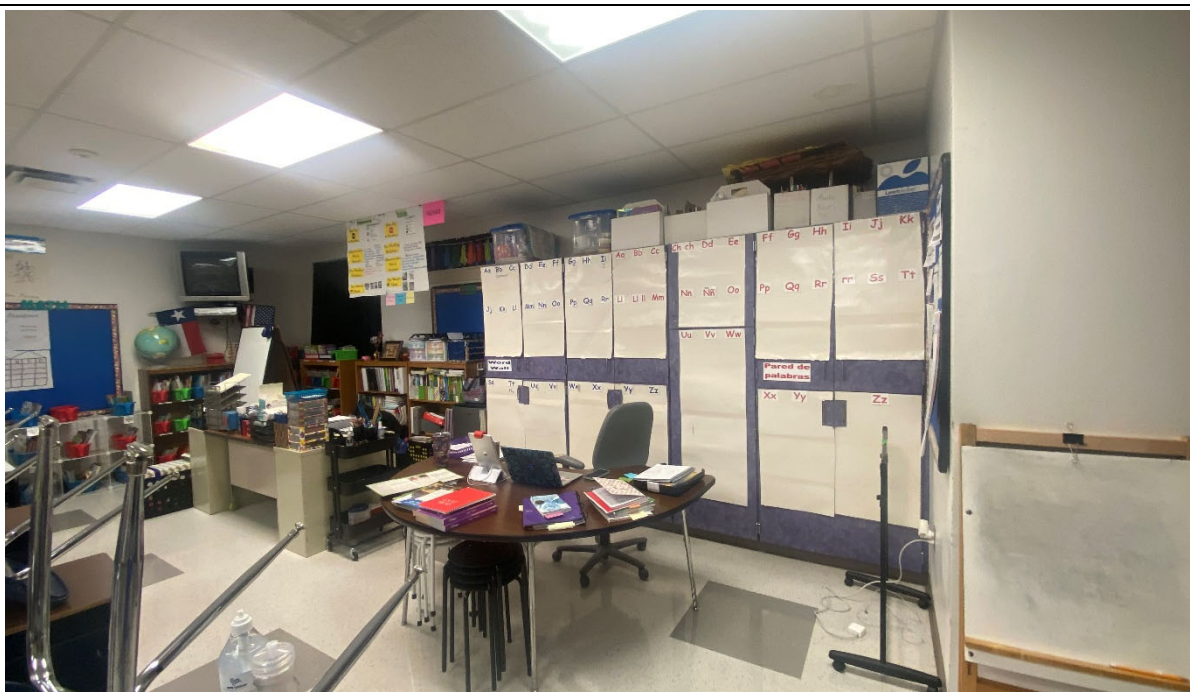
Announcements are shown on CRT monitors in studios, some of which are not functional. Studios are lacking adequate power outlets for student devices. PA system in cafeteria is not functional.

Studio with dated technology equipment that is relied upon with non-functioning technology. Announcements are missed in those studios.

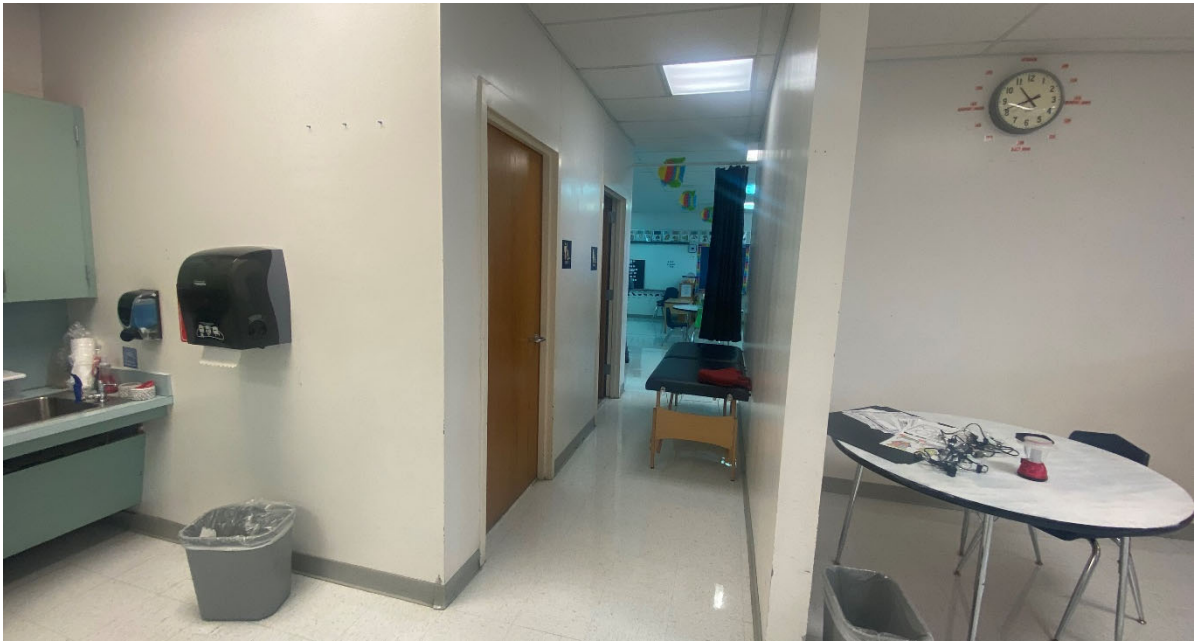
Sound transmits between studios because of open bathroom corridor between studios. Most studios have limited access to natural light, with small high windows and one larger window. No evidence of pest problems.

Studios configured with a connected corridor to connected restrooms. Connection allows sound to pass from one studio to the next.

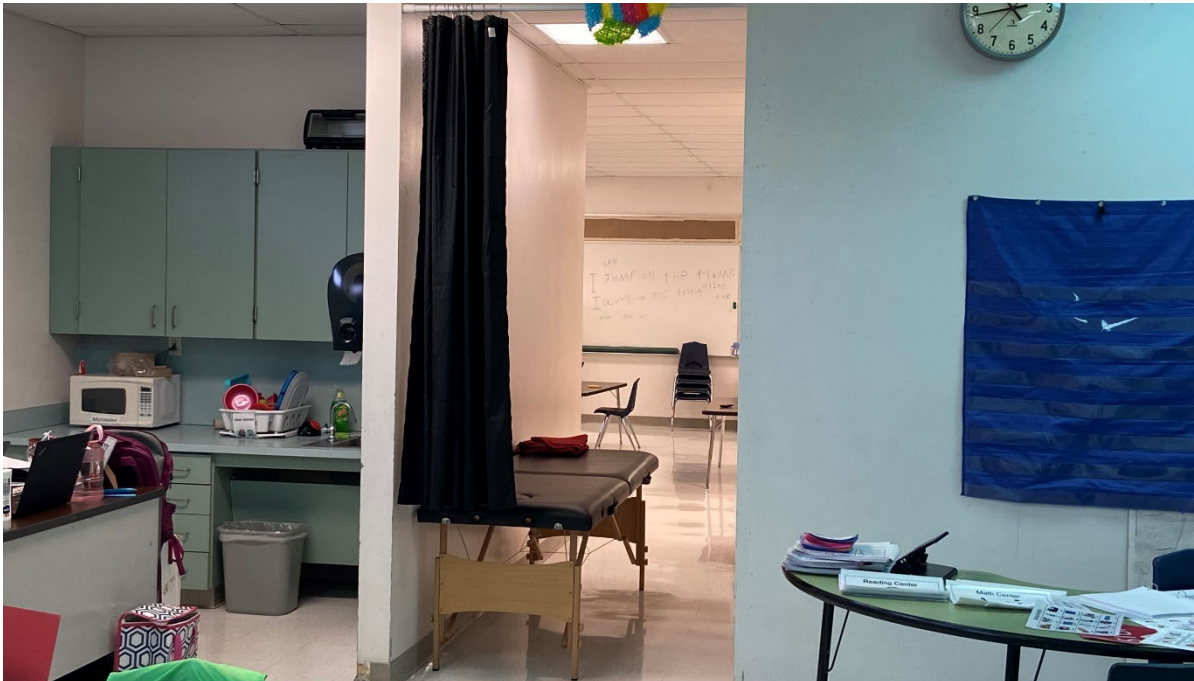
Restroom corridor at special education room with changing table unable to fit in restroom. Placement of a curtain provides inadequate privacy.
