## **Educational Suitability Summary Report**

Sunset Valley Elementary School

Date: 01/21/2021

**Score 56% Average**

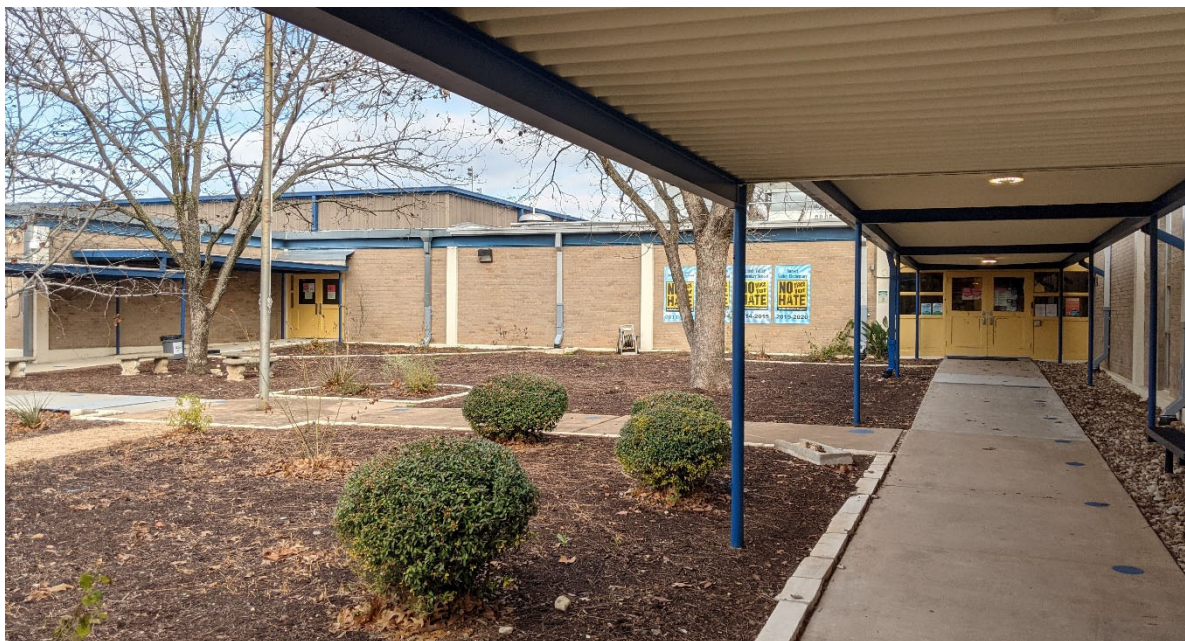
*Exterior: Drop-off canopy at main building entry.*

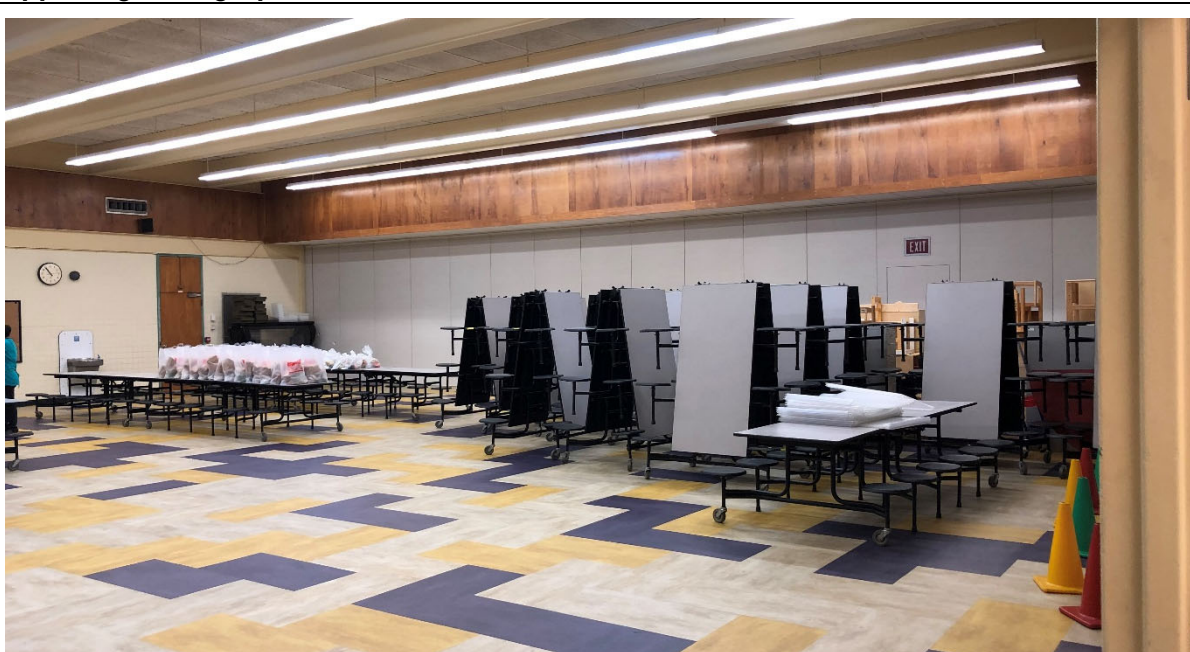
Cafeteria is too small with no natural light and has only one option for eating space. There is only one serving line for students, which wraps out into the narrow corridor.

*Food Services: Cafeteria with updated floor and original walls and ceiling.*

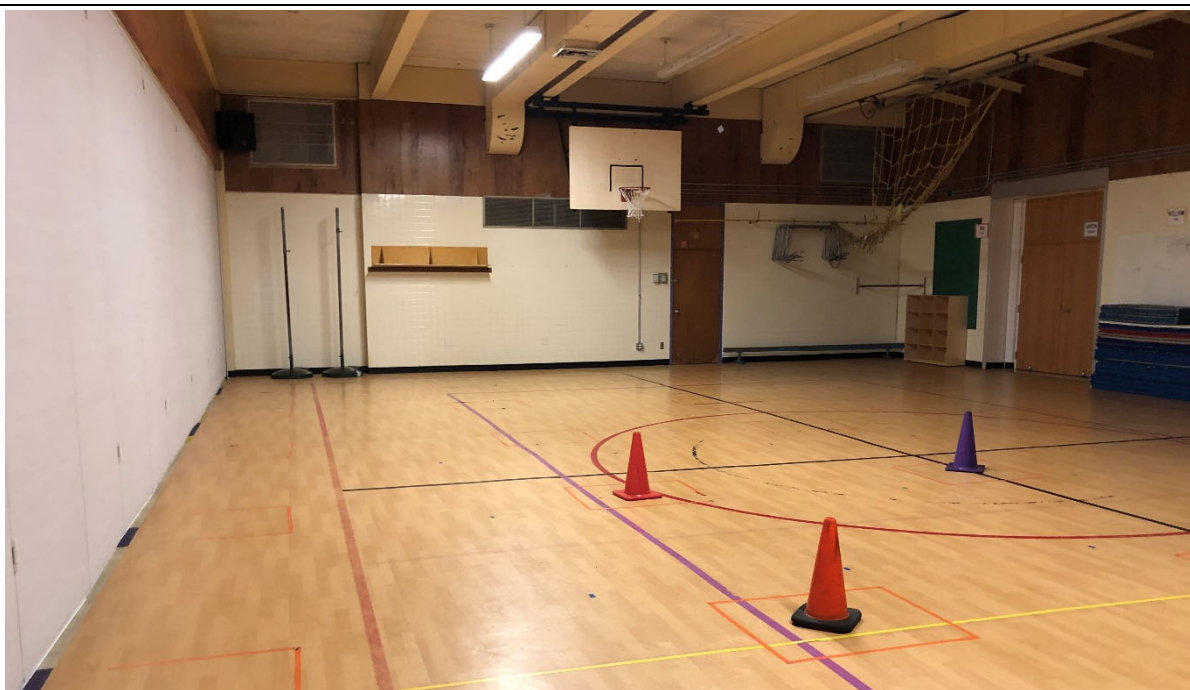
The gym is too small at 2,300 square feet with a low ceiling and no natural light. The hoops are original to the school and cannot be raised or lowered to increase the flexibility of the space. Support spaces for the gym were added in an addition and are spacious and well configured.

*PE and Wellness: Gym floor is new, but rest of gym is very dated.*

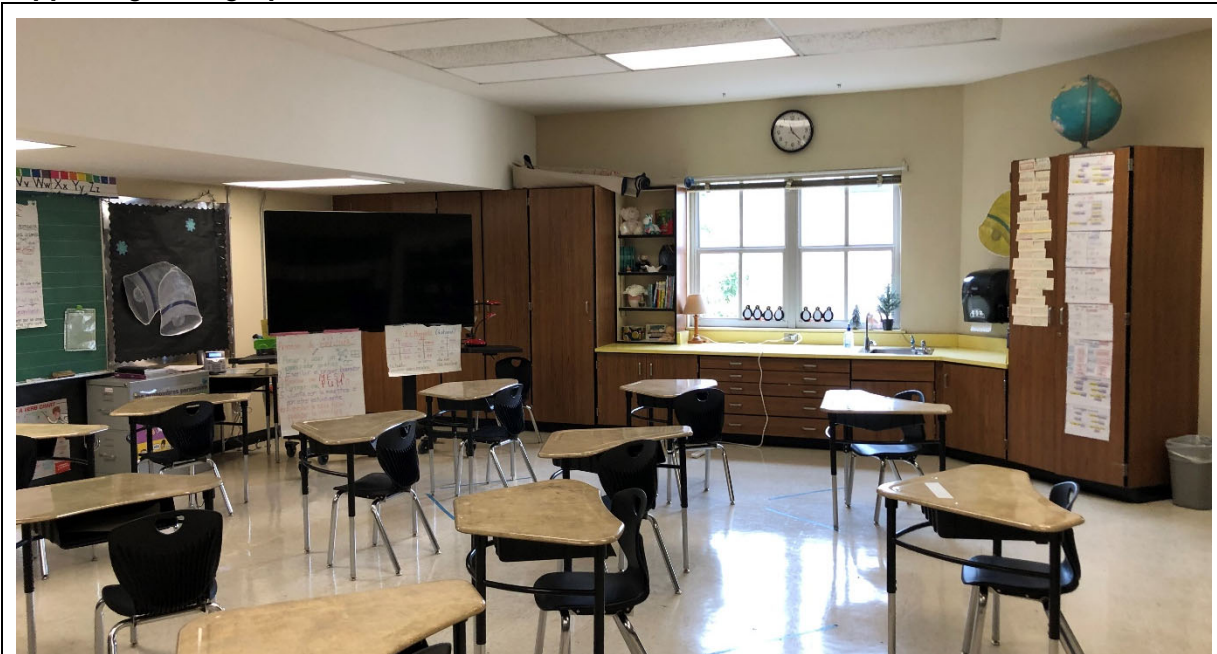
*Academics and Learning: Typical studio with mobile furniture and access to natural light.*

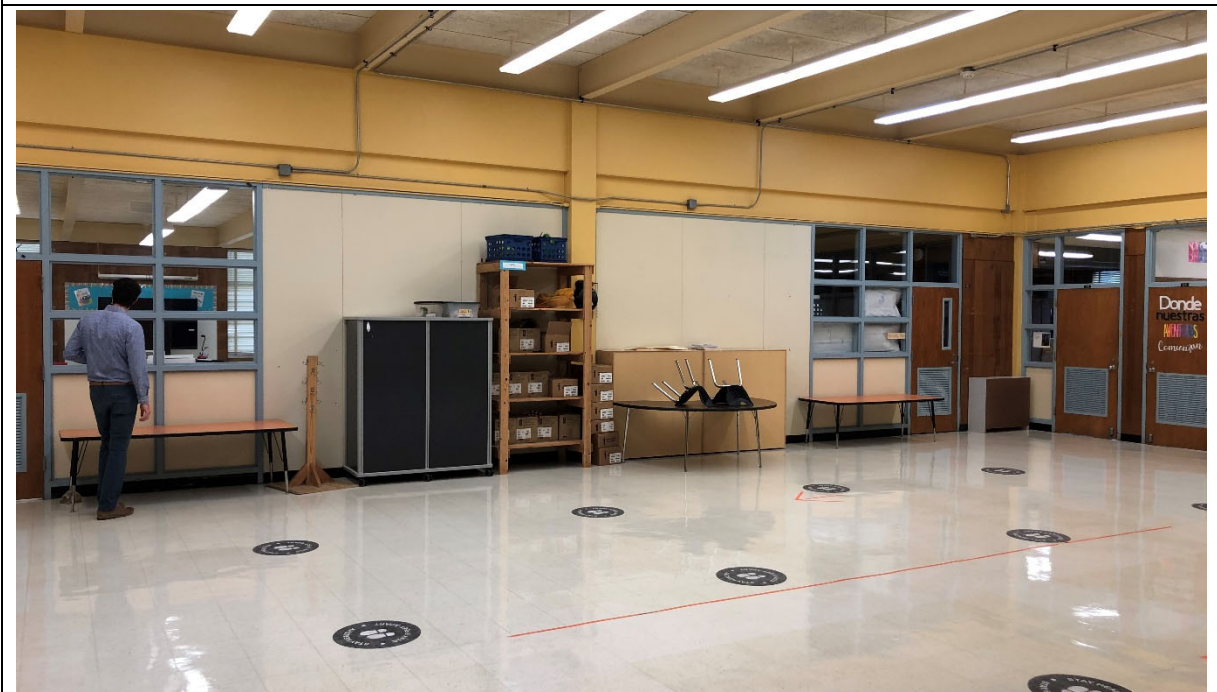
*Academics and Learning: Typical common space between studios.*

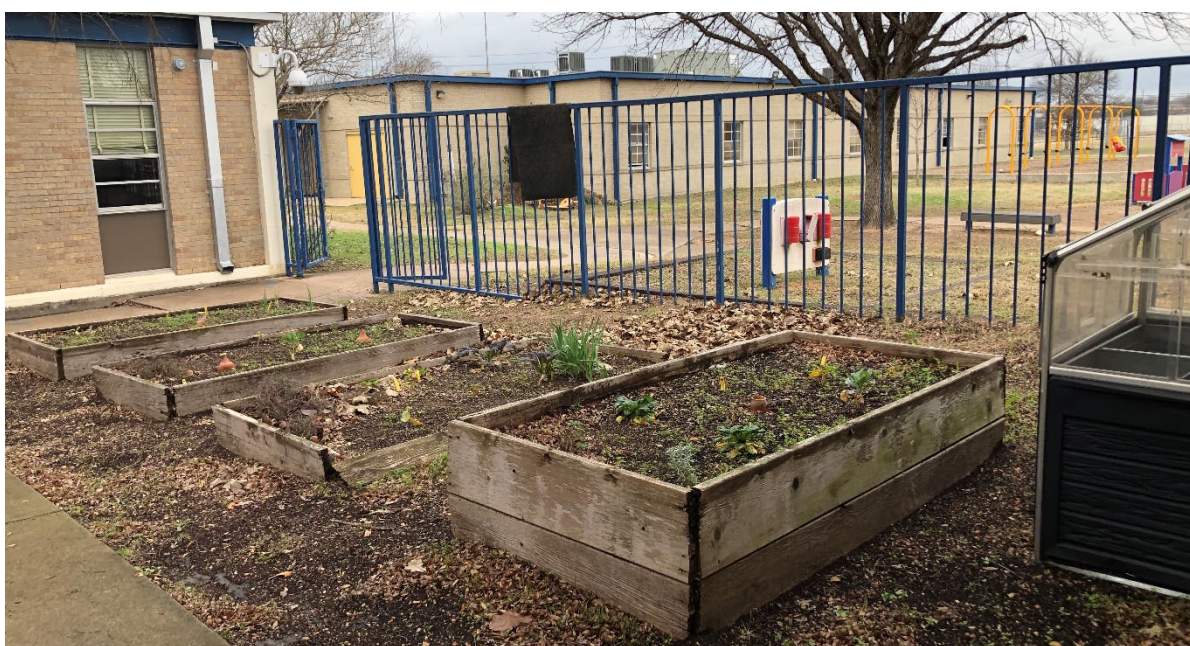
*Outdoor Learning and Activity: Learning garden planters need repairs.*

Improved outdoor learning spaces are needed. These spaces need to be covered and provided with durable furniture that does not need to be rebuilt or repainted annually. The school is working to update the learning gardens on campus and recently added a fruit tree orchard. These programs need additional storage spaces for supplies and tools to continue to function well.

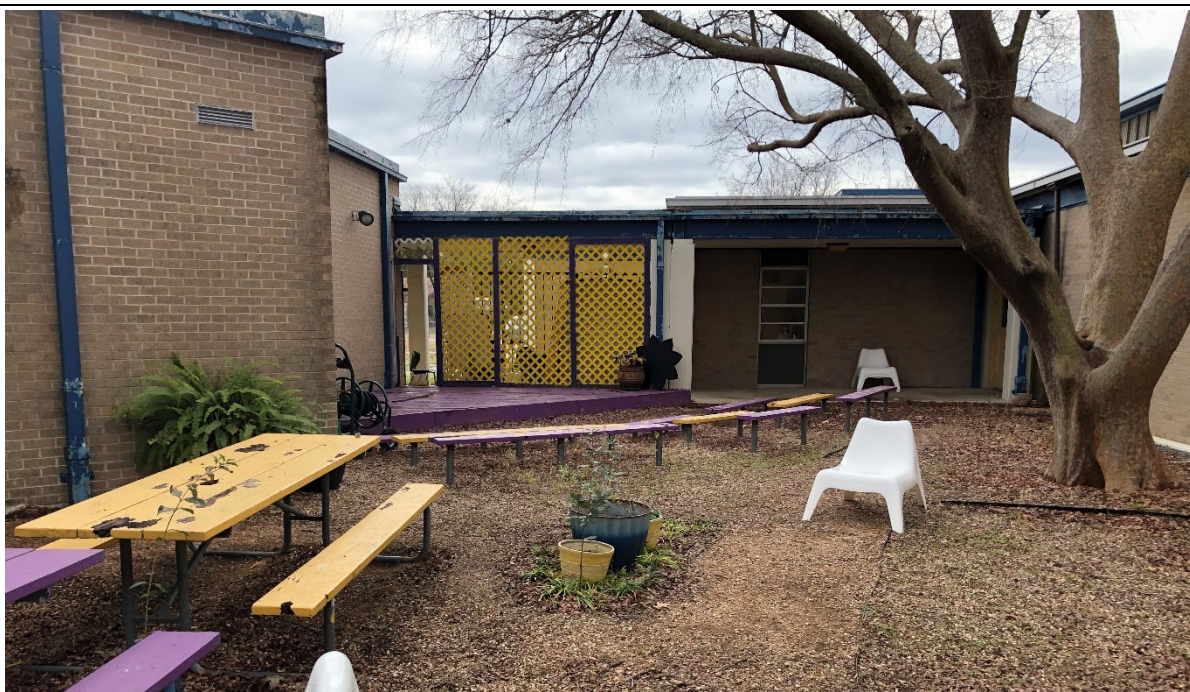
*Outdoor Learning and Activity: Courtyard space is accessible from studios.*

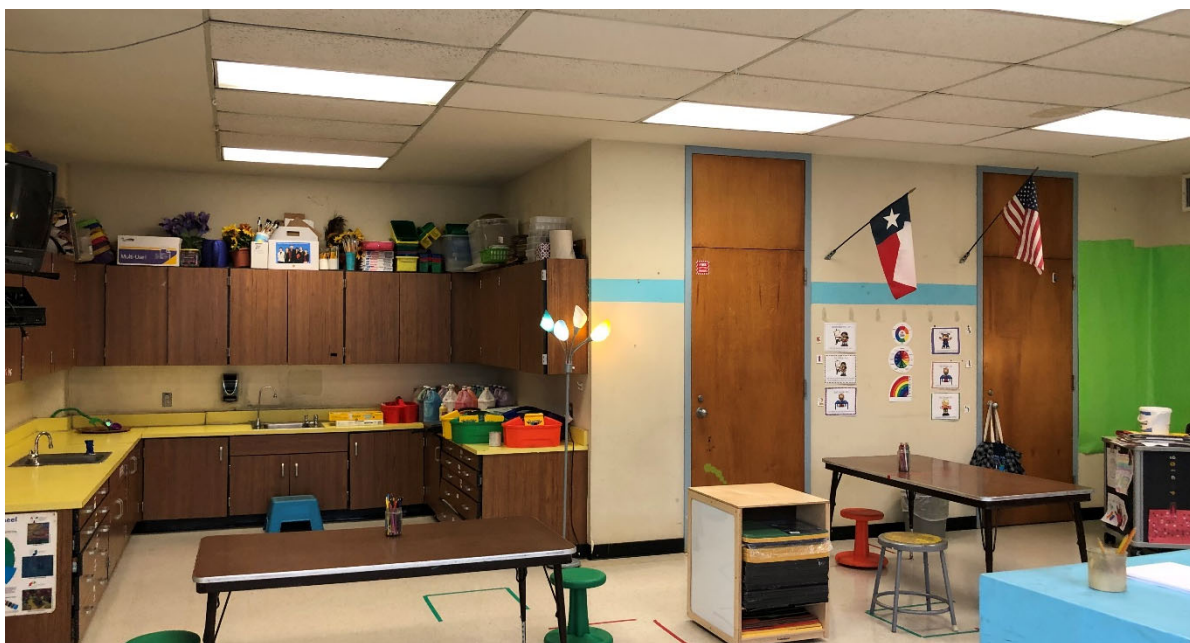
The cafeteria stage and music room are both of adequate size, but storage is limited. Art classes are split between a portable and an undersized studio within the building.

*Visual and Performing Arts: Art studio is undersized but includes kiln room and storage.*

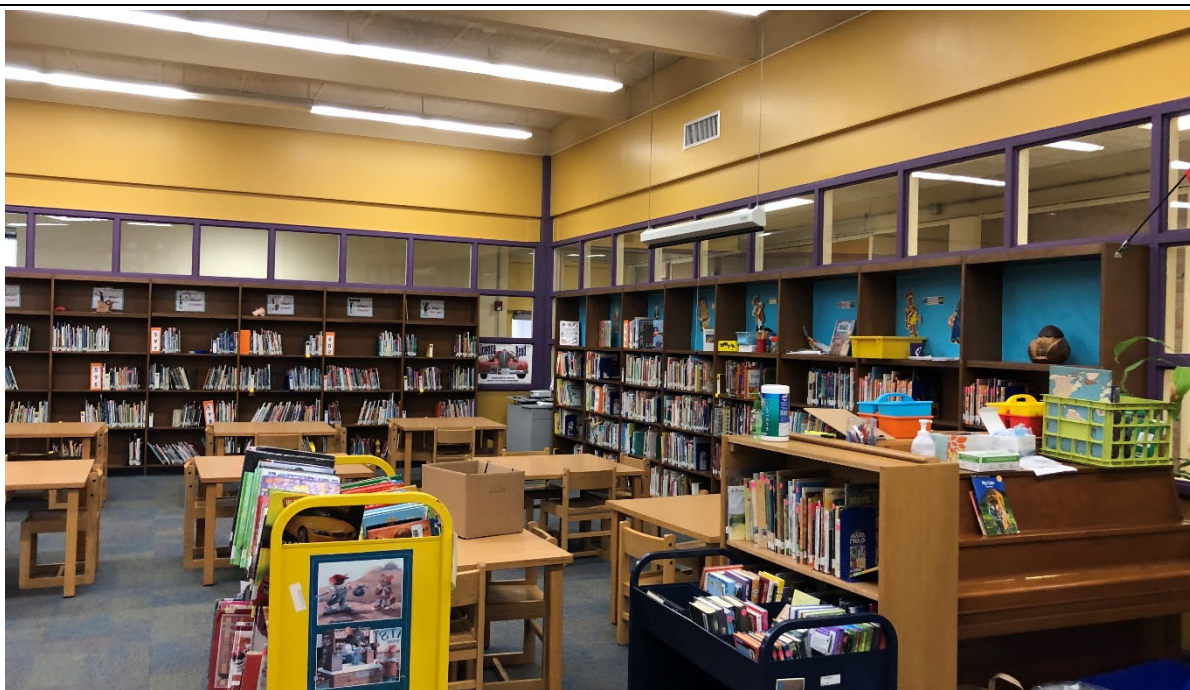
*Media Resources: Heavy furniture in library limits flexibility.*

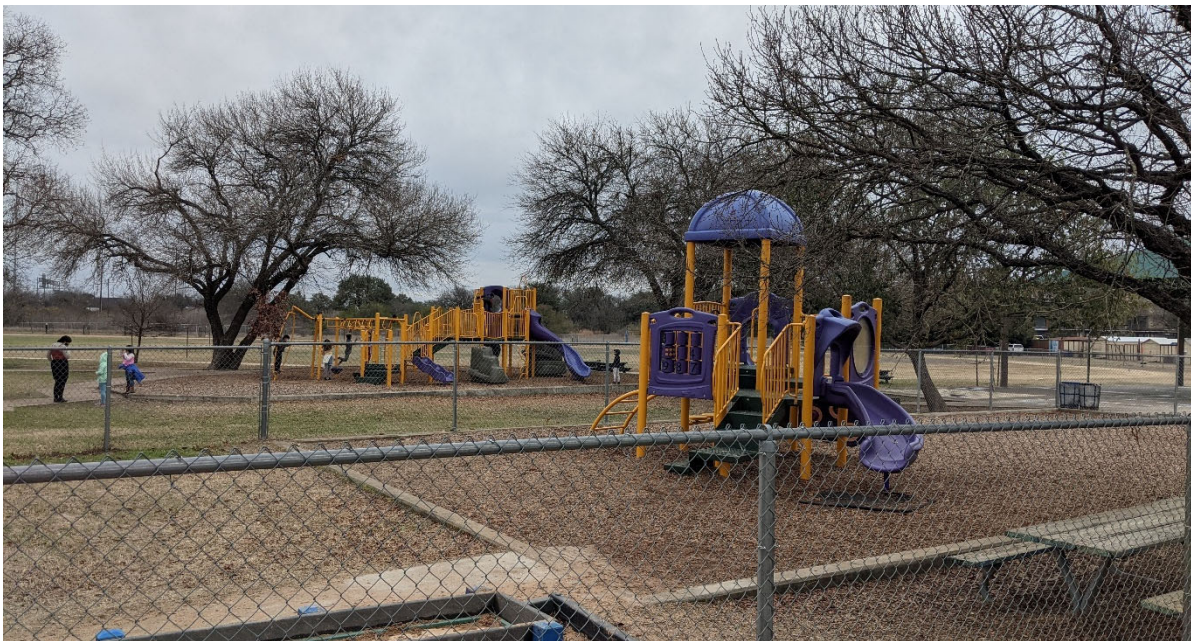
*Outdoor Learning and Activity: Playscapes are in good condition but do not have shade.*

The school has a serenity garden with a small stage and outdoor classroom. Several steel trellises are built around the exterior of the school that could be modified to provide better shade and protection from weather. There are several learning garden areas, but all of them need repairs and updates. The play areas are in good condition, with a large field and walking trail, and several playgrounds for students of different ages. More shade would help make the play areas safer and more usable in all weather.

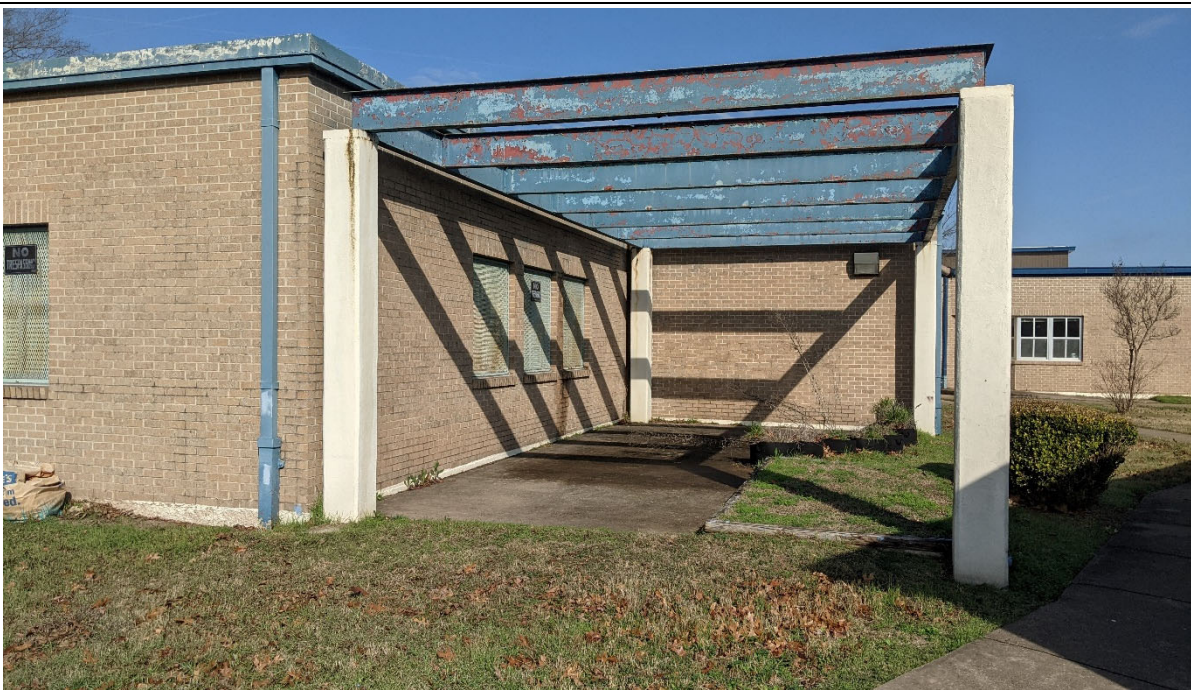
*Outdoor Learning and Activity: Trellised areas in corners of school could be modified to be functional outdoor studios.*
