Educational Suitability Summary Report

Winn Elementary School

Date: 01/07/2021

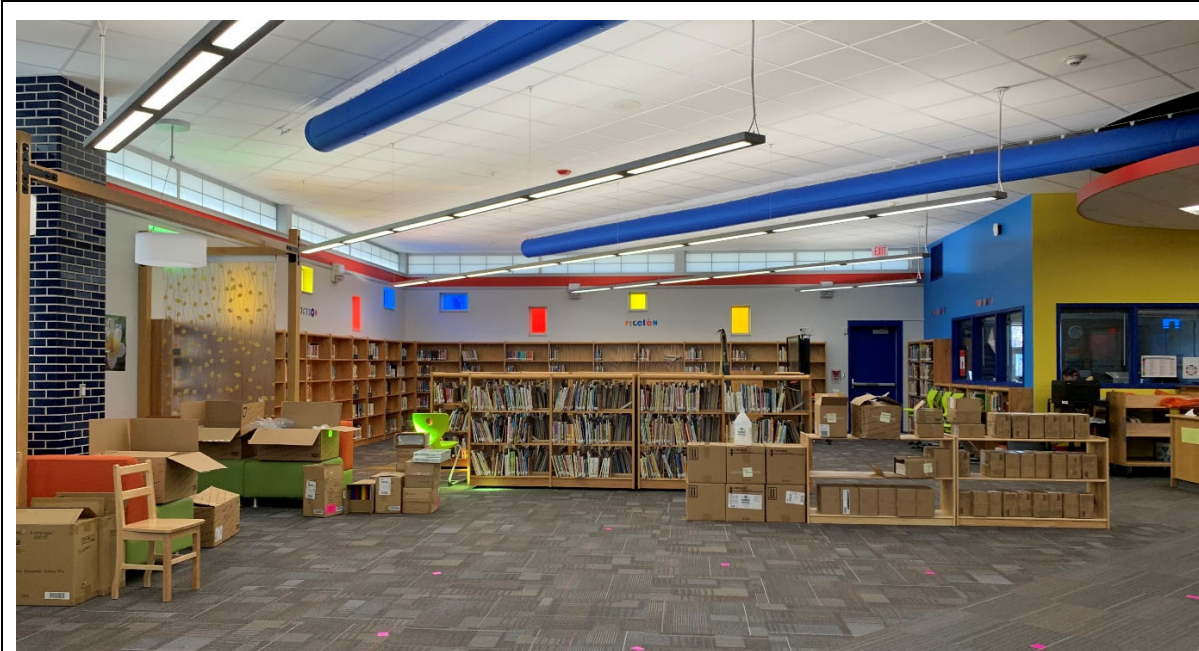
The new library offers plenty of space for various gatherings and events. The technology is brand new.

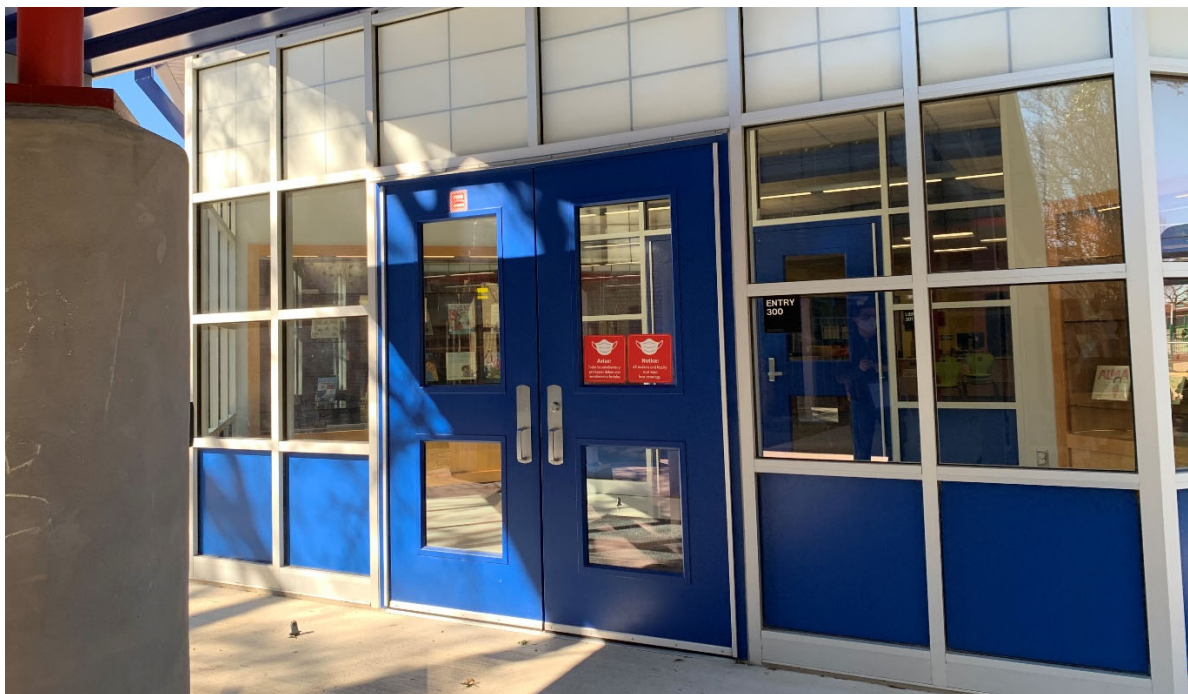
The new library is a stand-alone building and can be opened for after-hours events.

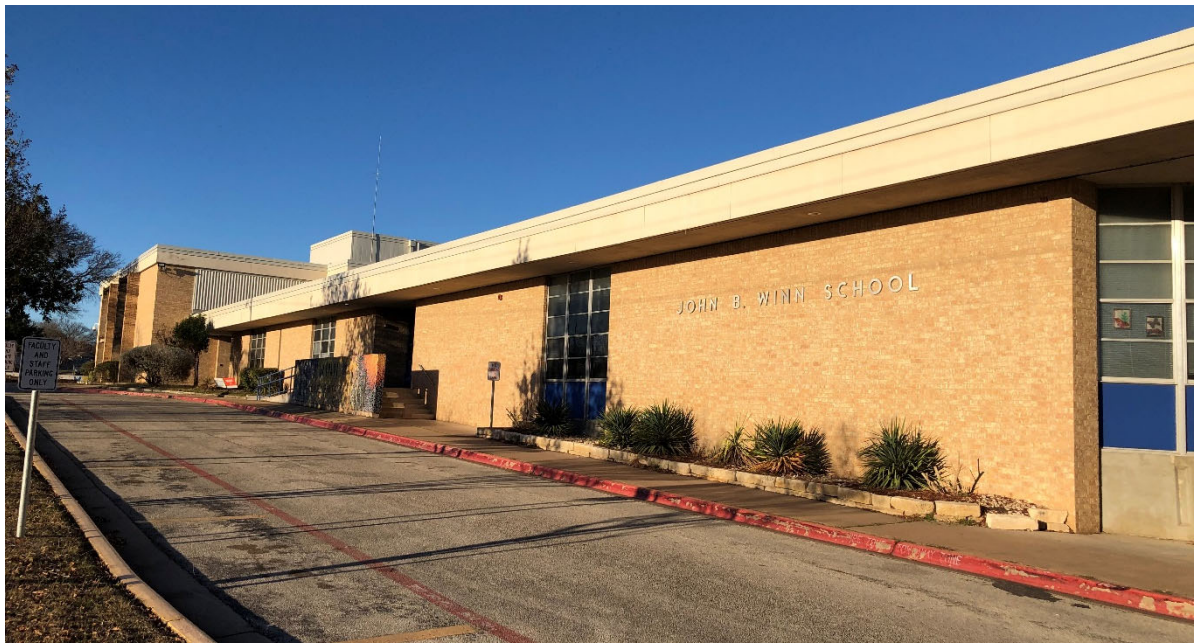
The main entry is difficult to locate. Wayfinding could be improved. There is no canopy.

1.2	Is the building easily identified with appropriate signage and community wayfinding?		2					Comments	0.25	0.50
	1 Very unsatisfactory - Campus has no signage / wayfinding							There is a school sign at the corner, but signage from the main road, Manor Road, and neighborhood is not evident. The school has tried numerous times to acquire funds for a digital marquee. Principal's notes - Mosaic wall with school name at the entrance has served as our signage since it was installed 7-8 years ago.		
	2 Unsatisfactory - Signage/wayfinding is faded/hidden									
	3 Average - Signage / wayfinding visible but not apparent									
	4 Satisfactory - Signage / wayfinding is visible but not good condition									
	5 Very satisfactory - Signage and wayfinding is visible and easy to use									
	N/A Does not apply

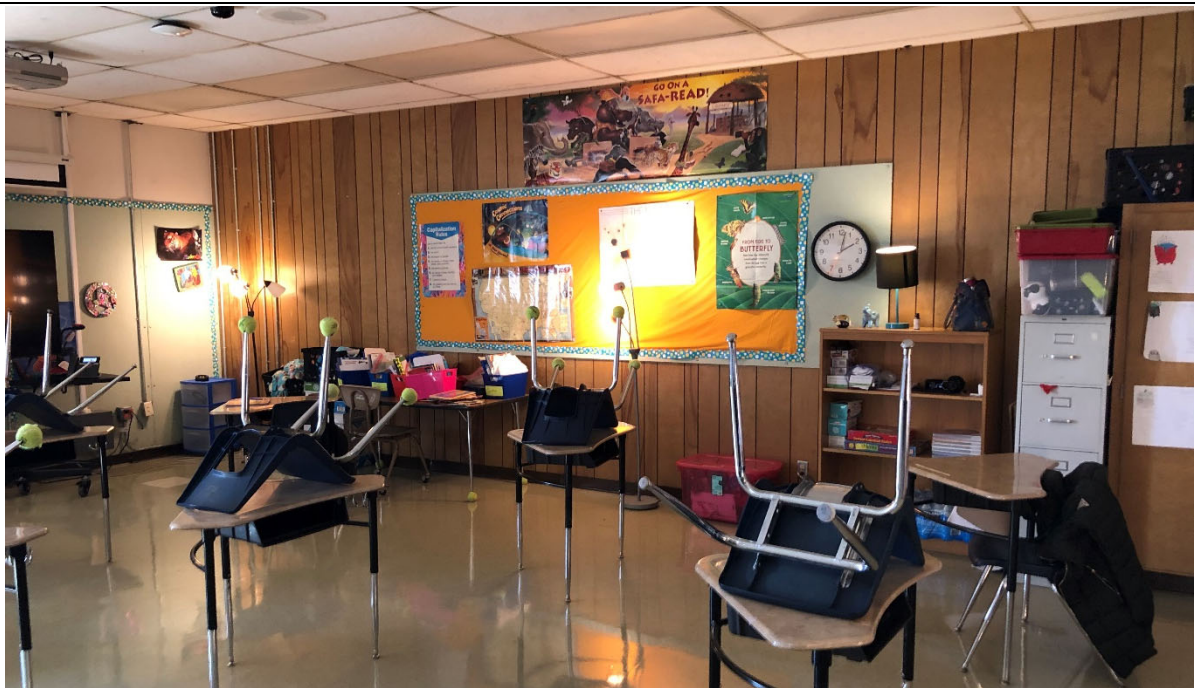
Studios in east wing have not been renovated to match west wing. Ceiling tiles, wall paneling and lighting are dated.

5.2	Is the studio artificial lighting adequate quality?			3				Comments	1.00 3.00
1	Very unsatisfactory - Sporadic lights work, glare, less than 20 FC							Only half of the studios have been upgraded with new lighting.	
2	Unsatisfactory - 10-19 FC or serious glare								
3	Average- 20-29 FC minor glare								
4	Satisfactory - 30-39 FC and no glare								
5	Very satisfactory - 40+ FC and no glare								
N/A	Does not apply

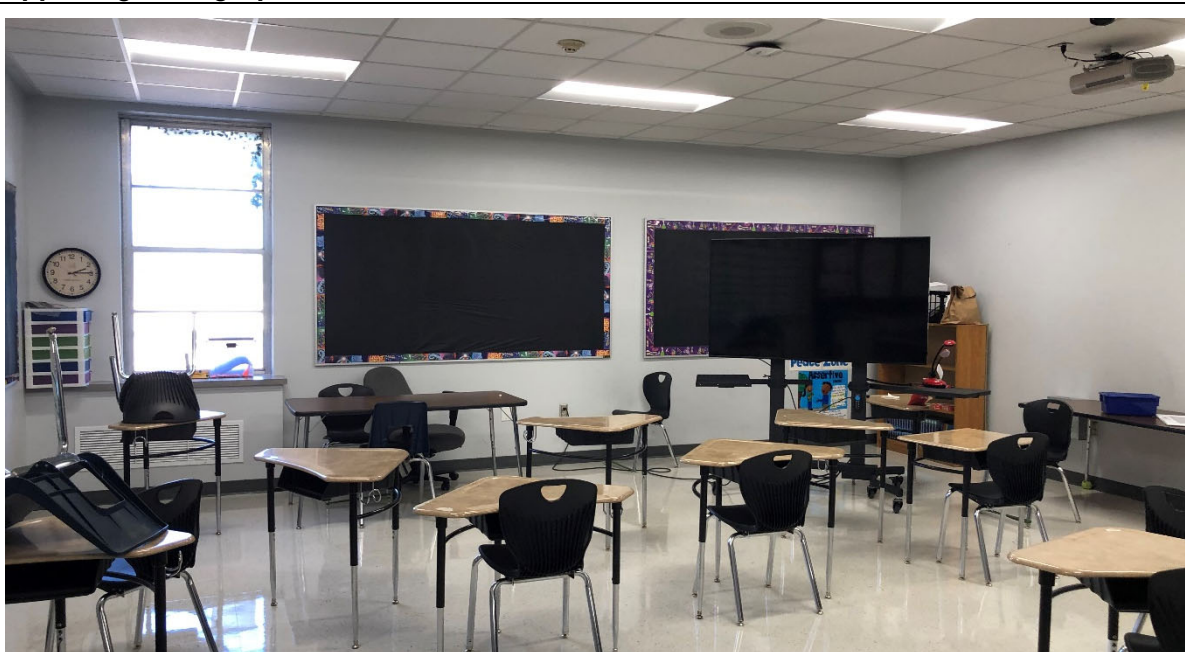
Studios in west wing are recently renovated. Windows did not have blinds at the time of assessment and were never installed after being renovated.

6.2	Are shades provided to control natural light in learning spaces?		2					Comments	1.00	2.00
1	Very unsatisfactory - No, windows are covered with boards/paper							Half of studios do not have blinds or any type of shading devices.		
2	Unsatisfactory - No, windows have no light control									
3	Average - Yes, but poor condition blinds									
4	Satisfactory - Yes, blinds									
5	Very satisfactory - Blackout shades									
N/A	Does not apply

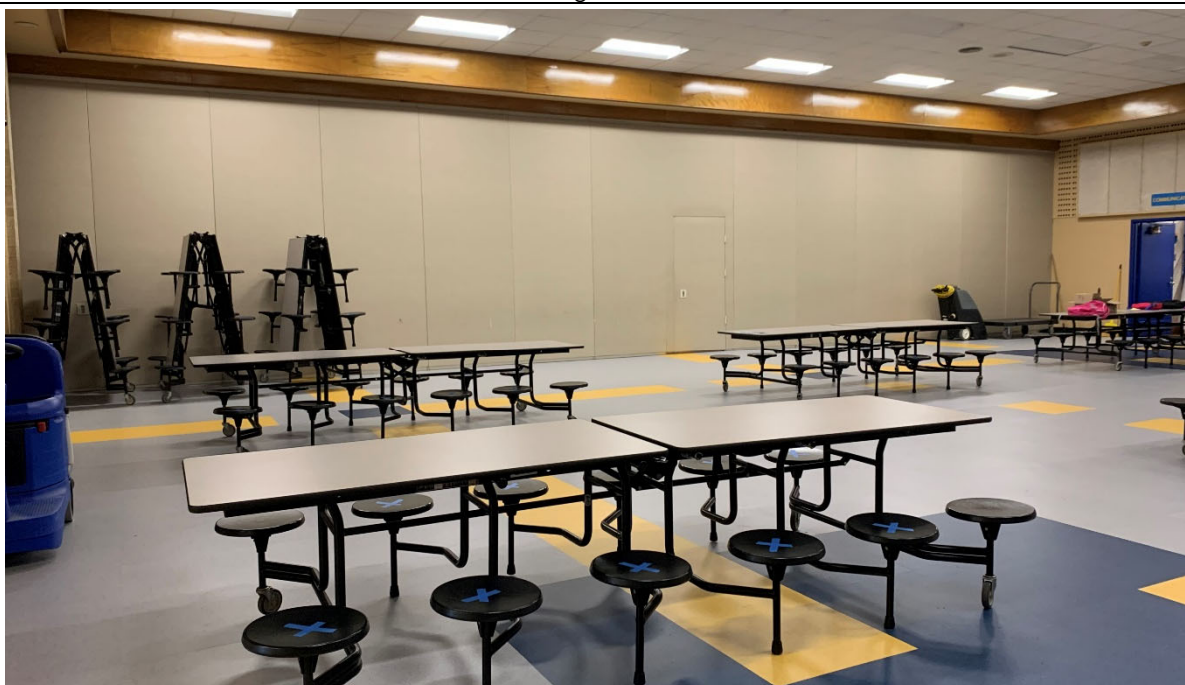
Cafeteria is slightly undersized for campus capacity but is adequate for enrollment. New flooring has recently been installed. No A/V equipment.

11.1	Is the Dining Commons appropriately configured per the ed spec?			3				Comments	1.00 3.00
	1 Very unsatisfactory - Too small, missing program spaces 2 Unsatisfactory - Too small, poor condition, only one option for eating space provided, inadequate circulation 3 Average - Adequate size and condition, needs updates or renovations to function well 4 Satisfactory - Good size and condition, good circulation, multiple options for eating space (ex: connection to outdoor eating space) 5 Very Satisfactory - Generous size, excellent condition and circulation, multiple options for eating space (ex: connection to outdoor eating space) N/A Does not apply	The dining commons is newly renovated, but is too small (400 SF undersized) to accommodate the school's capacity. It is a sufficient size for the school's current enrollment. There was an odor in the cafeteria the day of the assessment, which may have been from the recently installed floor.

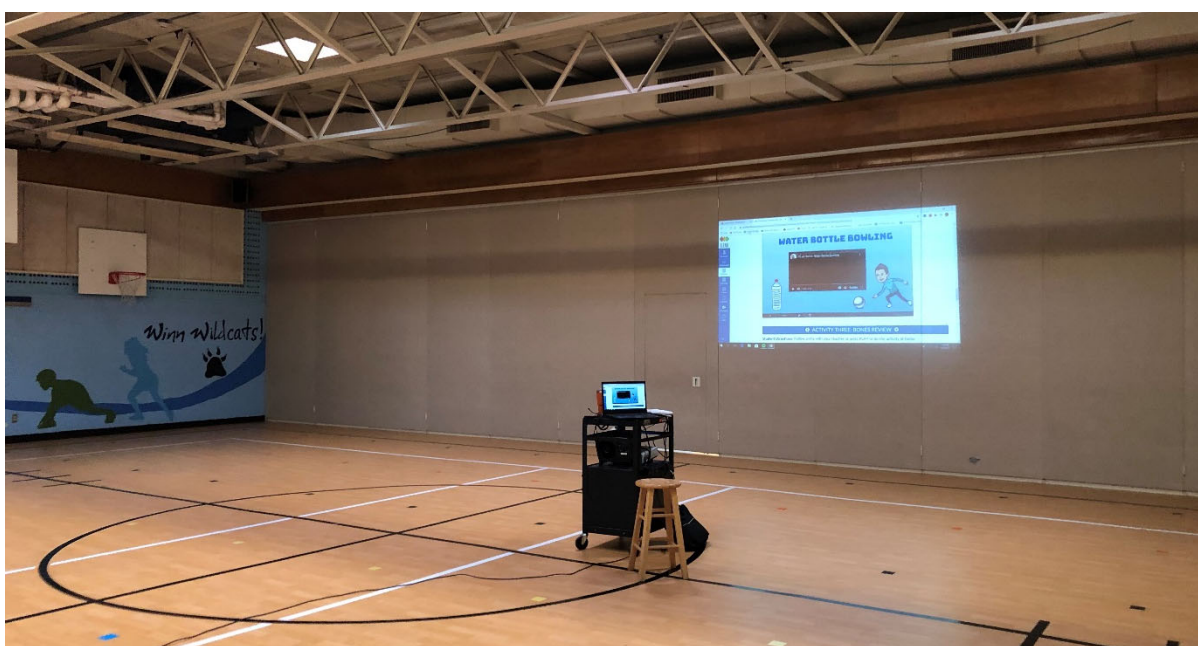
New floors in gym, but other surfaces need updating. It is undersized per Ed Spec at 2,200 SF. Acoustic control and ventilation are lacking.

10 - PE and Wellness		1	2	3	4	5	N/A	10.00	40%
10.1	Does the campus meet the ed spec standard for physical education program spaces?		2					Comments	1.00 2.00
	1 Very unsatisfactory - Too small, missing program spaces 2 Unsatisfactory - Too small, poor condition 3 Average - Adequate size, adequate condition, needs some renovations or updates to function well 4 Satisfactory - Good size, good condition 5 Very Satisfactory - Generous size, excellent condition N/A Does not apply	The gym is too small and poorly ventilated/daylit.

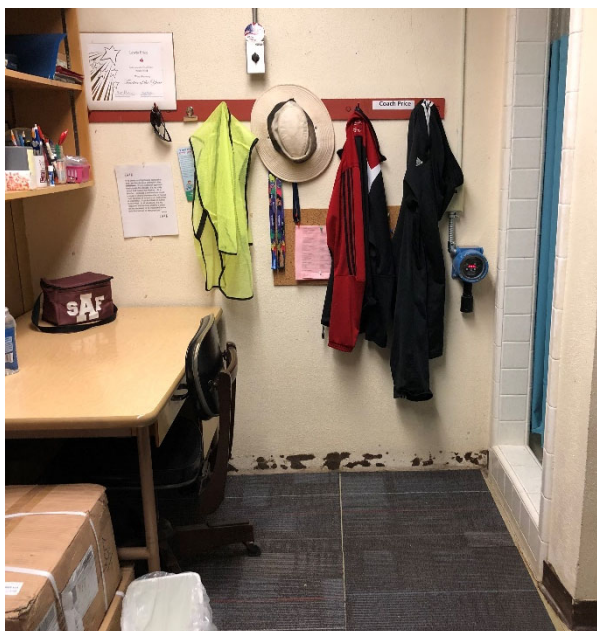
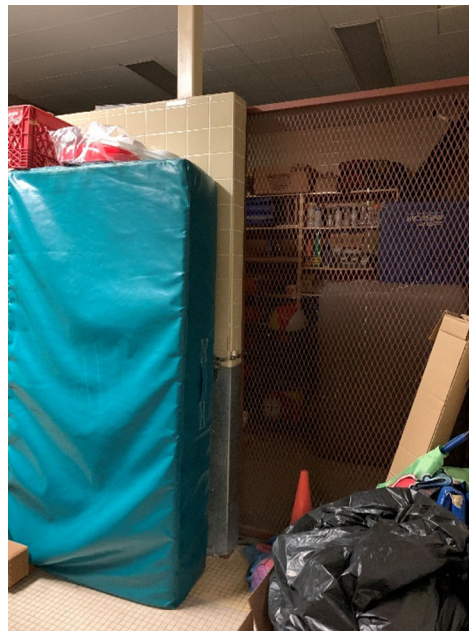
Gym Office and Storage: There have been several flooding events. The flooring has not been replaced, and there are odors. The storage is overflowing into the girls' restroom, making it unusable.

10.2	Are the physical education storage spaces appropriately configured per the ed spec?		2					Comments	1.00 2.00
	1 Very unsatisfactory - None provided 2 Unsatisfactory - Too small, disconnected, poor condition 3 Neutral - Adequate size, average condition, needs updates or renovations to function well 4 Satisfactory - Good size, connected, good condition 5 Very Satisfactory - Generous size, connected, excellent condition N/A Does not apply	There is no dedicated storage space for the gym. The restrooms have been taken over with equipment and are not usable.							
11 - Food Services		1	2	3	4	5	N/A	10.00	70%

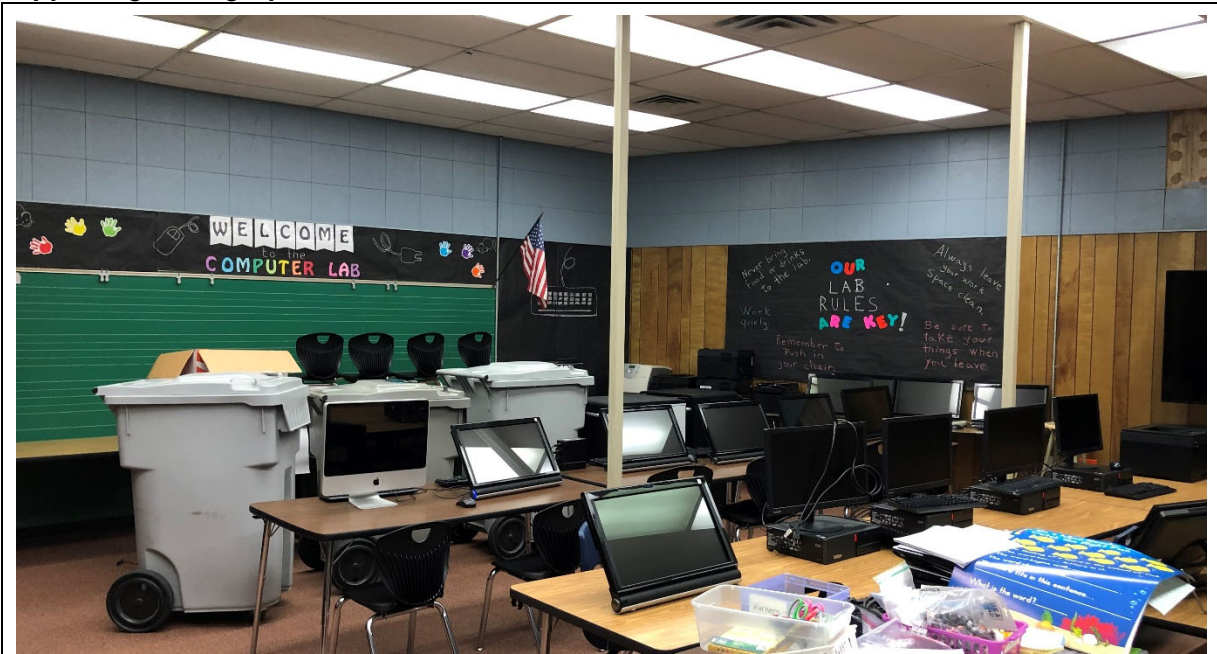
Computer lab finishes are dated. Thermal, acoustical and lighting quality are unsatisfactory and need attention. There was a strong odor in the room as well during the Assessment.

5 - Environmental Quality (cont.)		1	2	3	4	5	N/A			
5.5	Does the building have odor or pest problems?			3				Comments	1.00	3.00
1	Very unsatisfactory - Evidence of both pests and odors							Noticed odors in cafeteria and computer lab, but no pests.		
2	Unsatisfactory - Evidence of pests or odors									
3	Average - Limited evidence of pests, no odors									
4	Satisfactory - No evidence of pests / odors, school cleanliness in good condition									
5	Very Satisfactory - No evidence, school cleanliness in excellent condition									
N/A	Does not apply									
6 - Controllability of Systems		1	2	3	4	5	N/A	12.50		44%

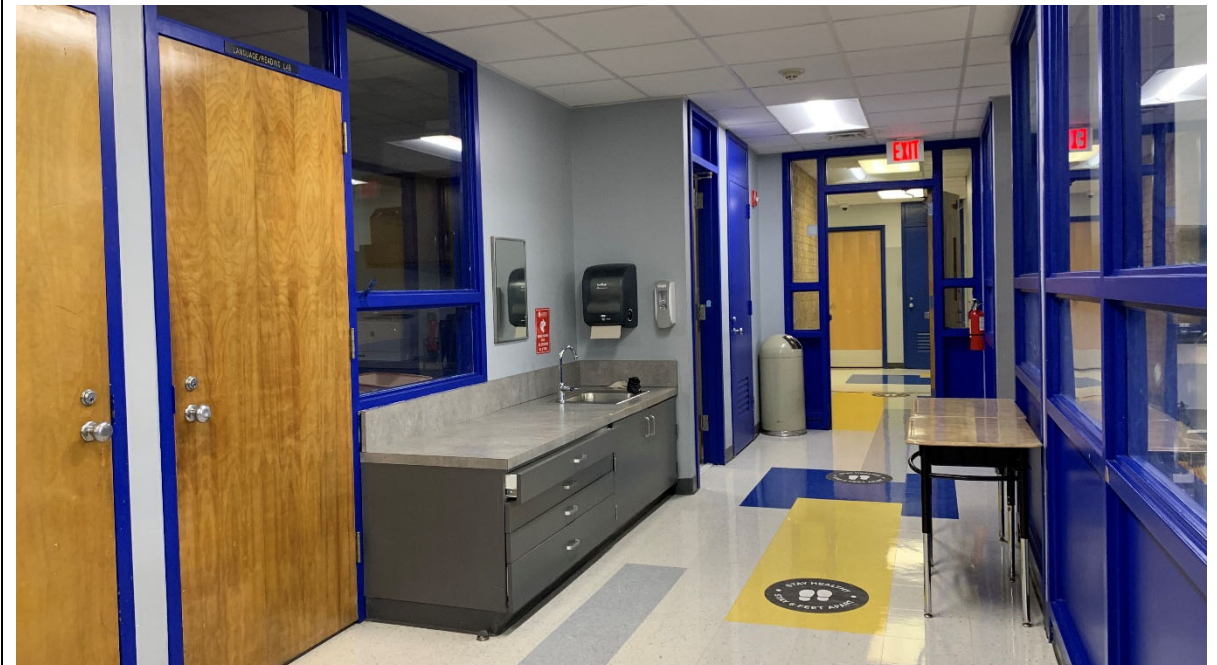
Renovated Studio Corridor: The studios have great visibility to the corridors; however, the quality/thickness of glass compromise acoustics.

5 - Environmental Quality		1	2	3	4	5	N/A	25.00	56%
5.1	How are acoustics in studios in general?		2					Comments	1.00 2.00
1	Very unsatisfactory - Recognized word/sound from adjacent studio/corridor							Large amount of glazing permits sound transmission from corridors.	
2	Unsatisfactory - Audible sound from adjacent studio/corridor								
3	Average - Slight sound from outside room								
4	Satisfactory - Walls to deck insulated only white noise from mechanical system								
5	Very satisfactory - Able to hear quiet speaking from across the room								
N/A	Does not apply

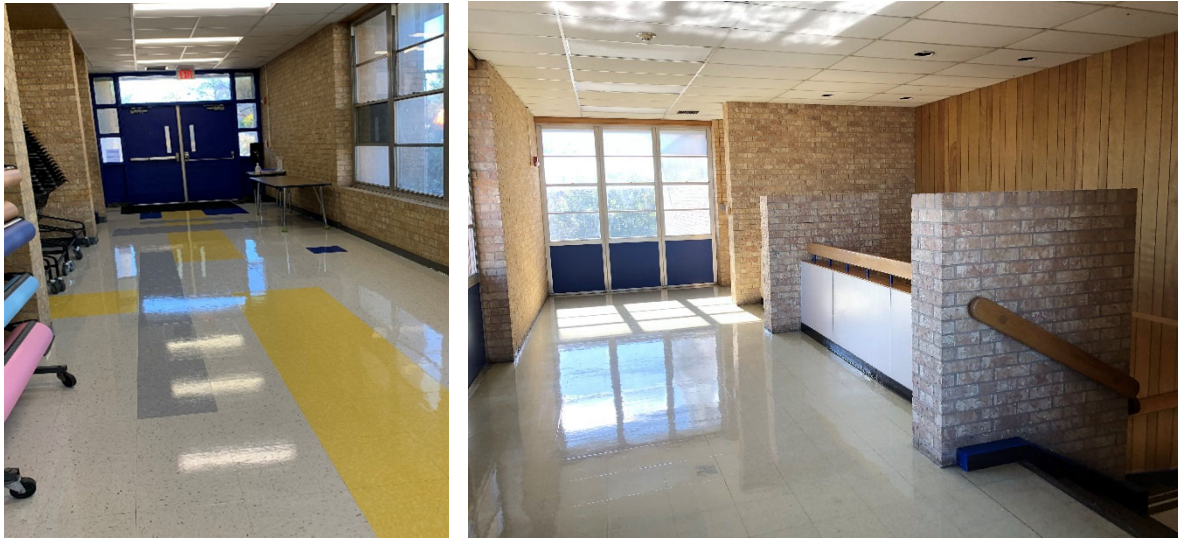
Corridors are generous and could provide opportunity to host informal interaction and/or breakout functions. The school currently does use this space for interventionists by setting up tables and chairs.

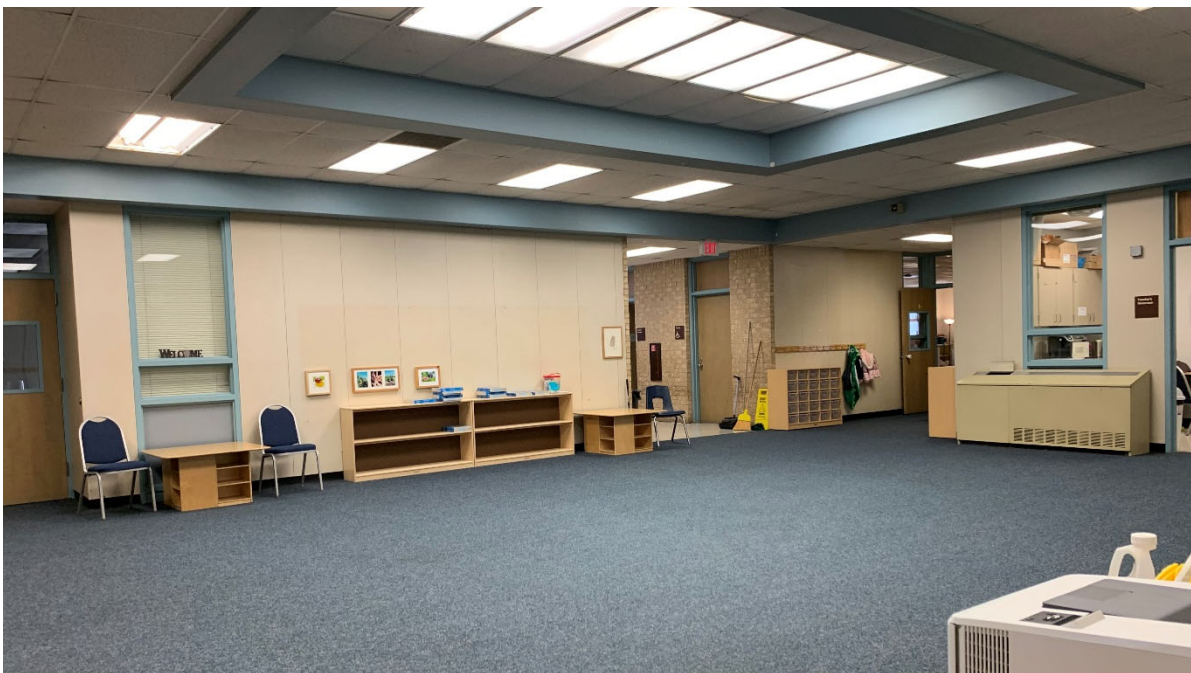
The annex building contains a large breakout space between studios.

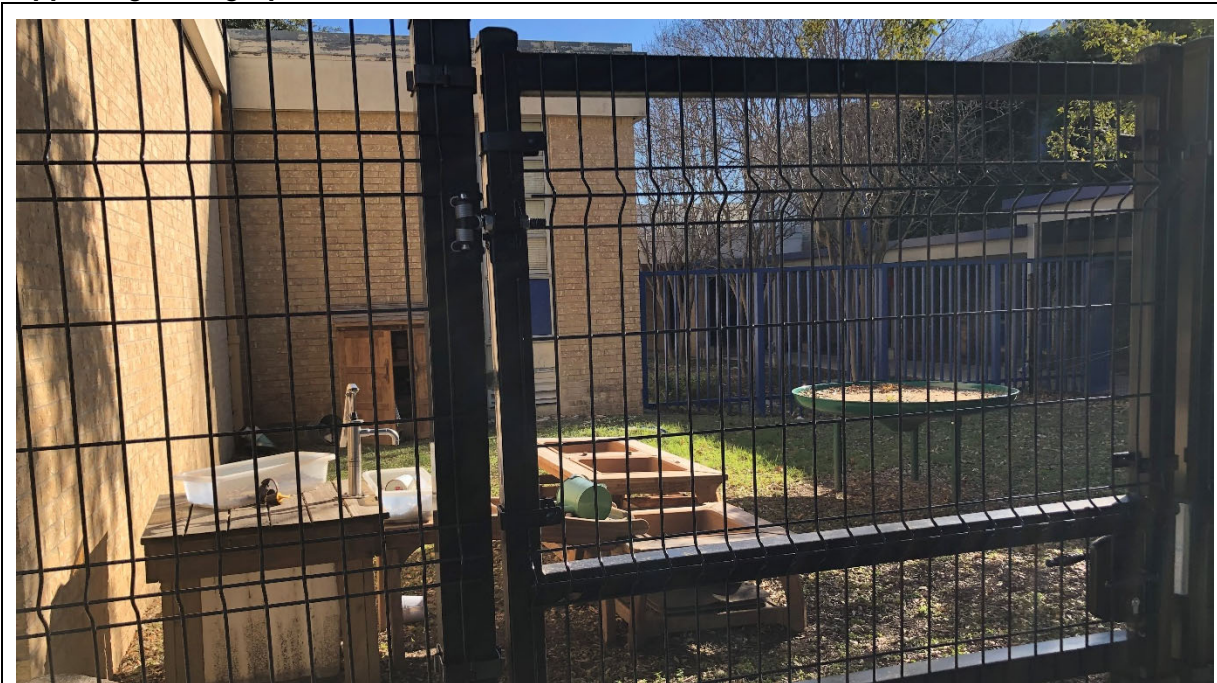
There are two enclosed areas outside for younger students.

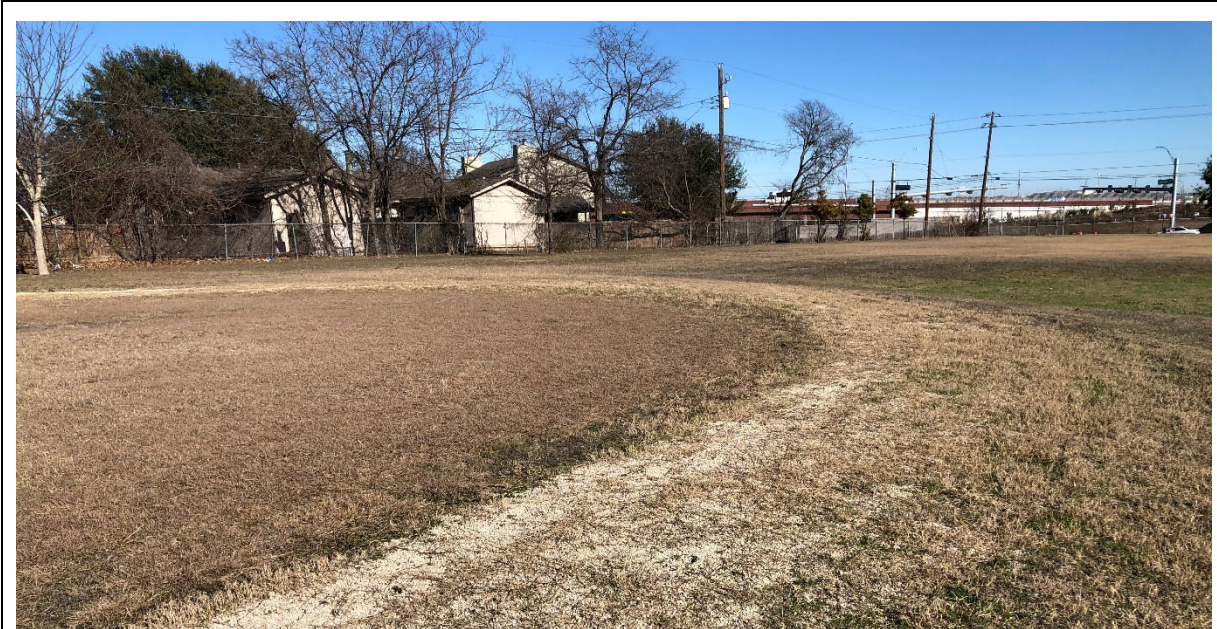
The school grounds are underdeveloped. There is a dirt track in the main field but needs maintenance to function well.

2.7	Does the school have a learning pond? (optional)					5			<p>Comments</p> <p>0.00 0.00</p>
1	No								
5	Yes								
2.8	Does the school have a grass play field and walking trail?					5			<p>Comments</p> <p>1.00 5.00</p>
1	No	Yes, but it needs maintenance and is very grown over							
5	Yes
