Educational Suitability Summary Report

Wooldridge Elementary School

Date: 01/14/2021

Score 56% Average

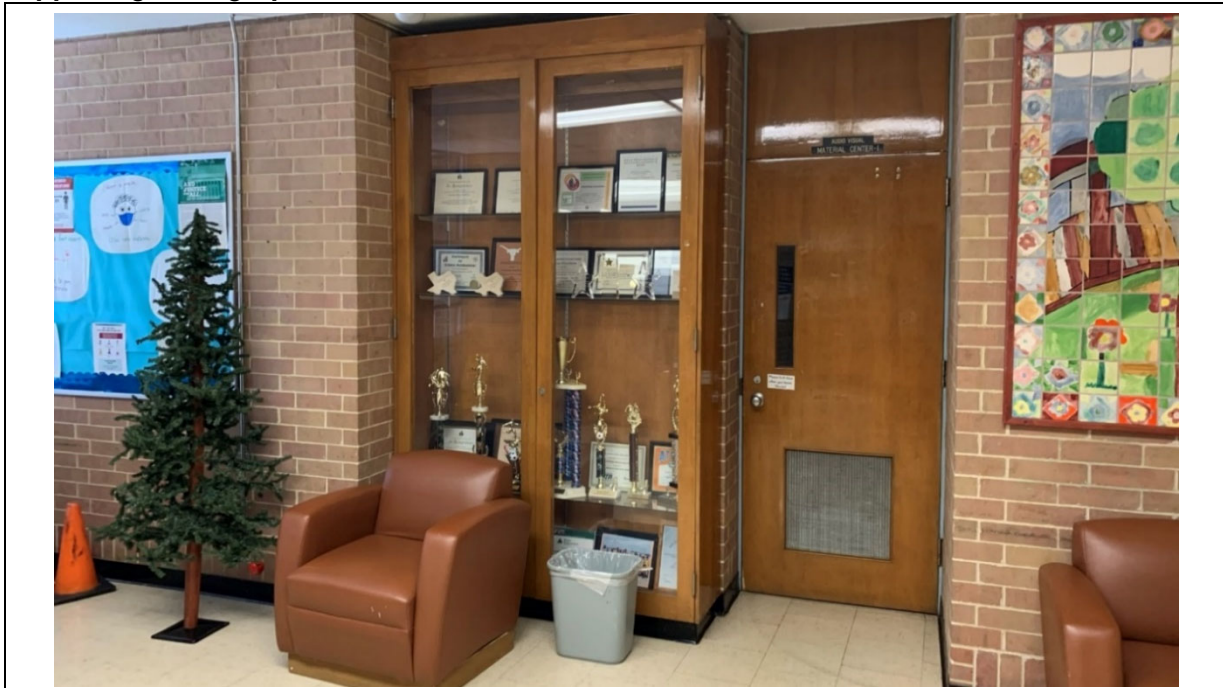
Main Entry: This display case is the only one found in the building. The adjacent room, which was at one point used for A/V, is now a storage and conference room for administration.

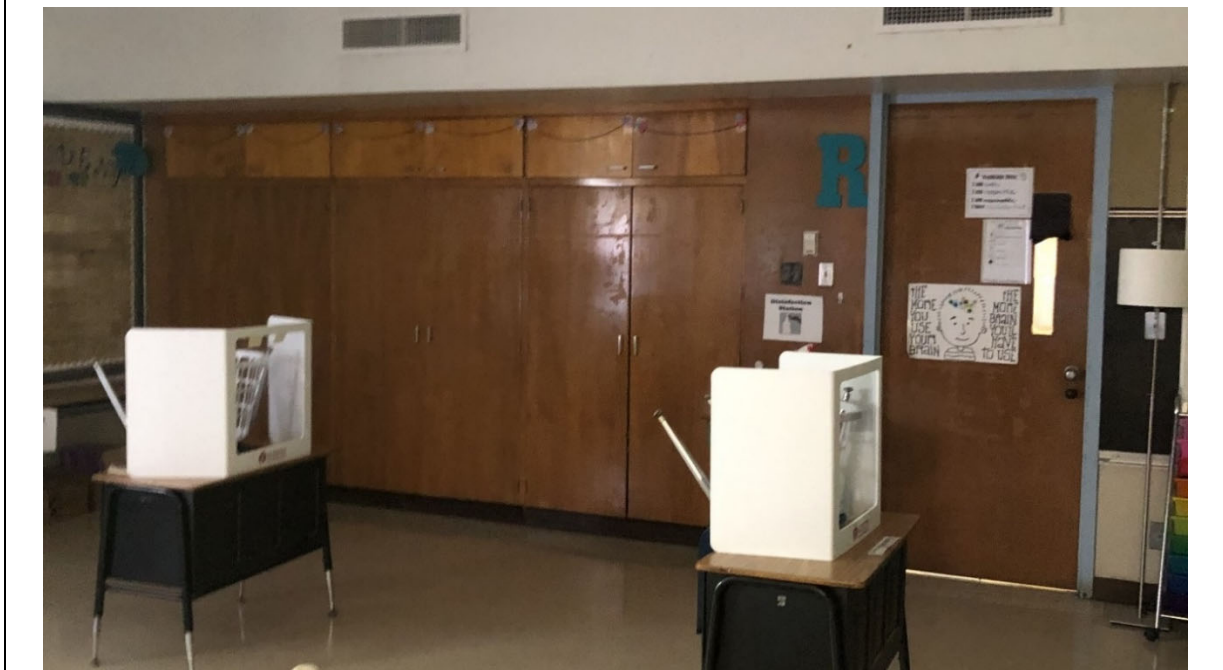
Typical Studio (Main Building): Each studio has existing built-in storage that is underutilized and discourages flexibility. There is no visibility into corridors.

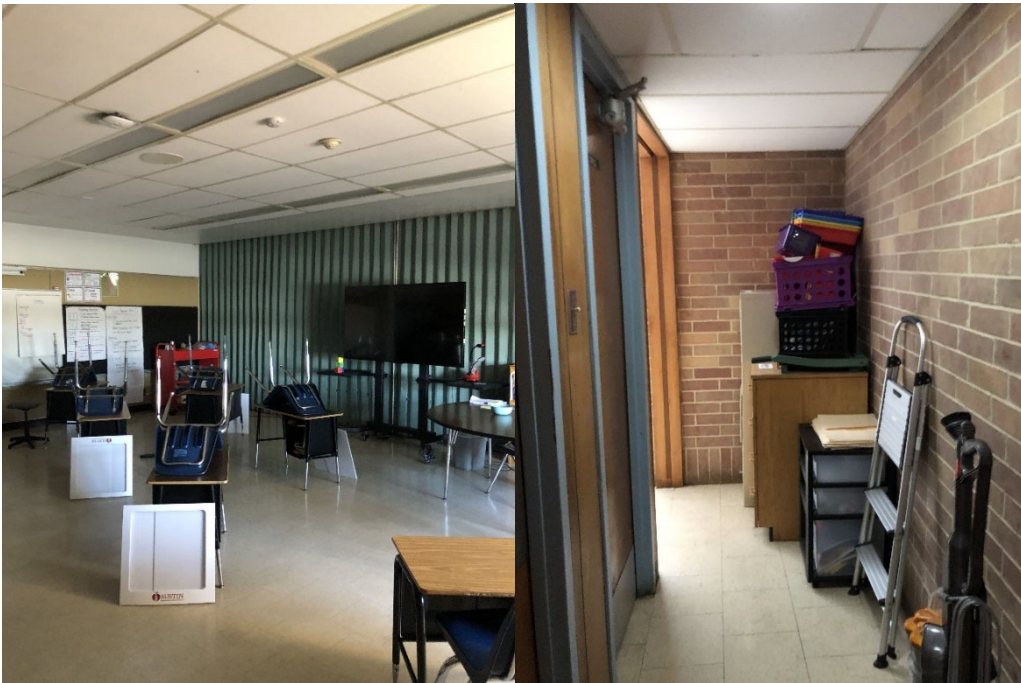
Typical Studio (Main Building): Two studios are separated by an accordion wall. The hallway connecting these two studios is small and often gets filled with storage.

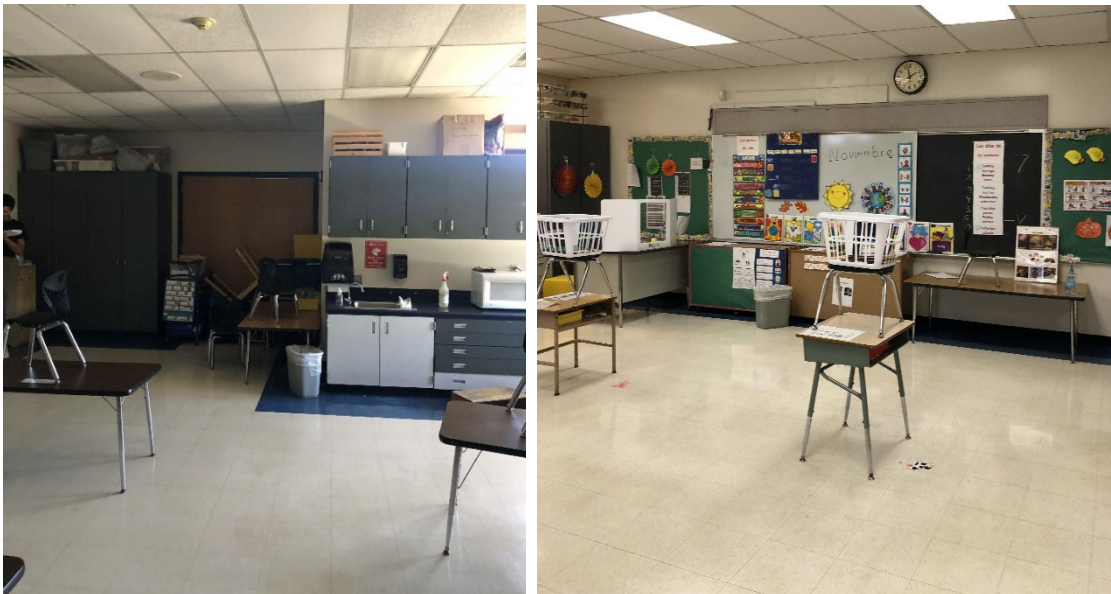
Pre-K Studios: Each studio in the pre-K building has one teaching wall, adequate storage, and a wide double door that opens to the adjacent studio. The restrooms are accessible and the connections between studios have no doors. The double doors do not appear to be utilized.

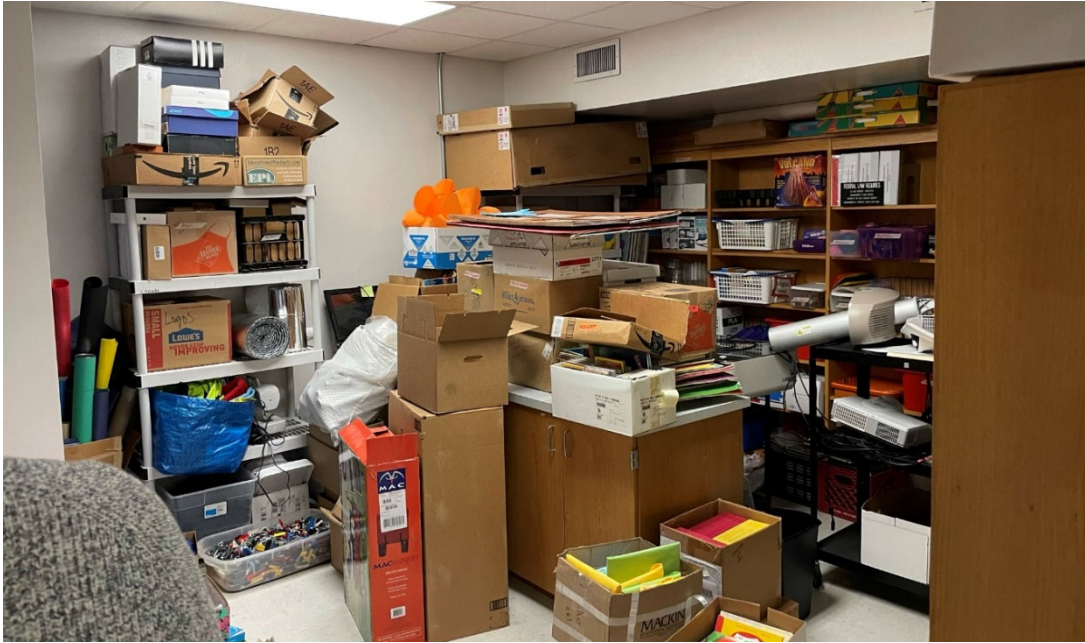
Maker Space: Maker space equipment and supplies are stored in this room, which is off the library. Items are pulled out of here and used in the library for activities. Storage is currently at a premium during Covid, and photo may not reflect conditions during normal school year.

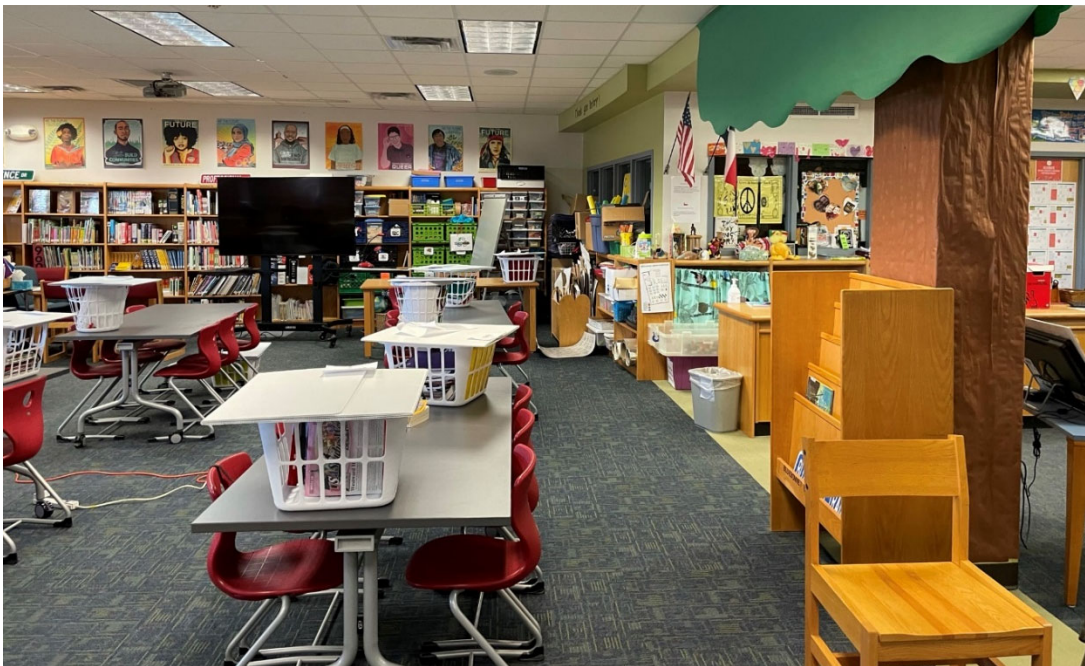
Media Center: Library is overcrowded with materials and could use additional storage. Existing furniture to be supplemented with additional updates in a refresh project during summer 2021.

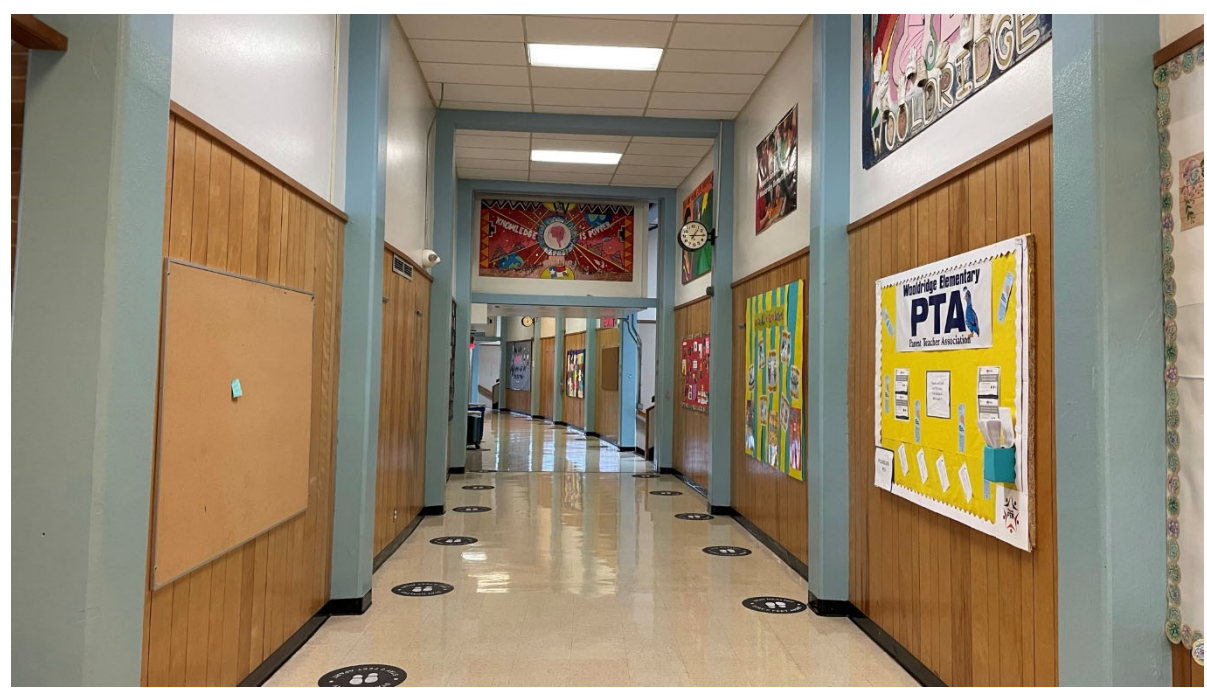
Corridor (Main Building): Corridors lack transparency, collaboration areas or display. There is very little natural light.

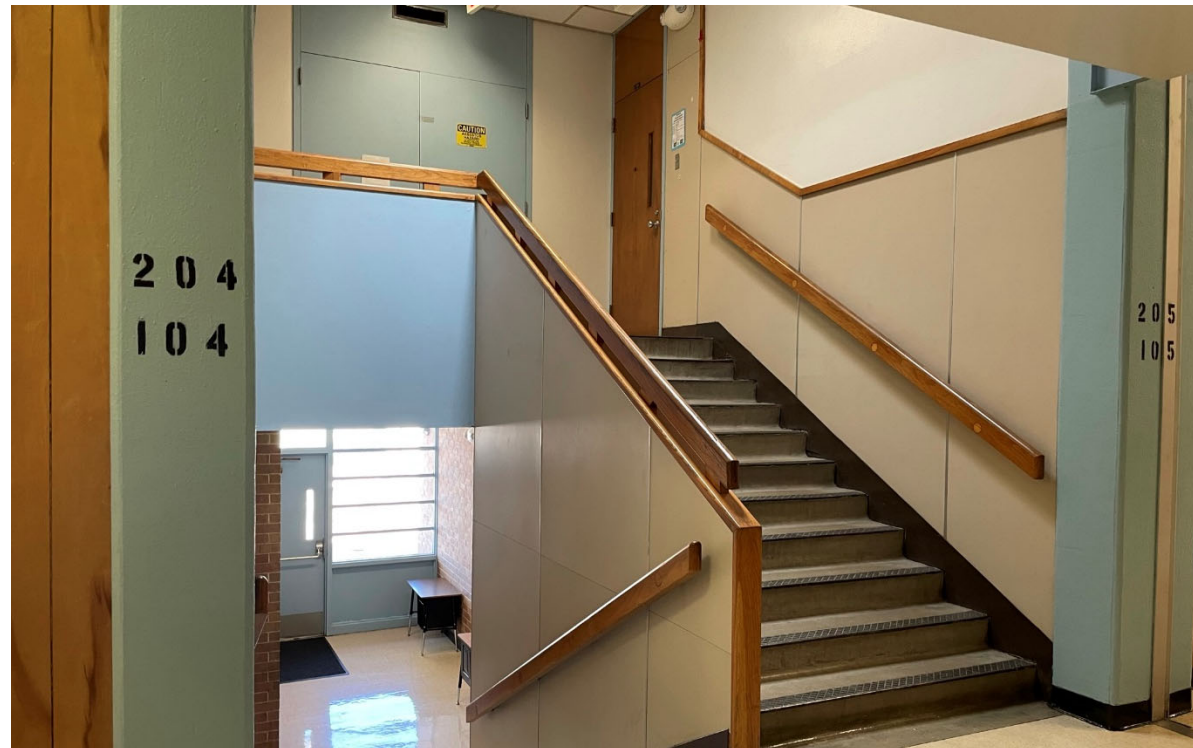
Corridors (Main Building): Studios can only be accessed from main corridor by going up or down a flight of stairs. A ramp and lift are provided at either end of the building

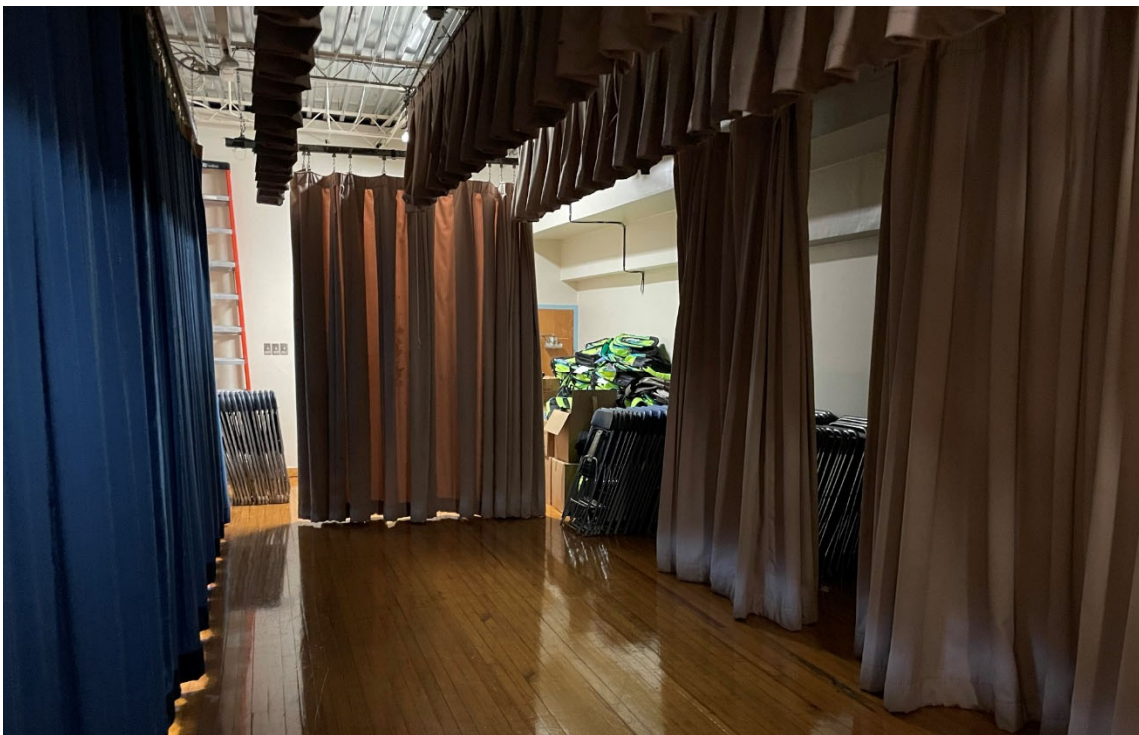
The stage in the cafeteria is not accessible and has no dedicated storage. There is no dedicated art or music studio – both are held in portables.

Visual and Performing Arts: Stage is not accessible and lacks storage.

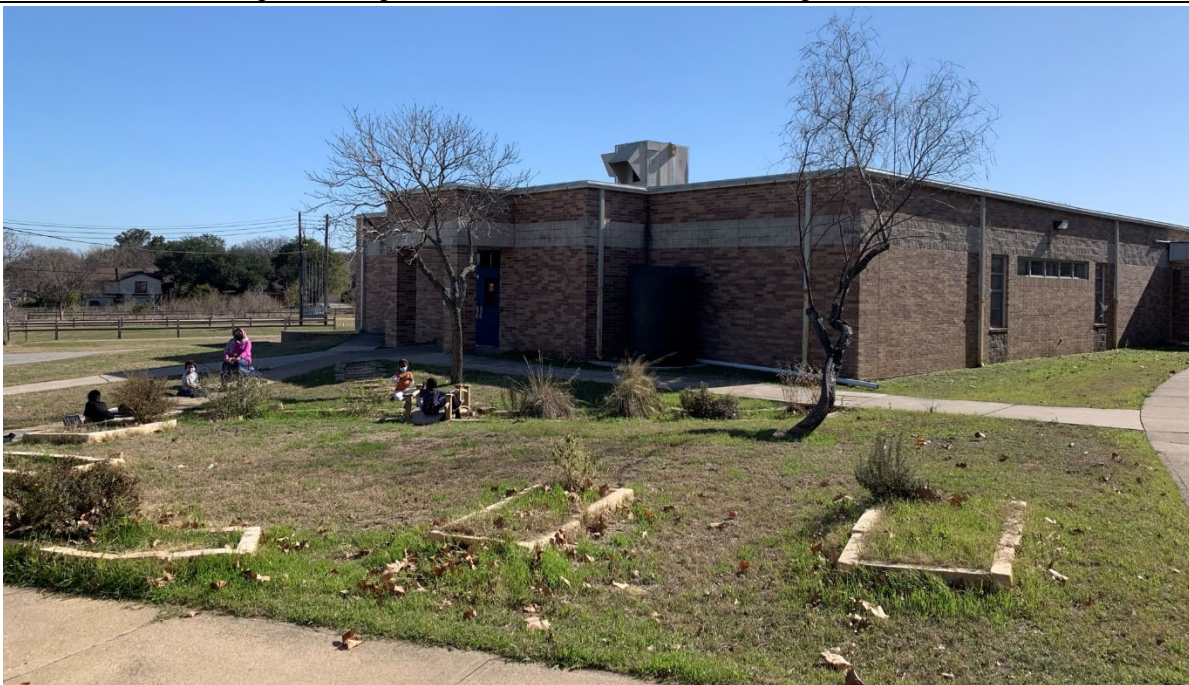
Exterior: Outdoor garden appears to be utilized but does not adequately support its use.
