FACILITY CONDITION ASSESSMENT

Lee ES | February 2022

Executive Summary

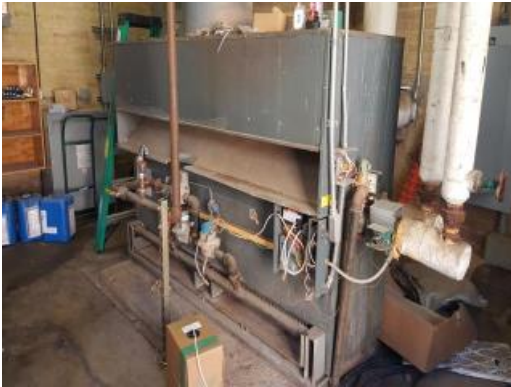
Boiler at end of its life

Deficiency	Category	Qty	UoM	Priority	Repair Cost	ID
Cast Iron Water Boiler Replacement Note: 1,670 MBH	Capital Renewal	1	Ea.	2	\$41,601	2029
Circulation Pump Replacement Note: 15 HP	Capital Renewal	2	Ea.	3	\$28,763	2041
Circulation Pump Replacement Note: 1.5 HP	Capital Renewal	2	Ea.	4	\$8,626	2036
Sub Total for System		3	items		\$78,990

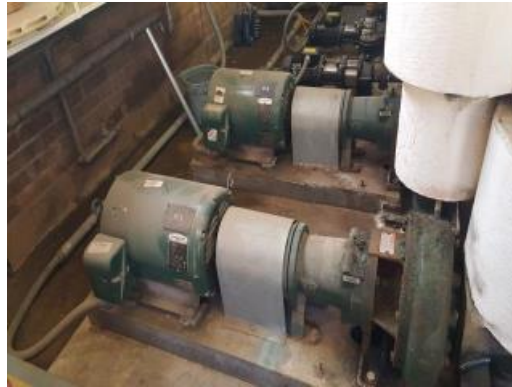
Circulating pumps at end of their life

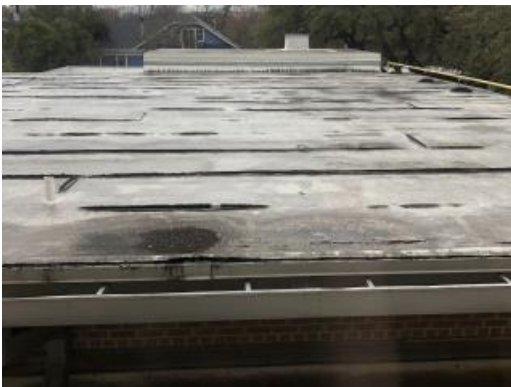
Deficient roofs

Deficiency	Category	Qty	UoM	Priority	Repair Cost	ID
Modified Roof Covering Replacement	Capital Renewal	36,571	SF	2	\$1,260,450	3805

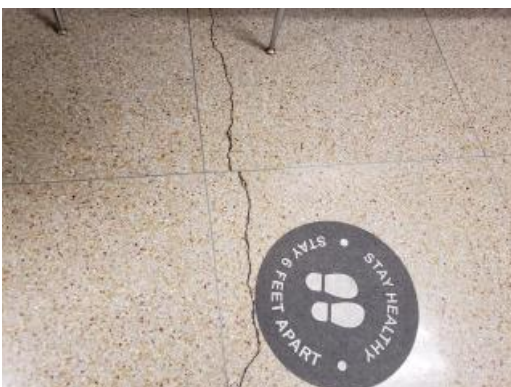
Cracked floor tiles

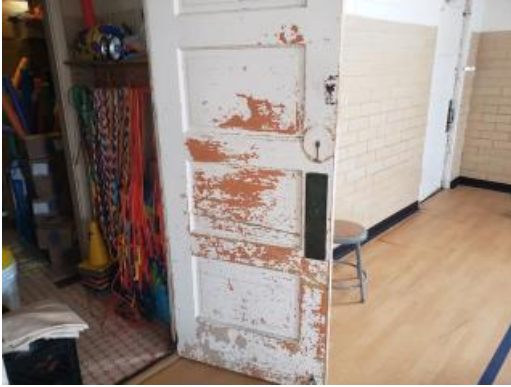
Aged wooden door

Deficiency	Category	Qty	UoM	Priority	Repair Cost	ID
Aluminum Window Replacement	Capital Renewal	48	SF	2	\$4,787	1921
Note: 4' x 4'						
Location: Kitchen						
Aluminum Window Replacement	Capital Renewal	24	SF	2	\$2,393	1922
Note: 3' x 2'						
Location: Kitchen Restrooms						
Aluminum Window Replacement	Capital Renewal	24	SF	2	\$2,393	1923
Note: 2' x 2'						
Location: Gym Restrooms						
Aluminum Window Replacement	Capital Renewal	360	SF	2	\$35,902	1924
Note: 10' x 4'						
Location: Gym						
Glass Wall Replacement (Bldg SF)	Capital Renewal	385	SF	2	\$26,156	1918
Note: Cracked and old glass block around steel windows.						
Metal Exterior Door Replacement	Capital Renewal	5	Door	2	\$18,535	3808
Steel Window Replacement	Capital Renewal	24	SF	2	\$3,469	1925
Note: 2' x 6'						
Location: Above street entrance doors						
Wood Exterior Door Replacement	Capital Renewal	22	Door	2	\$69,597	1929
Note: Old and deteriorated

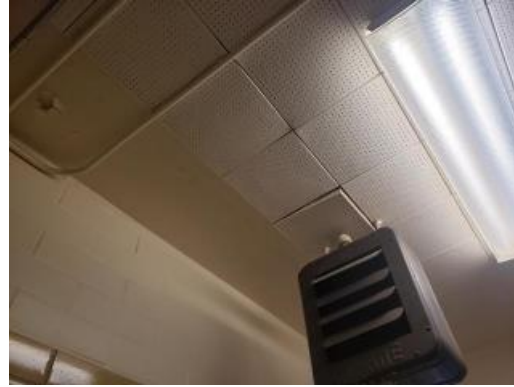
Aged acoustic ceiling tiles

Deficiency	Category	Qty	UoM	Priority	Repair Cost	ID
Interior Door Replacement Note: Original doors	Capital Renewal	65	Door	3	\$121,914	1941
Adhered Acoustical Ceiling Tile Replacement Note: Severe water damage in most east side classrooms	Capital Renewal	19,248	SF	4	\$134,114	1936
Vinyl Composition Tile Replacement Note: In poor condition particularly in the auditorium and cafeteria, but entire building is due for replacement.	Capital Renewal	27,717	SF	4	\$226,663	1939
Wood Flooring Repair Note: Refinish stage floor	Deferred Maintenance	1,155	SF	4	\$19,130	1940
Interior Ceiling Repainting Location: North Stairwell	Deferred Maintenance	300	SF	5	\$625	1938
Sub Total for System		6 items			\$548,469

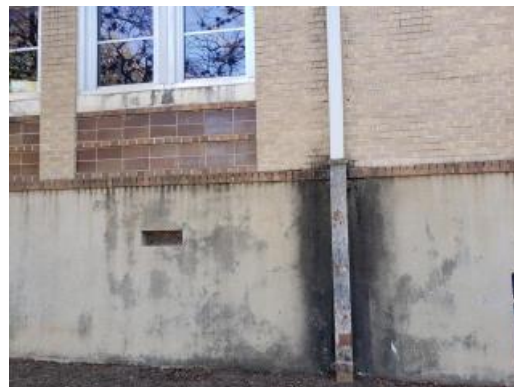
Stained exterior walls

Exterior Cleaning	Deferred Maintenance	500	SF Wall	5	\$1,936	1919
Note: Moisture stains near downspouts						
Sub Total for System	9	items			\$165,169
