FACILITY CONDITION ASSESSMENT

Navarro ECHS | February 2022

Executive Summary

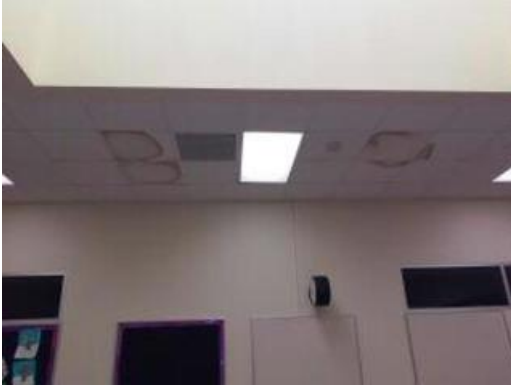
Stained acoustical tile flooring

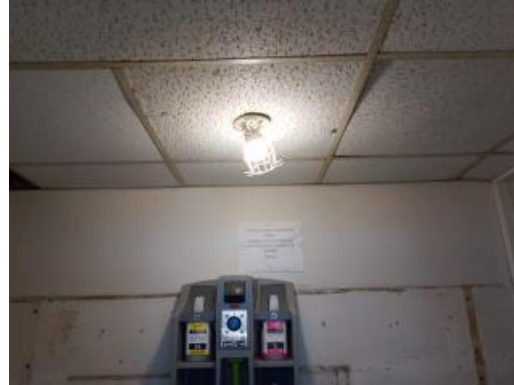
Aged acoustic ceiling tile

Deficiency	Category	Qty	UoM	Priority	Repair Cost	ID
Acoustical Ceiling Tile Replacement	Capital Renewal	35,083	SF	4	\$118,467	4102
Note: Beyond useful life						
Ceiling Grid Replacement	Capital Renewal	35,083	SF	4	\$146,094	4101
Note: Beyond useful life						
Stone/Quarry Flooring Replacement	Capital Renewal	5,613	SF	4	\$153,441	4103
Note: Beyond useful life

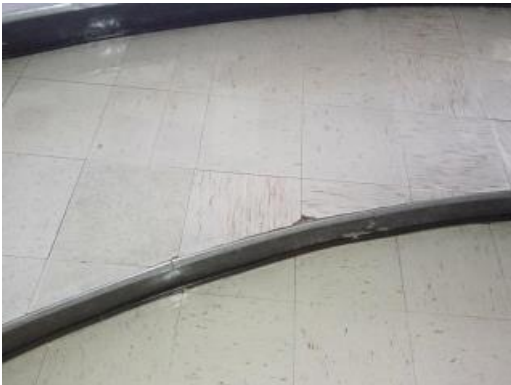
Worn vinyl composition tile flooring

Deficiency	Category	Qty	UoM	Priority	Repair Cost	ID
Vinyl Composition Tile Replacement Note: Old/Damaged/Beyond life	Capital Renewal	45,000	SF	4	\$367,997	4104
Sub Total for System		4	items		\$785,999

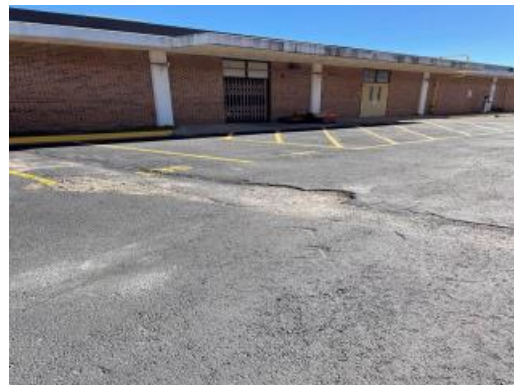
Aged asphalt paving

Deficiency	Category	Qty	UoM	Priority	Repair Cost	ID
Asphalt Driveway Replacement	Capital Renewal	7,996	SF	3	\$51,418	3695
Note: Drive aisle on north side of school has various potholes, and drive aisle wrapping around west side of building has uneven pavement which need to be repaved Location: North drive aisle, drive aisle west of building						
Asphalt Paving Resurfacing	Deferred Maintenance	350	SF	4	\$1,456	3694
Note: Cracked and broken, needs repaving Location: Parking spot 138						
Fencing Replacement (4' Chain Link Fence)	Capital Renewal	10	LF	4	\$472	3675
Location: Next to parking along Fairfield Dr.						
Gate Replacement	Deferred Maintenance	1	Ea.	4	\$617	3678
Location: Between parking lot along wood fence and band practice area						
Gate Replacement	Deferred Maintenance	5	Ea.	4	\$3,085	4098
Site Drainage Needs Installation Of Drainage Piping	Deferred Maintenance	2	LF	4	\$127	3697
Note: Several downspouts at portables near track are pinched shut, impeding drainage. Needs replacement. Location: Portables near track

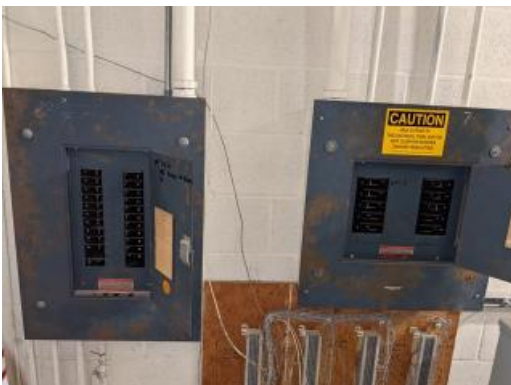
Aged electrical distribution panels
