FACILITY CONDITION ASSESSMENT

Sunset Valley ES | February 2022

Executive Summary

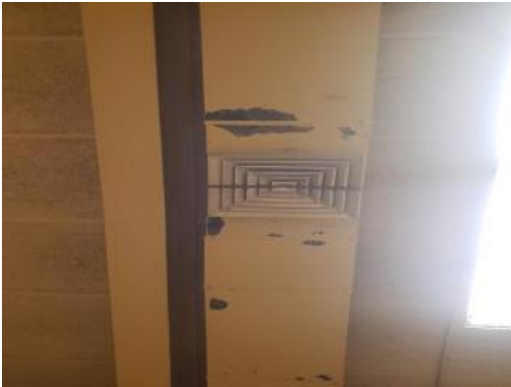
Ductwork is at end of life

Deficiency	Category	Qty	UoM	Priority	Repair Cost	ID
Ceiling Exhaust Fan Replacement	Capital Renewal	4	Ea.	4	\$1,947	2472
Ductwork Repair	Deferred Maintenance	20	LF	4	\$115	2379
Note: rust/exposed						
Location: gym						
Sub Total for System		4	items		\$174,567

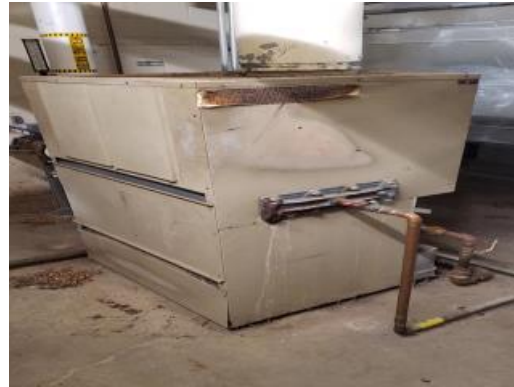
625 MBH boiler at end of life

Deficiency	Category	Qty	UoM	Priority	Repair Cost	ID
Boiler Replacement Note: age/condition Location: mech room	Capital Renewal	1	Ea.	2	\$24,593	2374
Boiler Replacement	Capital Renewal	1	Ea.	2	\$147,912	2375

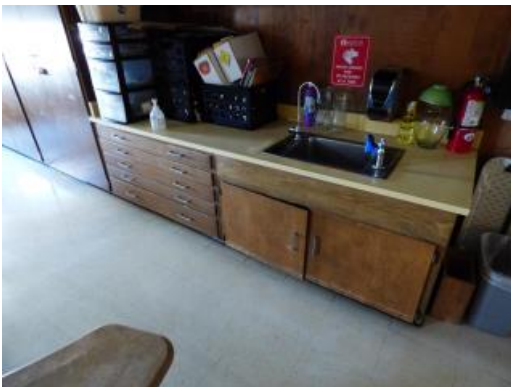
Aged cabinets

Deficiency	Category	Qty	UoM	Priority	Repair Cost	ID
Base Storage Cabinet Replacement	Capital Renewal	280	LF	4	\$154,293	2362
Note: replace due to age						
Location: various						
Replace Cabinetry In Classes/Labs	Capital Renewal	37	Room	4	\$325,669	3523
Upper Storage Cabinet Replacement	Capital Renewal	250	LF	4	\$268,730	2363
Note: replace due to age						
Location: various						
Sub Total for System		3	items		\$748,693

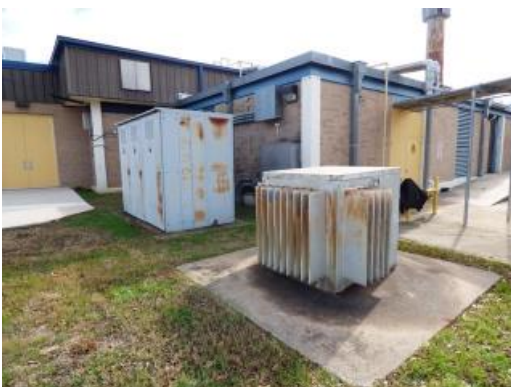
Aged exterior electrical service

Deficiency	Category	Qty	UoM	Priority	Repair Cost	ID
Exterior Electrical Enclosure Replacement	Deferred Maintenance	2	Ea.	2	\$1,430	2455
Note: Site transformer is aged						
Sub Total for System		1	items		\$1,430	
Sub Total for School and Site Level		6	items		\$1,412,543
