FACILITY CONDITION ASSESSMENT

Zavala ES | February 2022

Executive Summary

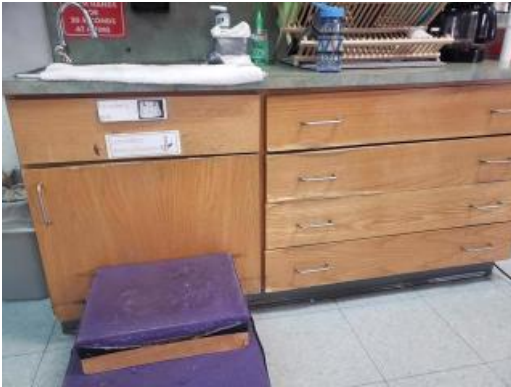
Casework finish is worn and damaged

| Deficiency | Category | Qty | UoM | Priority | Repair Cost | ID |
|---|---|---|---|---|---|---|
| Replace Cabinetry In Classes/Labs | Capital Renewal | 30 | Room | 4 | \$264,056 | 2500 |

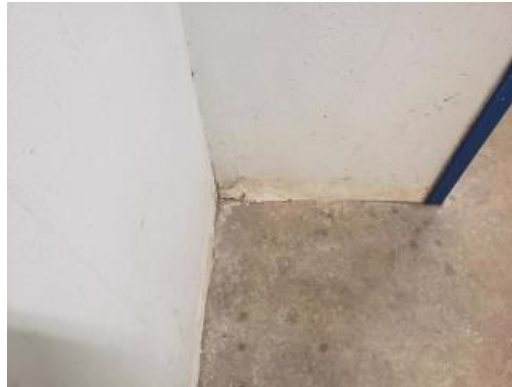
Damaged wall seal

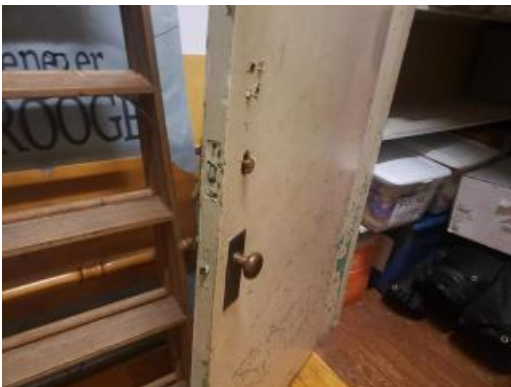
Damaged door

| Deficiency | Category | Qty | UoM | Priority | Repair Cost | ID |
|---|---|---|---|---|---|---|
| Interior Door Replacement | Capital Renewal | 60 | Door | 3 | \$112,536 | 2498 |

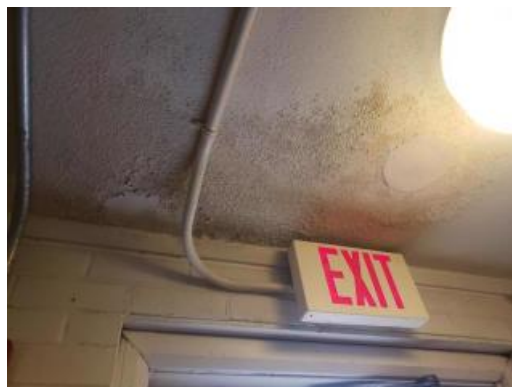
Stained plaster ceiling

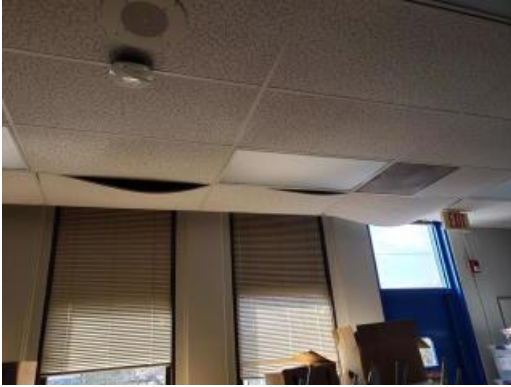
Warped/damaged acoustical ceiling tile

| Deficiency | Category | Qty | UoM | Priority | Repair Cost | ID |
|---|---|---|---|---|---|---|
| Acoustical Ceiling Tile Replacement | Capital Renewal | 400 | SF | 4 | \$1,351 | 2496 |
| Note: Wet tiles in various places. | | | | | | |

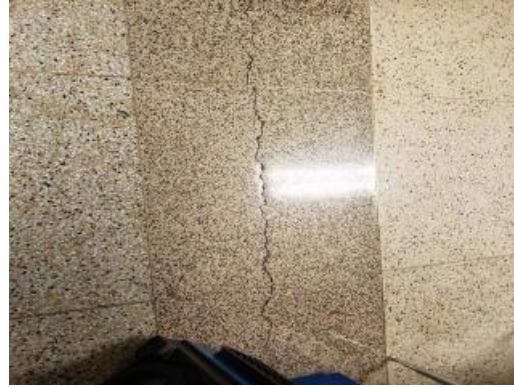
Cracked terrazzo

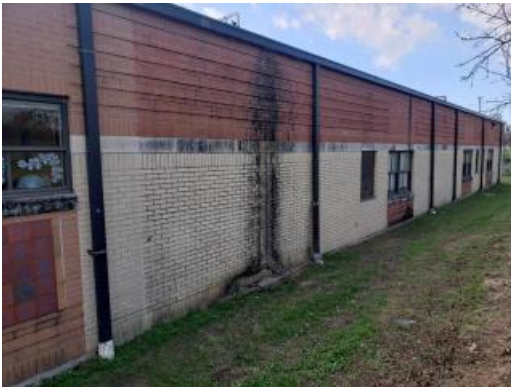
Stained brick wall

| Deficiency | Category | Qty | UoM | Priority | Repair Cost | ID |
|---|---|---|---|---|---|---|
| Exterior Cleaning | Deferred Maintenance | 1,000 | SF Wall | 5 | \$3,873 | 2493 |
| Note: Primarily near downspouts | | | | | | |

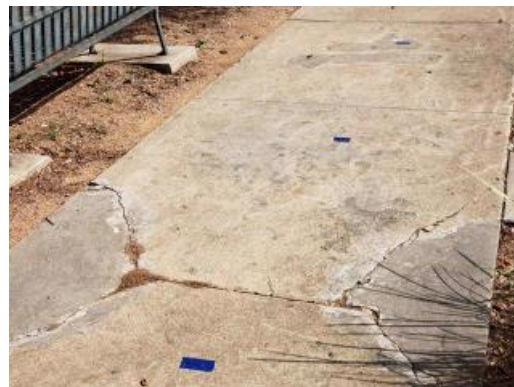
Damaged sidewalk

| Deficiency | Category | Qty | UoM | Priority | Repair Cost | ID |
|---|---|---|---|---|---|---|
| Concrete Walks Replacement | Capital Renewal | 30 | SF | 3 | \$340 | 2492 |
| Note: Sidewalks near flagpole are damaged. | | | | | | |

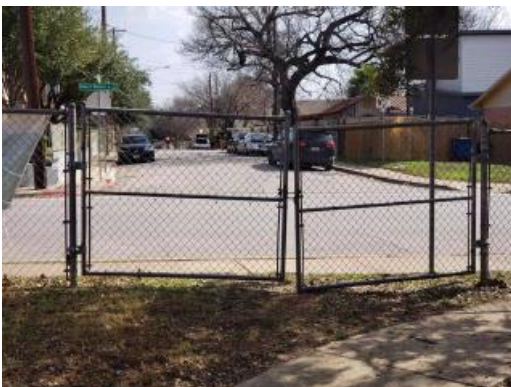
Warped/damaged gate

| Deficiency | Category | Qty | UoM | Priority | Repair Cost | ID |
|---|---|---|---|---|---|---|
| Gate Replacement | Deferred Maintenance | 1 | Ea. | 4 | \$617 | 2491 |
| Note: Gate by front playground is sagging. | | | | | | |
