# FACILITY CONDITION ASSESSMENT

*Doss ES* | February 2022

Doss ES is located at 7005 Northledge Dr in Austin, Texas. The oldest building is 10 years old (at time of 2020 assessment). It comprises 61,101 gross square feet.

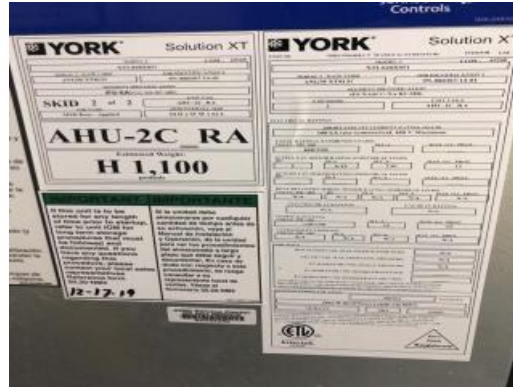
Air handling unit name plate

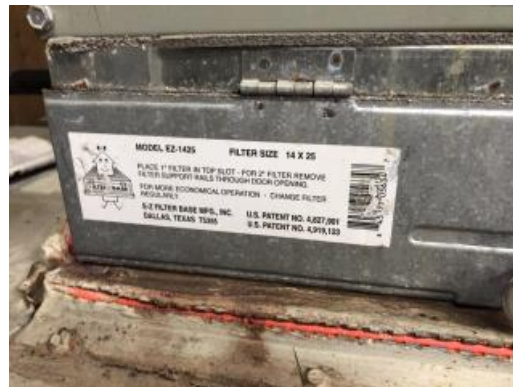
Mechanical name plate
