FACILITY CONDITION ASSESSMENT

Menchaca ES | February 2022

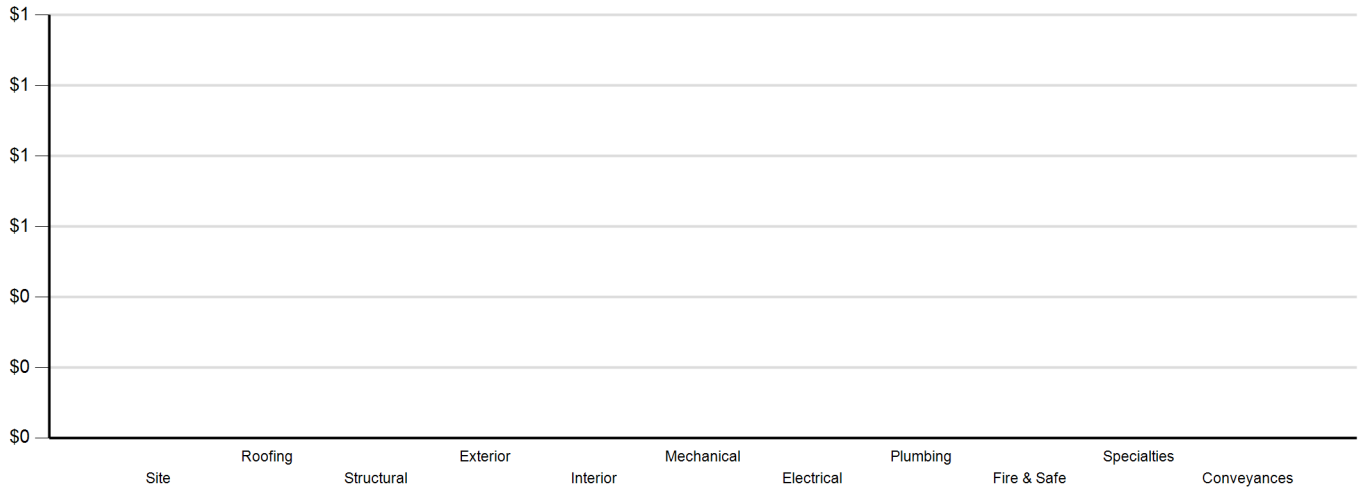
Figure 1: System Deficiencies

The chart below represents the building systems and associated deficiency costs.

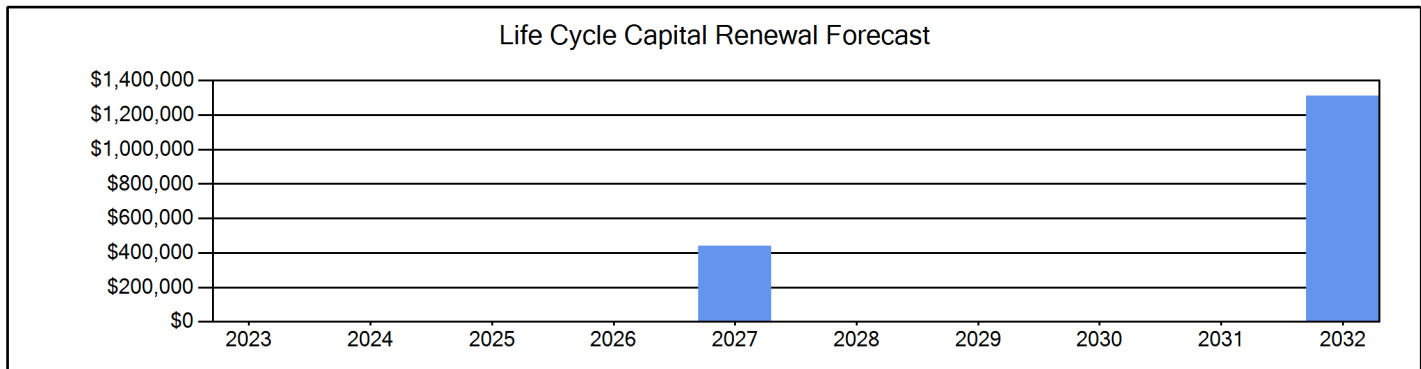
Figure 2: Ten Year Capital Renewal Forecast

The following tables show current deficiencies and the subsequent ten-year life cycle capital renewal projections. The projections outline costs for major building systems in which a component is expected to reach the end of its useful life and require capital funding for replacement.

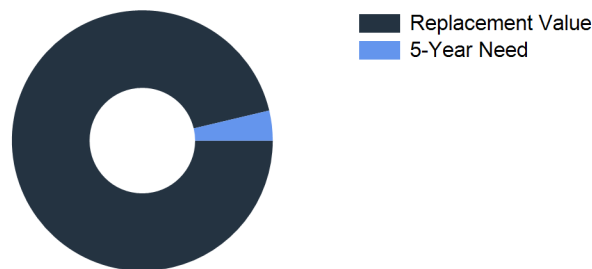
Figure 3: 5-Year FCA

The replacement value represents the estimated cost of replacing the current building with another building of like size, based on today’s estimated cost of construction in the Austin area. The estimated replacement cost for this facility is \$11,397,102. For planning purposes, the total 5-year need at the Menchaca ES is \$440,068 (Life Cycle Years 1-5 plus the FCA deficiency cost). The Menchaca ES facility has a 5-year FCA of 96.14%.

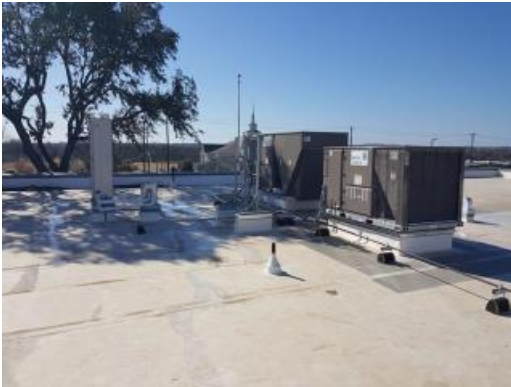
Rooftop heating ventilation and air conditioning units

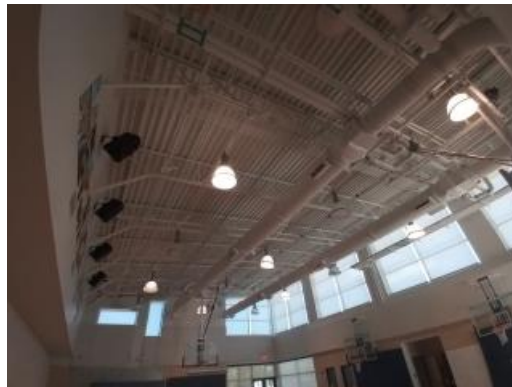
Gymnasium roof structure
